SERVICE BULLETIN 26

SUBJECT: GLASAIR RG NOSE GEAR DRAG BRACE REINFORCEMENT

APPLICATION: GLASAIR RG LANDING GEAR SERIAL Nos. 01 thru 230  
(Serial number is stamped on the landing gear struts)

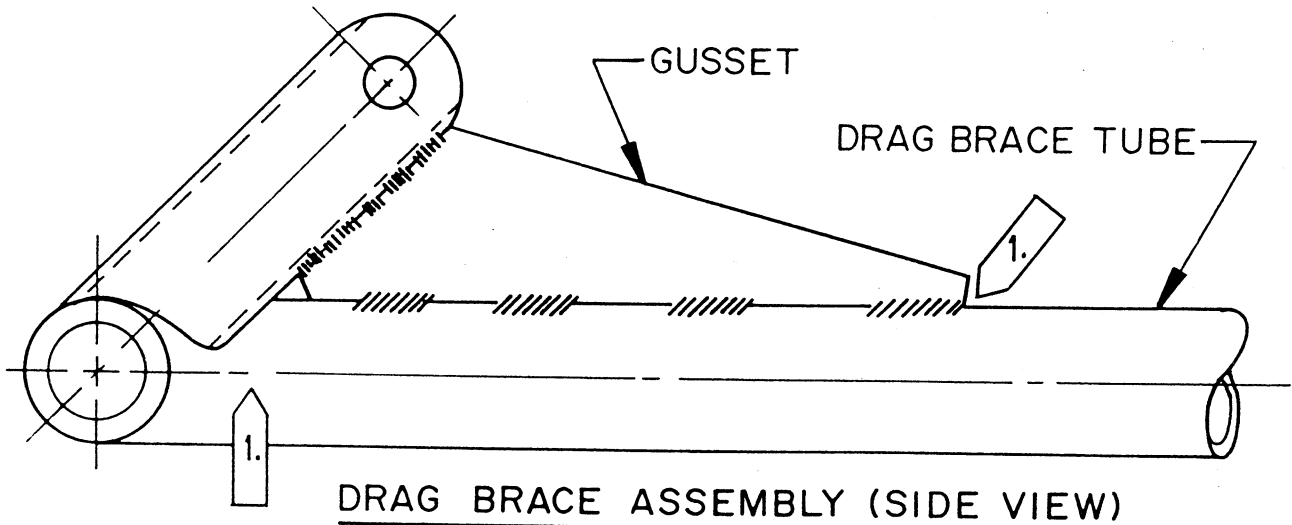
FIGURE (1)

1. INSPECT TUBE AND GUSSET FOR CRACKING

COMPLIANCE: MANDATORY All Glasair RG's currently flying must comply with the nose gear drag brace reinforcement prescribed in this service bulletin by July 1, 1987. A pre-flight inspection of the drag brace, in the areas indicated by Flag no. 1 in FIGURE (1), must be performed prior to each flight until compliance with this service bulletin is made.

NOTE: Fatigue cracking and drag brace failure has been reported on several Glasair RGs. Possible causes of this condition are:

1. An over-load of the drag brace resulting from improper adjustment of the hydraulic actuator piston rod.
2. A fatigue condition occurring over time.
3. A combination of both conditions.

Glasair RG nose gear drag braces with landing gear serial numbers 01 thru 70 are made from 3/4" O.D. x .035" wall 4130 steel tubing; drag braces with serial numbers 71 thru 230 (approx.) use 3/4" O.D. x .049" wall tubing; and drag braces with serial numbers 231 thru 290 use 3/4" O.D. x .083 wall tubing and a thicker .080" gusset. To determine whether your drag brace has the heaviest tubing (.083" wall thickness), measure the thickness of the gusset that spans from the right brace tube to the actuator arm (short square tube). The gusset thickness is .080" thick on drag braces fabricated from .083" wall 4130 tube. Drag braces with .083" wall thickness tubing are strong enough to withstand some adjustment error over time. Drag braces with the thinner wall tubing (.035" and .049") do not have adequate strength and, therefore, must be reinforced.

SOLUTION: All Glasair RGs with earlier drag braces (landing gear serial numbers 01 through approximately 230) manufactured with the thinner wall tubing (.035" and .049"), must have the drag brace arms on the hydraulic actuator side reinforced. To accomplish this we list three options:

The thin wall tubing drag braces can be reworked by the removing the original gusset, sleeving the existing right side brace tube and installing a heavier gusset.
