SERVICE BULLETIN 28

SUBJECT: FITTING OF VARIOUS GLASAIR I PARTS TO GLASAIR II FUSELAGE

APPLICATION: BUILDER OPTION

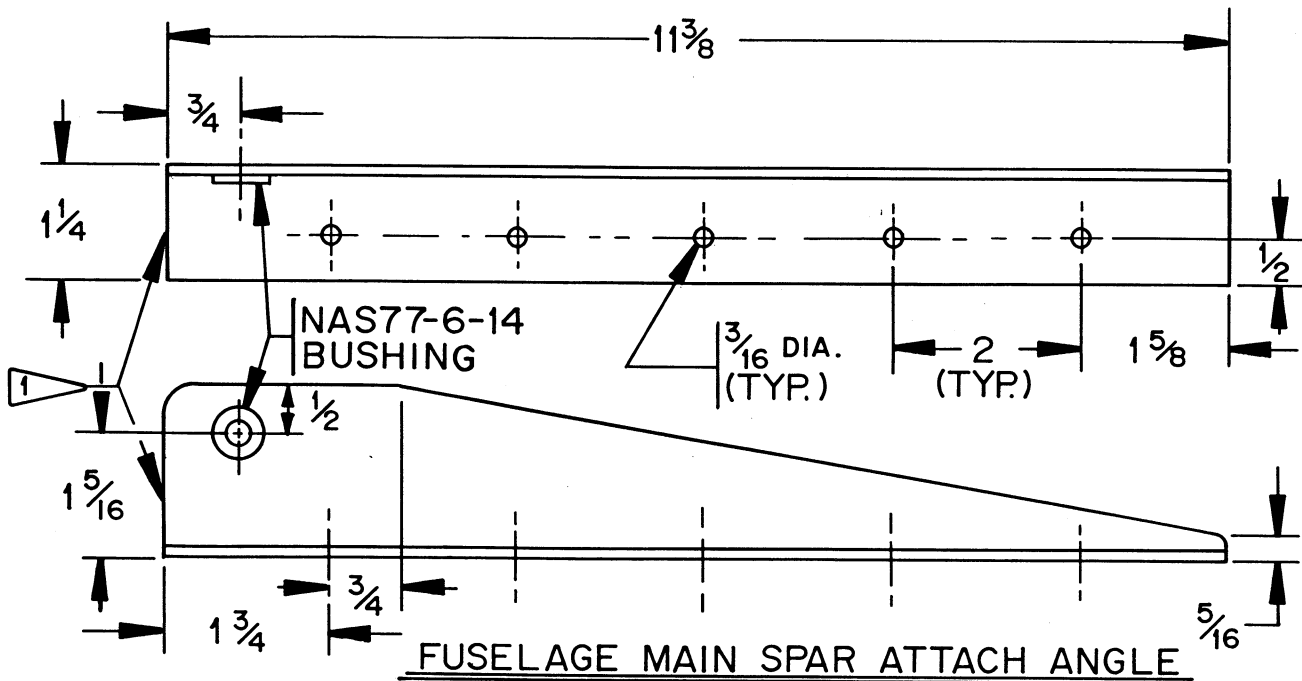
FIGURE (1)

When using a Glasair I wing with a Glasair II fuselage, wider fuselage main spar attach angles must be fabricated, as shown in FIGURE (1), from material supplied in the upgrade kit. Use these angles when mating the wing to the fuselage, as described in the Wing to Fuselage Installation subdivision of the Final Assembly section of your original Glasair Instruction Manual.

Fabricate the fuselage main spar attach angles from 2" x 1-1/4" x 1/8" 2024-T3 aluminum angle, as shown in FIGURE (1).

NOTE: Make (4) fuselage main spar attach angles: (2) identically alike and (2) the exact mirror image of the first two.

File any saw-cut roughness smooth and deburr. Scuff the parts with a fine "scotch brite" pad and wipe with acetone to prepare for painting. Spray the parts with a light coat of zinc chromate or epoxy primer to prevent corrosion.

To drill the holes for the NAS77-6-14 bushings, start with a 1/8" pilot hole and then step drill to enlarge the hole to size. For the final hole size, use a sharp drill bit just smaller than .500" and then ream the hole to size with a .500 reamer. The O.D. of the bushings are slightly larger than 1/2" (.5013"), so a press fit can be achieved if the holes are not drilled too large. We suggest using a drill press or a vise, if a small press is not available, to press the NAS77-6-14 bushings into the angles. Make sure the bushing collars are on the "outsides" of the angles, as shown.

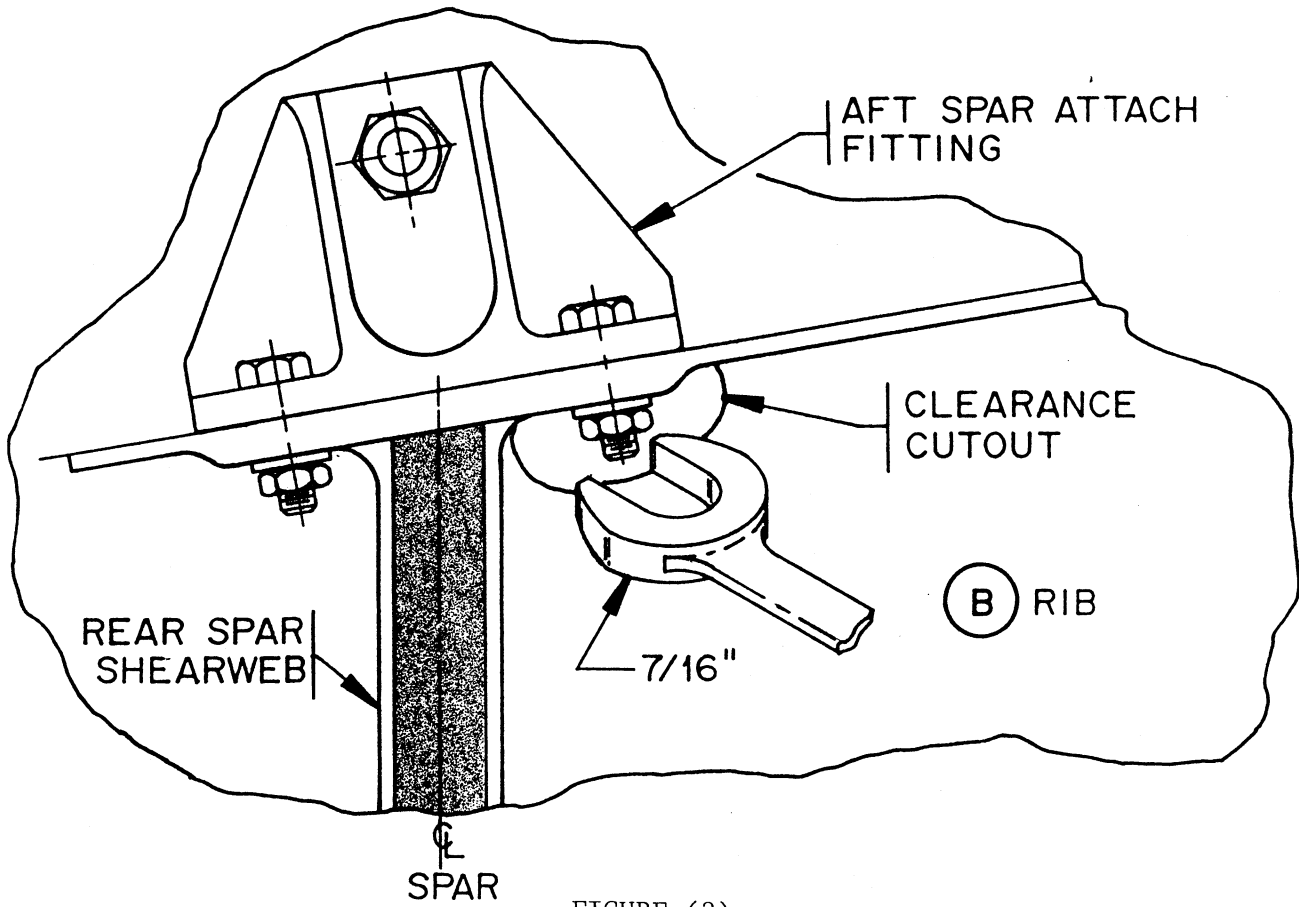
FIGURE (2)

Because of the extra width of the Glasair II fuselage, the rear spar attach fittings must be moved outboard about 1-1/2" which places them very close to the inboard sides of the "B" ribs in the wing. If building an RG or a TD, the builder must carve out areas of the "B" ribs to provide clearance for the nuts that secure the attach fittings to the rear spar cap. Grind or carve away the minimum amount of "B" rib necessary to allow the AN364-428A nuts to fit the AN3-7A bolts. Allow sufficient clearance for an open end wrench to hold each nut, as shown in FIGURE (2). Make smooth radius corners on the clearance cutout.

NOTE: The "B" ribs on the FT model cannot be carved out in this area due to the unidirectional laminates in the upper edges of the ribs. If building an FT, install 3/16" aluminum spacers between the aft spar attach fittings and the insides of the fuselage panels to provide clearance from the "B" rib reinforcement cap laminates. This change requires longer bolts (AN4-15A instead of AN4-13A) for attaching the fuselage panels to the aft spar attach fittings.

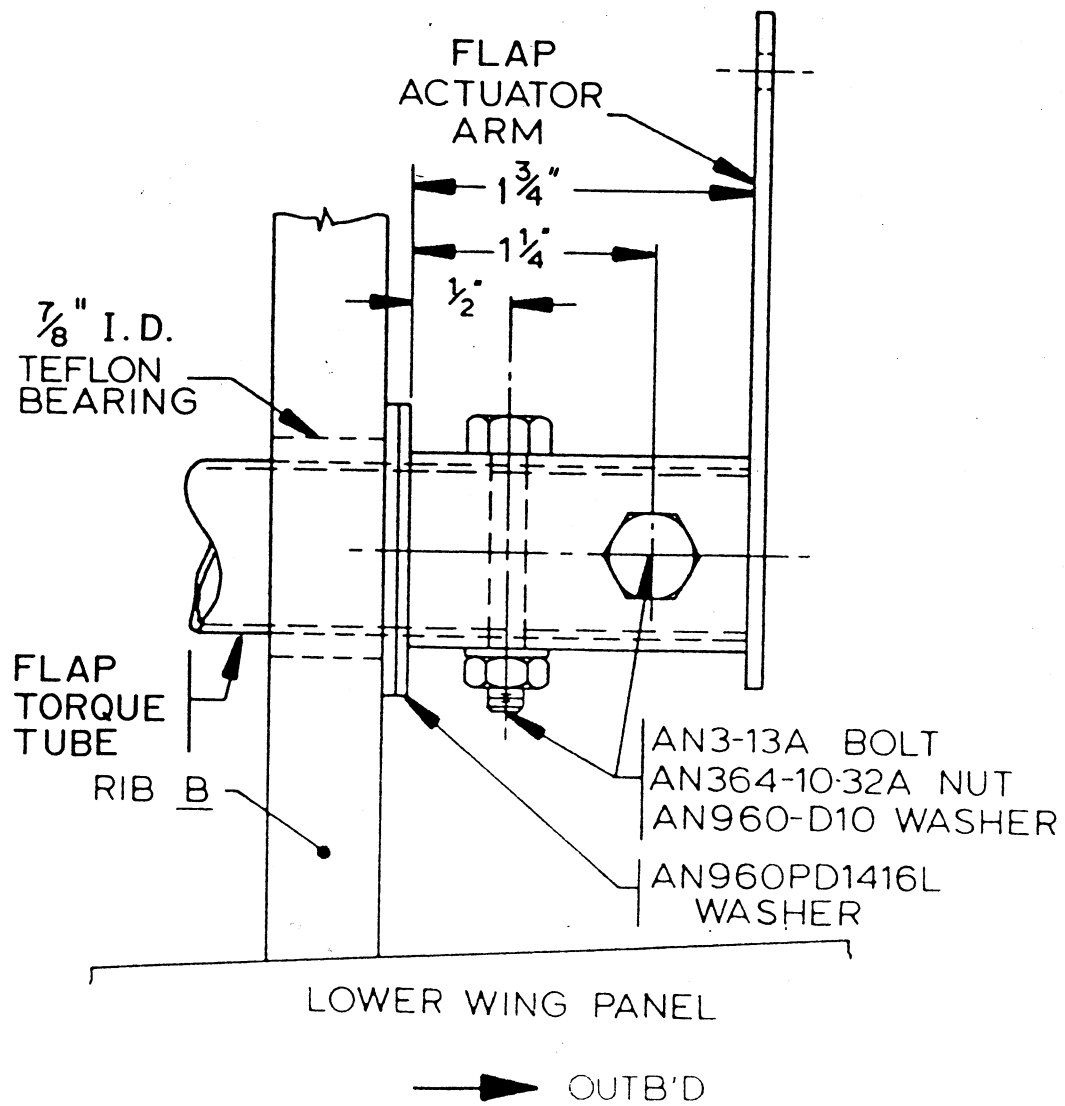
For FT and TD models of the Glasair I in which the wing ribs are already installed in their original locations, the flap actuator arm installation illustrated in FIGURE (3) must be used. This is the configuration of the flap linkage on the original Glasair I kits (by "original kits" we mean the earliest kits in which all the welding was left for the builder to complete), so, for these kits, no change in the flap linkage is required.

For later model Glasair I kits (kits for which all welding is completed during manufacture) that have already had the wing ribs installed, the flap actuator arms must be repositioned to align with the repositioned flap actuator fittings. For these airplanes, use a longer flap torque tube, install a 7/8" I.D. flanged teflon bearing in the B rib in place of the 1" I.D. bearing originally supplied, shorten the tubular part of the flap actuator arm to a 1-3/4" length, and assemble the components as shown in FIGURE (3). The longer flap torque tubes, 7/8" I.D. flanged teflon bearings, and the AN960PD1416L thrust washer shown in FIGURE (3) are available as part of the upgrade kit. Please call to request these parts if you fall into this category.
