SERVICE BULLETIN 32

SUBJECT: GLASAIR III ENGINE MOUNT AND FIREWALL TEMPLATE.

APPLICATION: Glasair III kits; S/N 3001 thru 3009
S/N 3011 thru 3014

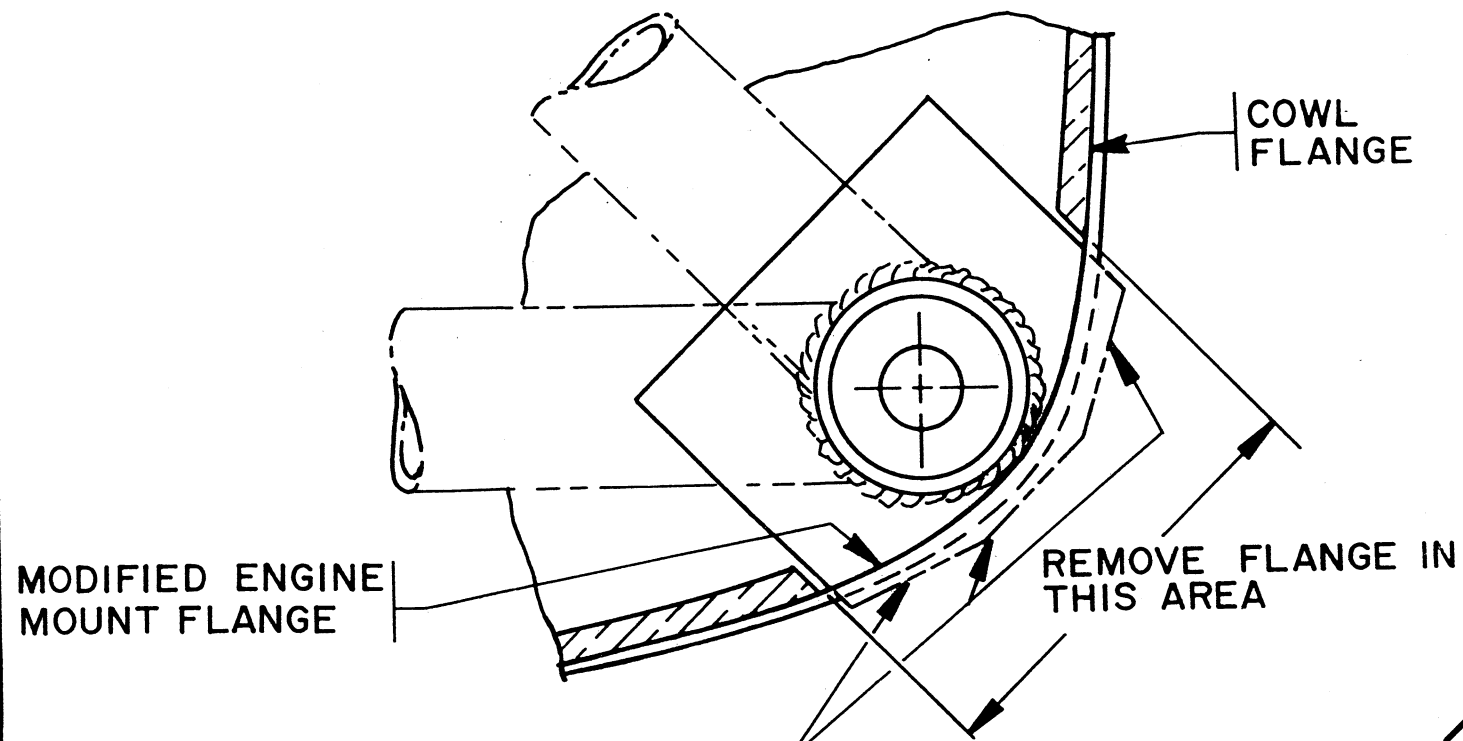
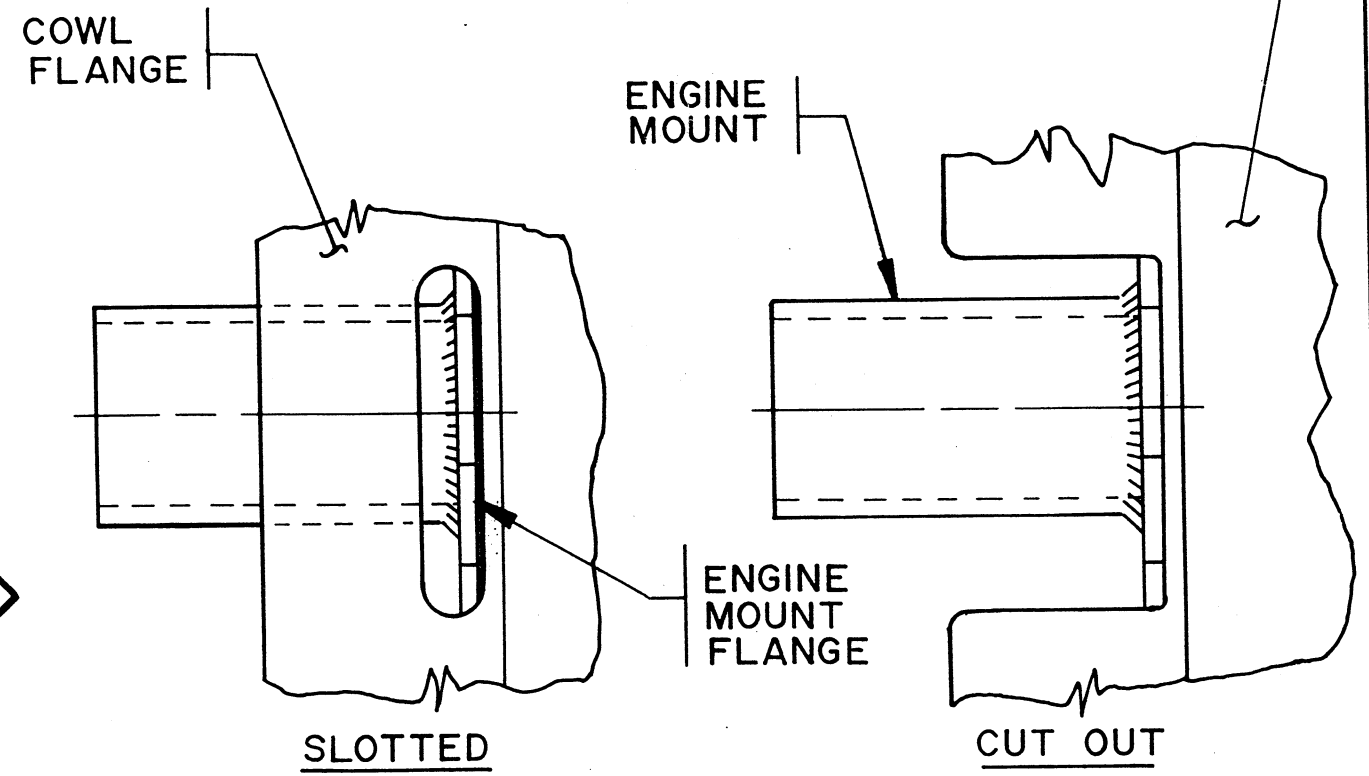
FIGURE (1)

Field reports and our subsequent investigation confirm that these original Glasair III engine mounts will not fit inside the cowling flanges located on the front of the fuselage without interference with the flange and engine mount base plates.

With the original style engine mounts, the fiberglass cowl flanges must be locally trimmed back flush with the firewall or slotted to provide clearance, yet even with this modification, it is possible that the engine mount lower corner flange will still interfere with the engine cowling itself.

In addition a slight interference may exist between the lower corner engine mount tube and the lower cowling. The lower cowling slopes upward from the firewall and the engine mount tube extends straight forward. These tubes may also be ground for proper clearance when the lower cowling is fit to the aircraft.

Locate the center of the two upper engine mount bolt holes 5.25" above Waterline 100. It will be necessary to grind back the steel base plate of the engine mount attach points to allow them to fit. It is permissible to grind the base plate back to the base of the weld. Level the engine mount laterally at the nose gear trunion attach points following the instructions given in Service Bulletin 22.

TRIM ENGINE MOUNT
FLANGE TO MATCH
COWL FLANGE
