SERVICE BULLETIN 33

SUBJECT: GLASAIR III ENGINE MOUNT AND FIREWALL TEMPLATE.

APPLICATION: Glasair III kits; S/N 3015 thru 3026

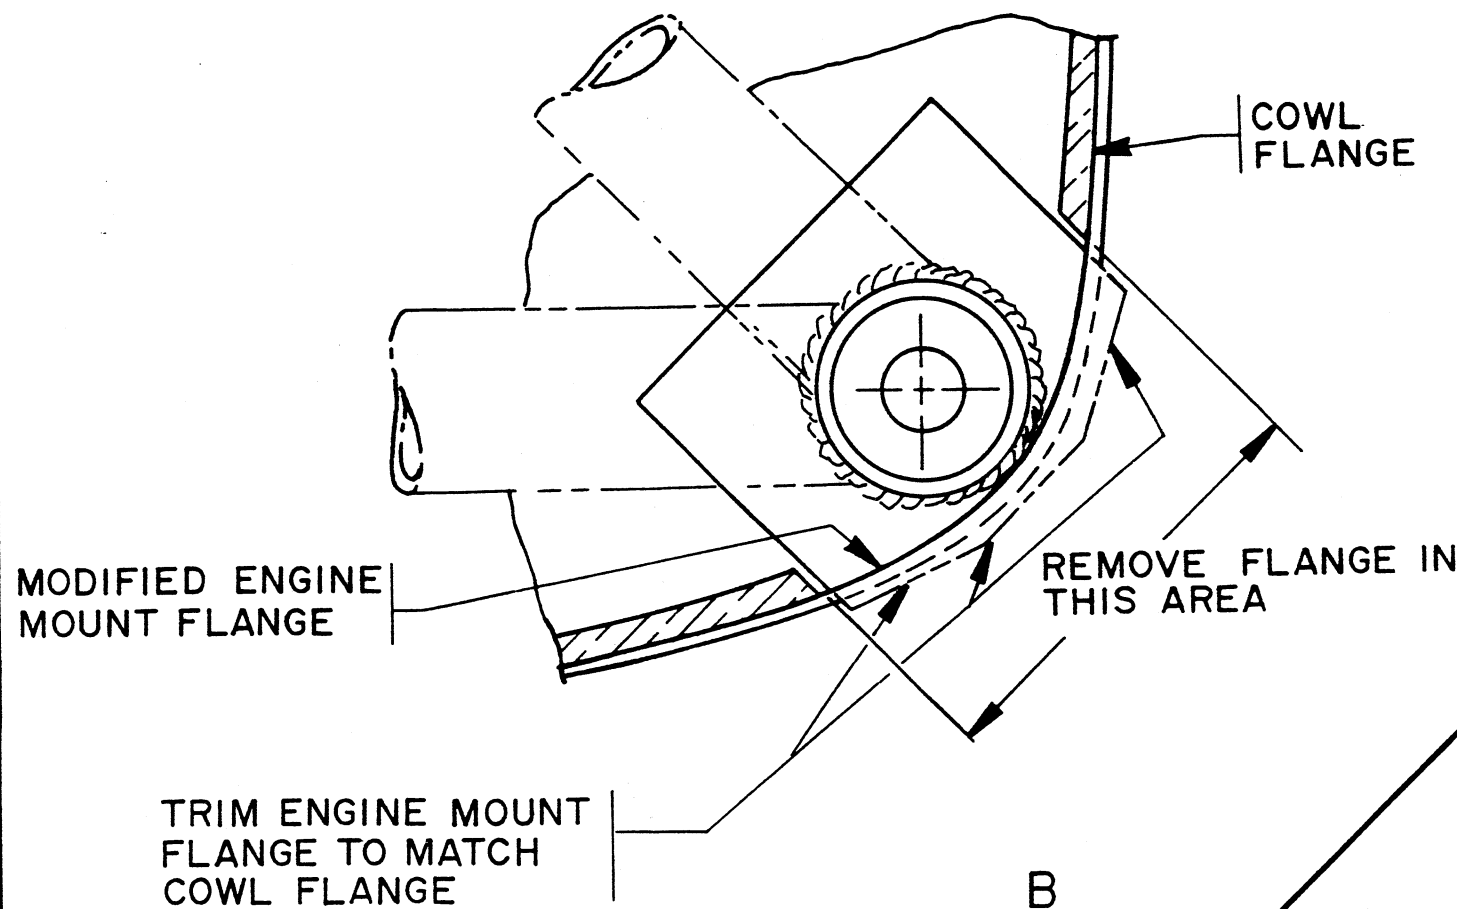
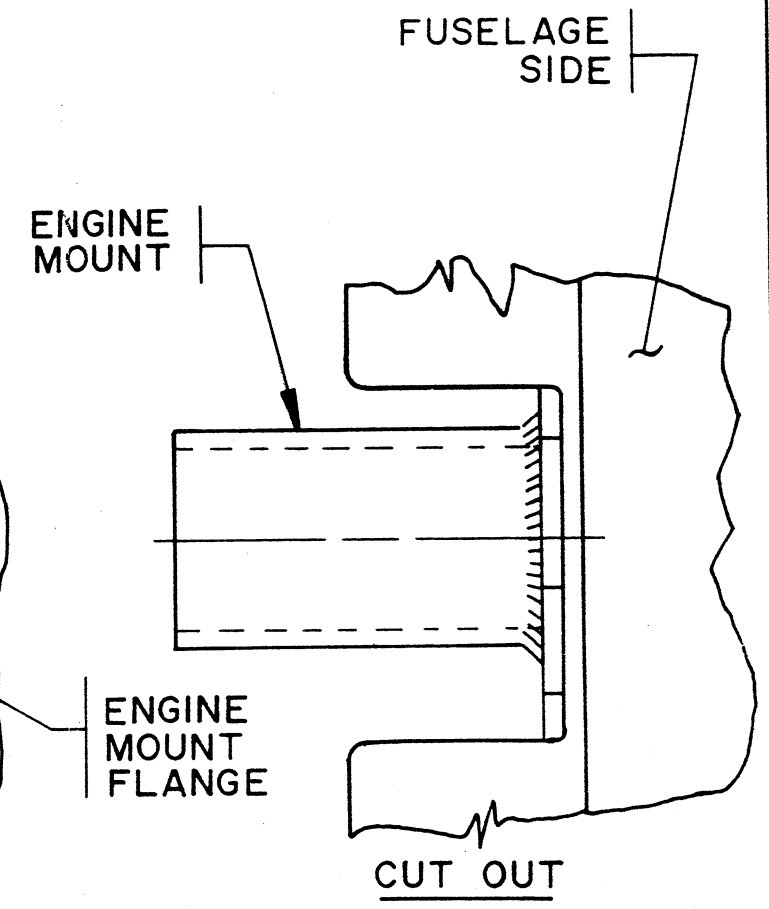
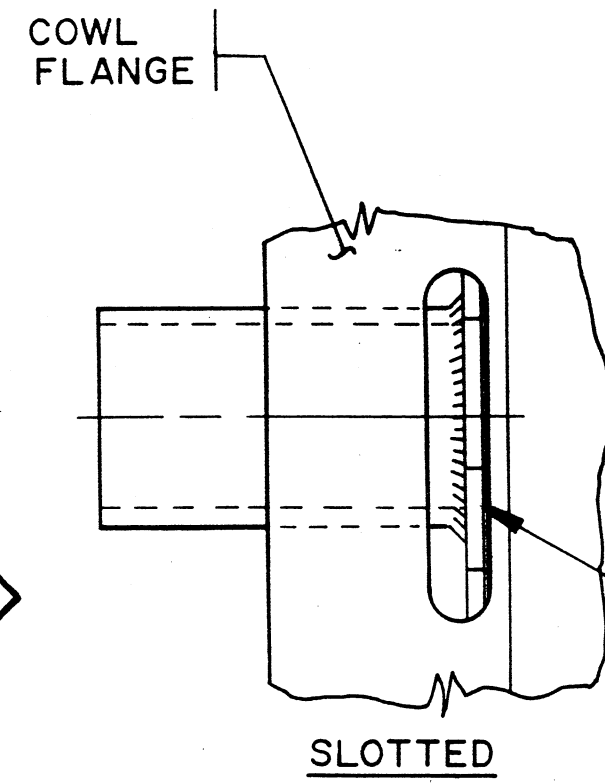
FIGURE (1)

Field reports and our subsequent investigation confirms that the Revision A engine mounts sent to kit serial numbers 3015 through 3026 will not fit inside the cowling flanges located on the front of the fuselage without interference with the flange and the engine mount base plate.

In addition a slight interference may exist between the lower corner engine mount tube and the lower cowling. The lower cowling slopes upward from the firewall and the engine mount tube extends straight forward. These tubes may also be ground for proper clearance when the lower cowling is fit to the aircraft.

Locate the center of the two upper engine mount bolt holes 5.25" above Waterline 100. It will be necessary to grind back the steel base plate of the engine mount attach points to allow them to fit. It is permissible to grind the base plate back to the base of the weld. Level the engine mount laterally at the nose gear trunion attach points following the instructions given in Service Bulletin 22.

On the Revision A style engine mounts, the lower outboard engine mount points will require grinding of the base plates. The fiberglass cowl flanges must be locally trimmed back flush with the firewall or slotted to provide clearance for the baseplate. See FIGURE (1).
