SERVICE BULLETIN 33

SUBJECT: GLASAIR III ENGINE MOUNT AND FIREWALL TEMPLATE.

APPLICATION: Glasair III kits; S/N 3015 thru 3026

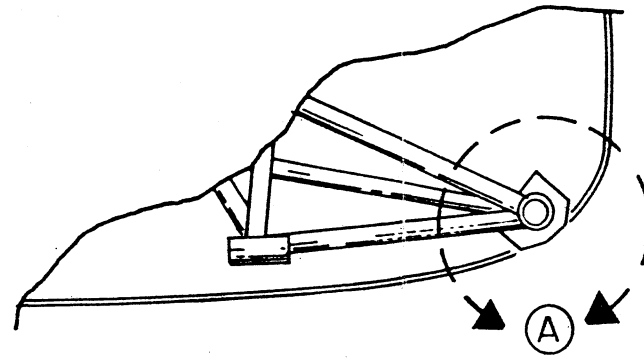
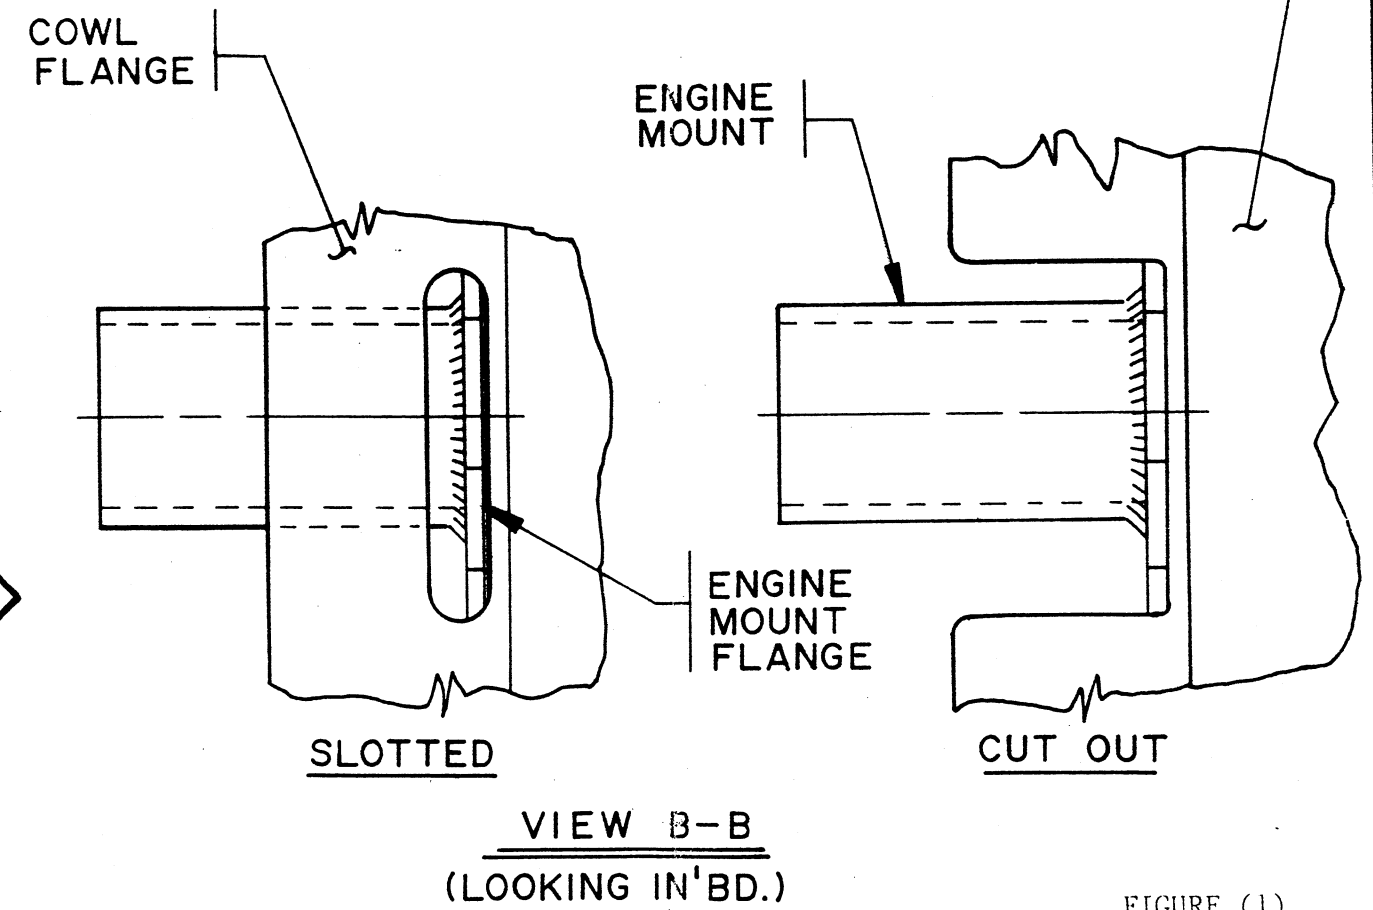
FIGURE (1)

Field reports and our subsequent investigation confirms that the Revision A engine mounts sent to kit serial numbers 3015 through 3026 will not fit inside the cowling flanges located on the front of the fuselage without interference with the flange and the engine mount base plate.

On the Revision A style engine mounts, the lower outboard engine mount points will require grinding of the base plates. The fiberglass cowl flanges must be locally trimmed back flush with the firewall or slotted to provide clearance for the baseplate. See FIGURE (1).

Locate the center of the two upper engine mount bolt holes 5.25" above Waterline 100. It will be necessary to grind back the steel base plate of the engine mount attach points to allow them to fit. It is permissible to grind the base plate back to the base of the weld. Level the engine mount laterally at the nose gear trunion attach points following the instructions given in Service Bulletin 22.

NOTE: Grinding the base plates and trimming or slotting the fiberglass flanges are both structurally permissible and will not have any cosmetic effect pm the finished product.
