SERVICE BULLETIN 35

SUBJECT: CORRECT CONTROL STICK SLEEVE FOR THE GLASAIR II AIRCRAFT

APPLICATION: GLASAIR II KITS SHIPPED WITH A P/N 475-10195-01 CONTROL SLEEVE

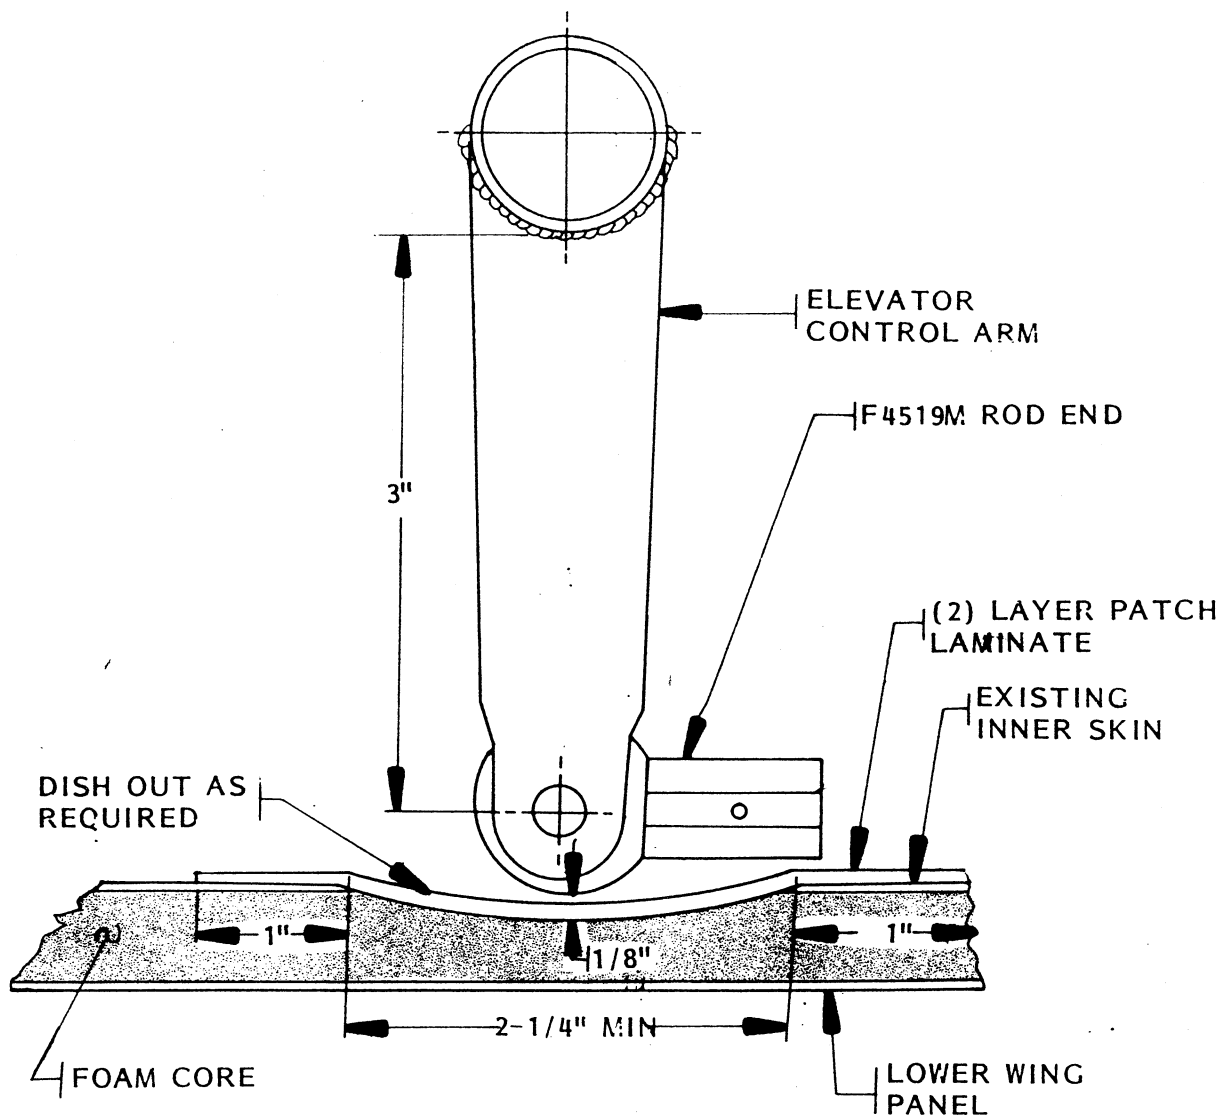
FIGURE (1)

If you have any doubt as to which control sleeve tube was sent to you, the part number of the control sleeve can be determined by measuring the distance between the outside surface of the control sleeve tube to the center of the bolt hole in the control sleeve actuating arm, as shown in FIGURE (1).

P/N 475-3G-3220-01 _____ 3"
P/N 475-10195-01 _____ 2-1/2"

SOLUTION: If you have recieved the incorrect control sleeve (P/N 475-10195-01), return the incorrect control sleeve to the Shipping Dept. at Stoddard-Hamilton aircraft and the correct P/N control sleeve will be sent to you.
