SERVICE BULLETIN 42

SUBJECT: INADEQUATE FT NOSE WHEEL PIVOT RANGE

APPLICATION: First production run of Glasair FT landing gear:
(These parts were supplied in kits shipped prior to October 15, 1985).

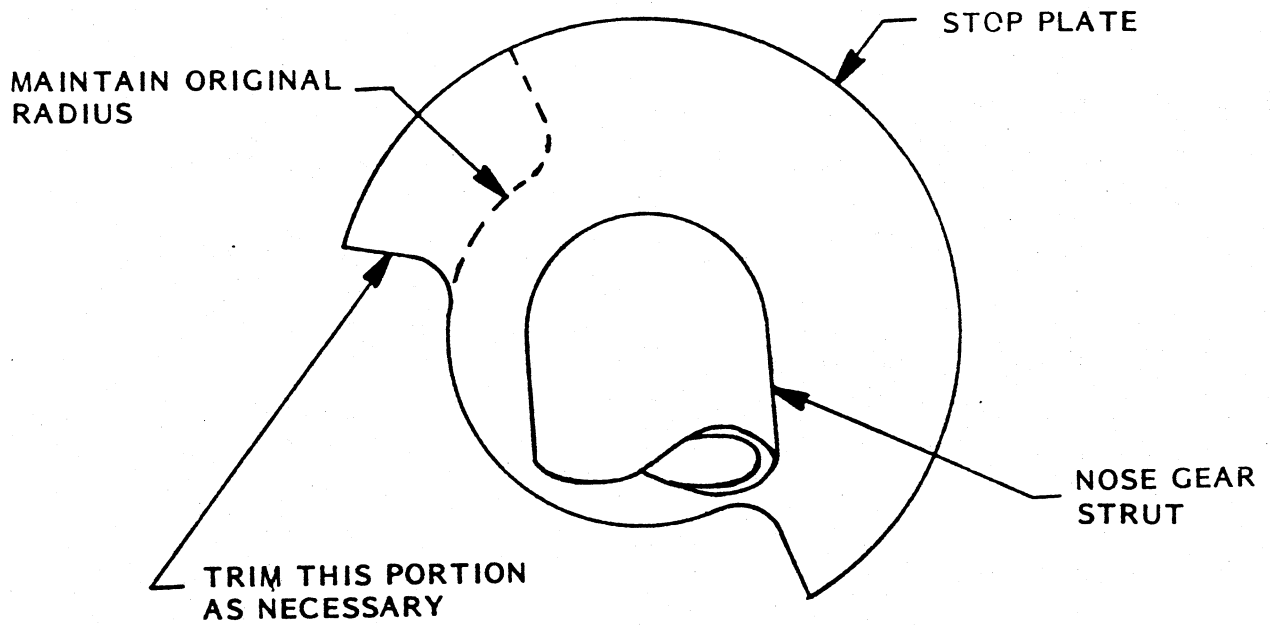
FIGURE (1)

DESCRIPTION: On affected aircraft, the configuration of the nose gear stop plate (welded to the nose gear strut) and the nose gear wear plate (bolted to the stop plate as shown in FIGURE [C-20] on page C-28 of the Glasair FT Instruction Appendix) is such that the nose wheel can pivot almost 90° in one direction but only about 45° in the other direction.

SOLUTION: If after finishing the airplane you find this pivot range limitation to be inconvenient, carefully cut (a good hack saw blade will easily cut the material) and grind away part of the nose gear stop plate/wear plate assembly to allow the landing gear to pivot to the same angle in both directions. Remove the minimum material necessary to achieve the same pivot range in both directions. Continue the existing cut around the plates, maintaining the same radial distance from the strut, as shown in FIGURE (1).

CAUTION: Be careful when cutting and grinding the nose gear strut assembly. The entire nose strut is heat treated, so cut slowly to prevent building up excessive heat that might destroy the temper of the strut.
