SERVICE BULLETIN 45

SUBJECT: POSSIBLE INCORRECT RUDDER PEDAL CENTER SUPPORT BRACKET

APPLICATION: All Glasair II RG aircraft shipped prior to 10/21/87

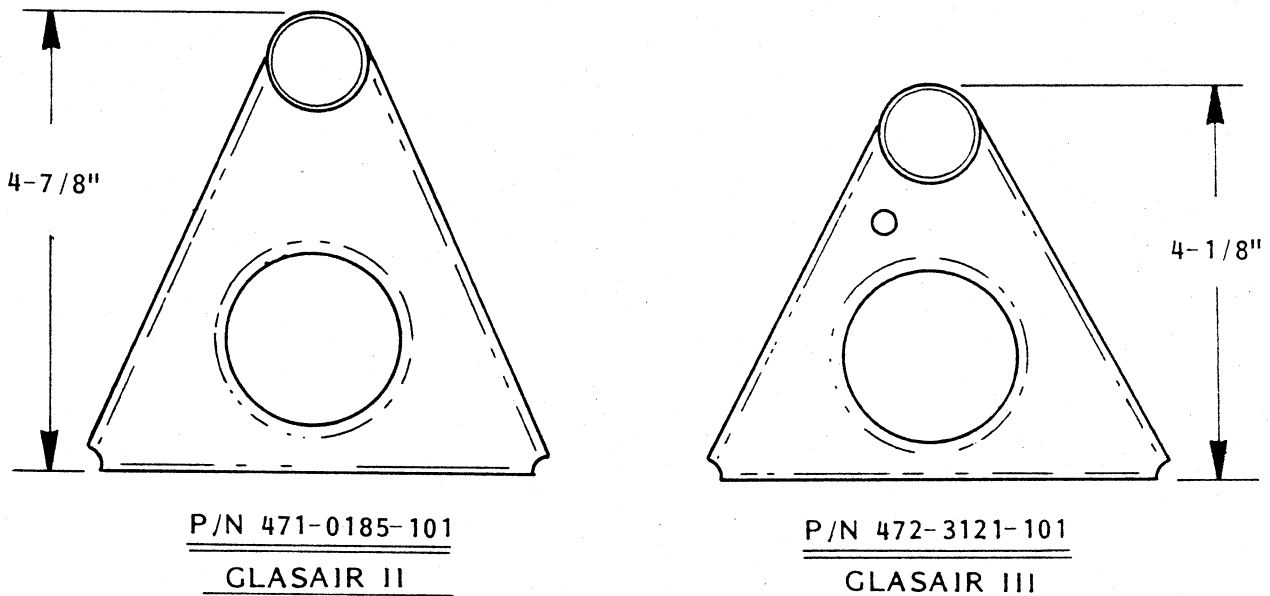
FIGURE (1)

DESCRIPTION: Glasair II RG kits shipped prior to 10/21/87 may have incorrectly included a a Glasair III rudder pedal center support bracket rather than the Glasair II RG center support bracket. The support bracket for the Glasair III (P/N 472-3121-101) looks similar, but is approximately 3/4" shorter than the bracket for the Glasair II (P/N 471-0185-101). The difference in height is due to the different sizes of the nose landing gear boxes on which the brackets are mounted. Use of the shorter (P/N 472-3121-101) bracket on the Glasair II will result in reduced rudder pedal clearance from the upper surface of the forward belly panel.

SOLUTION: Check the rudder pedal center support bracket supplied with your kit against the dimensions provided in FIGURE (1). If you have received the incorrect center support bracket (P/N 472-3121-101), return it to Stoddard-Hamilton Aircraft's Shipping department by 12/31/87 and the correct (P/N 471-0185-101) center support bracket will be sent to you.

NOTE: If you have already installed the rudder pedal assembly using the shorter center support bracket, contact our Builder Support department for assistance.
