SERVICE BULLETIN 45

SUBJECT: POSSIBLE INCORRECT RUDDER PEDAL CENTER SUPPORT BRACKET

APPLICATION: All Glasair II RG aircraft shipped prior to 10/21/87

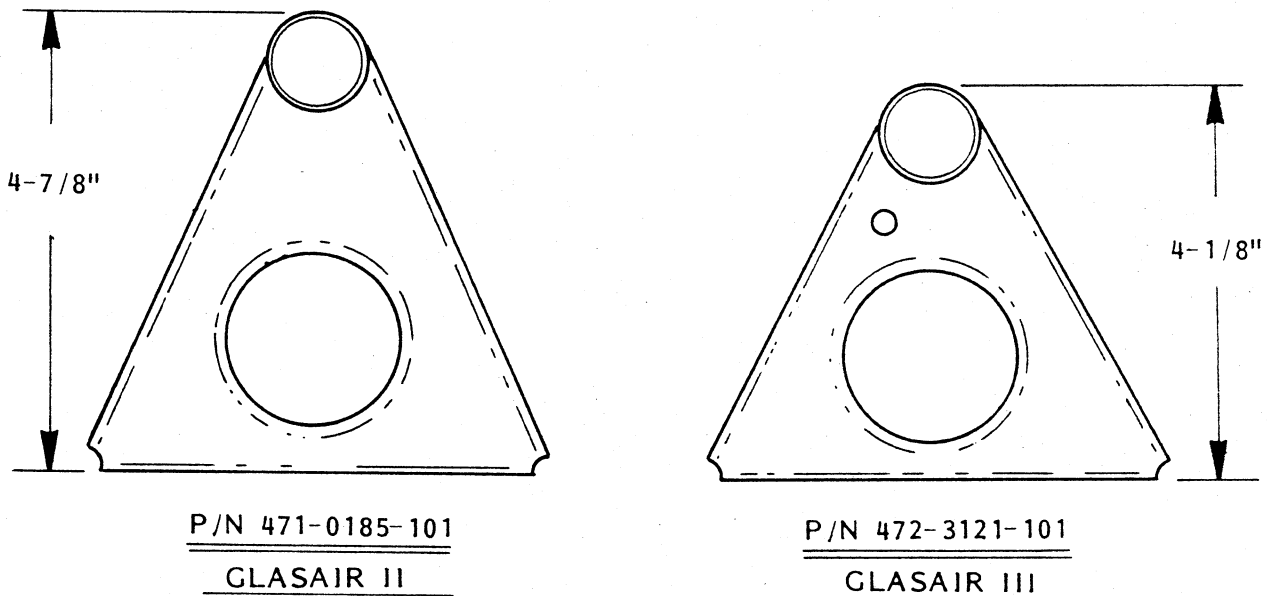
FIGURE (1)

DESCRIPTION: Glasair II RG kits shipped prior to 10/21/87 may have incorrectly included a Glasair III rudder pedal center support bracket rather than the Glasair II RG center support bracket. The support bracket for the Glasair III (P/N 472-3121-101) looks similar, but is approximately 3/4" shorter than the bracket for the Glasair II (P/N 471-0185-101). The difference in height is due to the different sizes of the nose landing gear boxes on which the brackets are mounted. Use of the shorter (P/N 472-3121-101) bracket on the Glasair II will result in reduced rudder pedal clearance from the upper surface of the forward belly panel.

SOLUTION: Check the rudder pedal center support bracket supplied with your kit against the dimensions provided in FIGURE (1). If you have received the incorrect center support bracket (P/N 472-3121-101), return it to Stoddard-Hamilton Aircraft's Shipping department by 12/31/87 and the correct (P/N 471-0185-101) center support bracket will be sent to you.

NOTE: If you have already installed the rudder pedal assembly using the shorter center support bracket, contact our Builder Support department for assistance.
