SERVICE BULLETIN 51

SUBJECT: POSSIBLE NOSE GEAR DRAG BRACE BINDING

APPLICATION: Glasair III welded nose gear drag brace (363-5419-001).

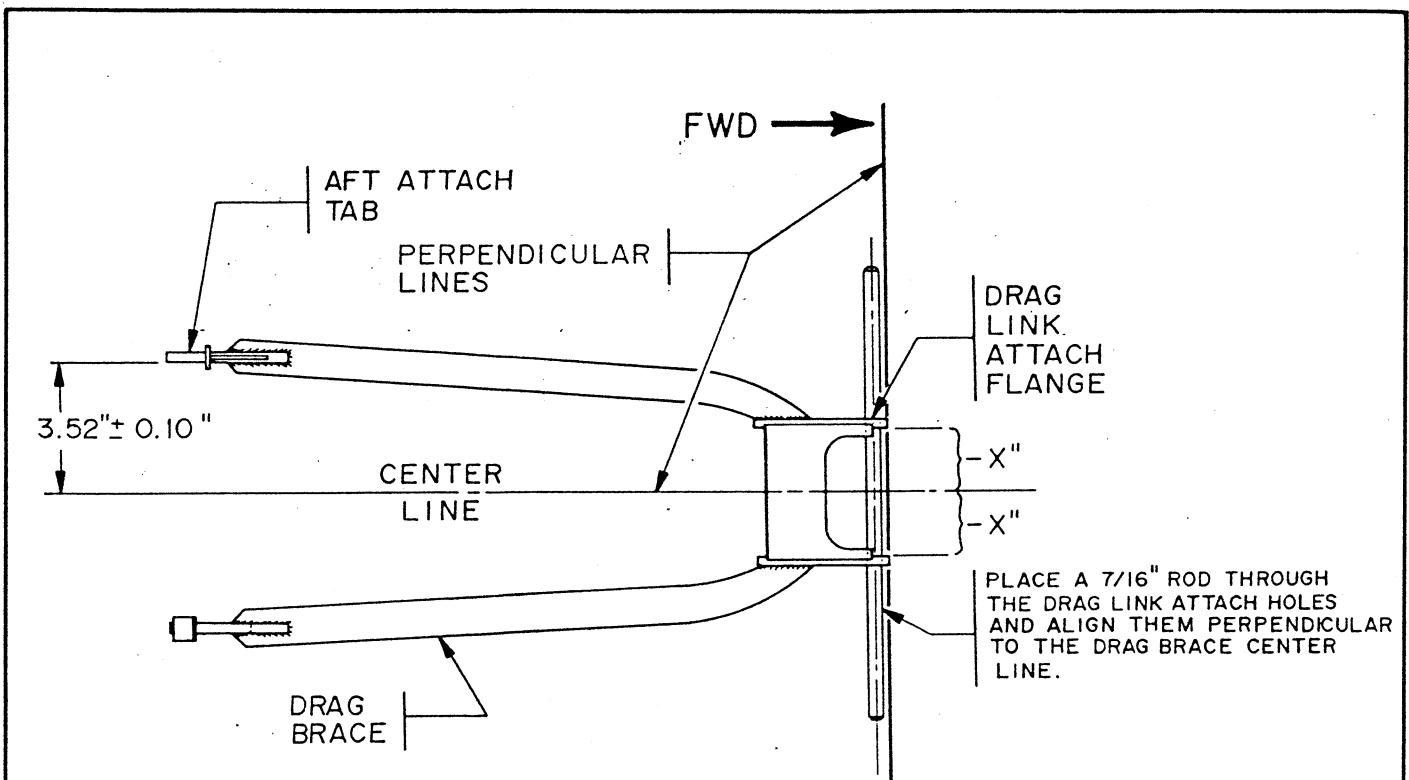
FIGURE (1)

DESCRIPTION: During the fabrication of the first production run (50 assemblies) of the Glasair III nose gear drag brace, an unknown number of the drag braces were not jugged properly, resulting in the aft end of one (or both) drag brace tube(s) being an incorrect distance from the part centerline. This improper jugging of the drag brace could cause a binding or interference problem when retracting the nose gear.

Center one of the perpendicular lines between the two drag link attach flanges, as shown, and align the forward edge of the 7/16" rod with the remaining line. Measure the distance between the center line (line running between the drag link attach flanges) and the drag brace aft attach tabs for both sides. The correct distance between the center line and the drag brace aft attach tab is 3.52" + or - 0.10".

SOLUTION: To determine whether your nose gear drag brace was jugged improperly, mark two perpendicular lines on a flat surface and insert a 7/16" rod through the drag link attach holes, as shown in FIGURE (1).

If the drag brace supplied with your kit does not meet the dimensional requirements listed above, we request that the drag brace be returned to Stoddard-Hamilton Aircraft's shipping department by May 30, 1988. It is very important that Stoddard-Hamilton receive the dimensionally incorrect drag brace by this date, since we wish to adjust all incorrect drag brace assemblies at one time. Any parts returned after this deadline will not be corrected until the next production run of drag braces is fabricated (estimated time: 9 months).
