SERVICE BULLETIN 62

SUBJECT: POSSIBLE WING LEADING EDGE INTERFERENCE WITH THE NOSE GEAR BOX AND THE FUSELAGE REINFORCEMENT RIB

APPLICATION: GLASAIR III KITS THROUGH SERIAL NUMBER 3128.

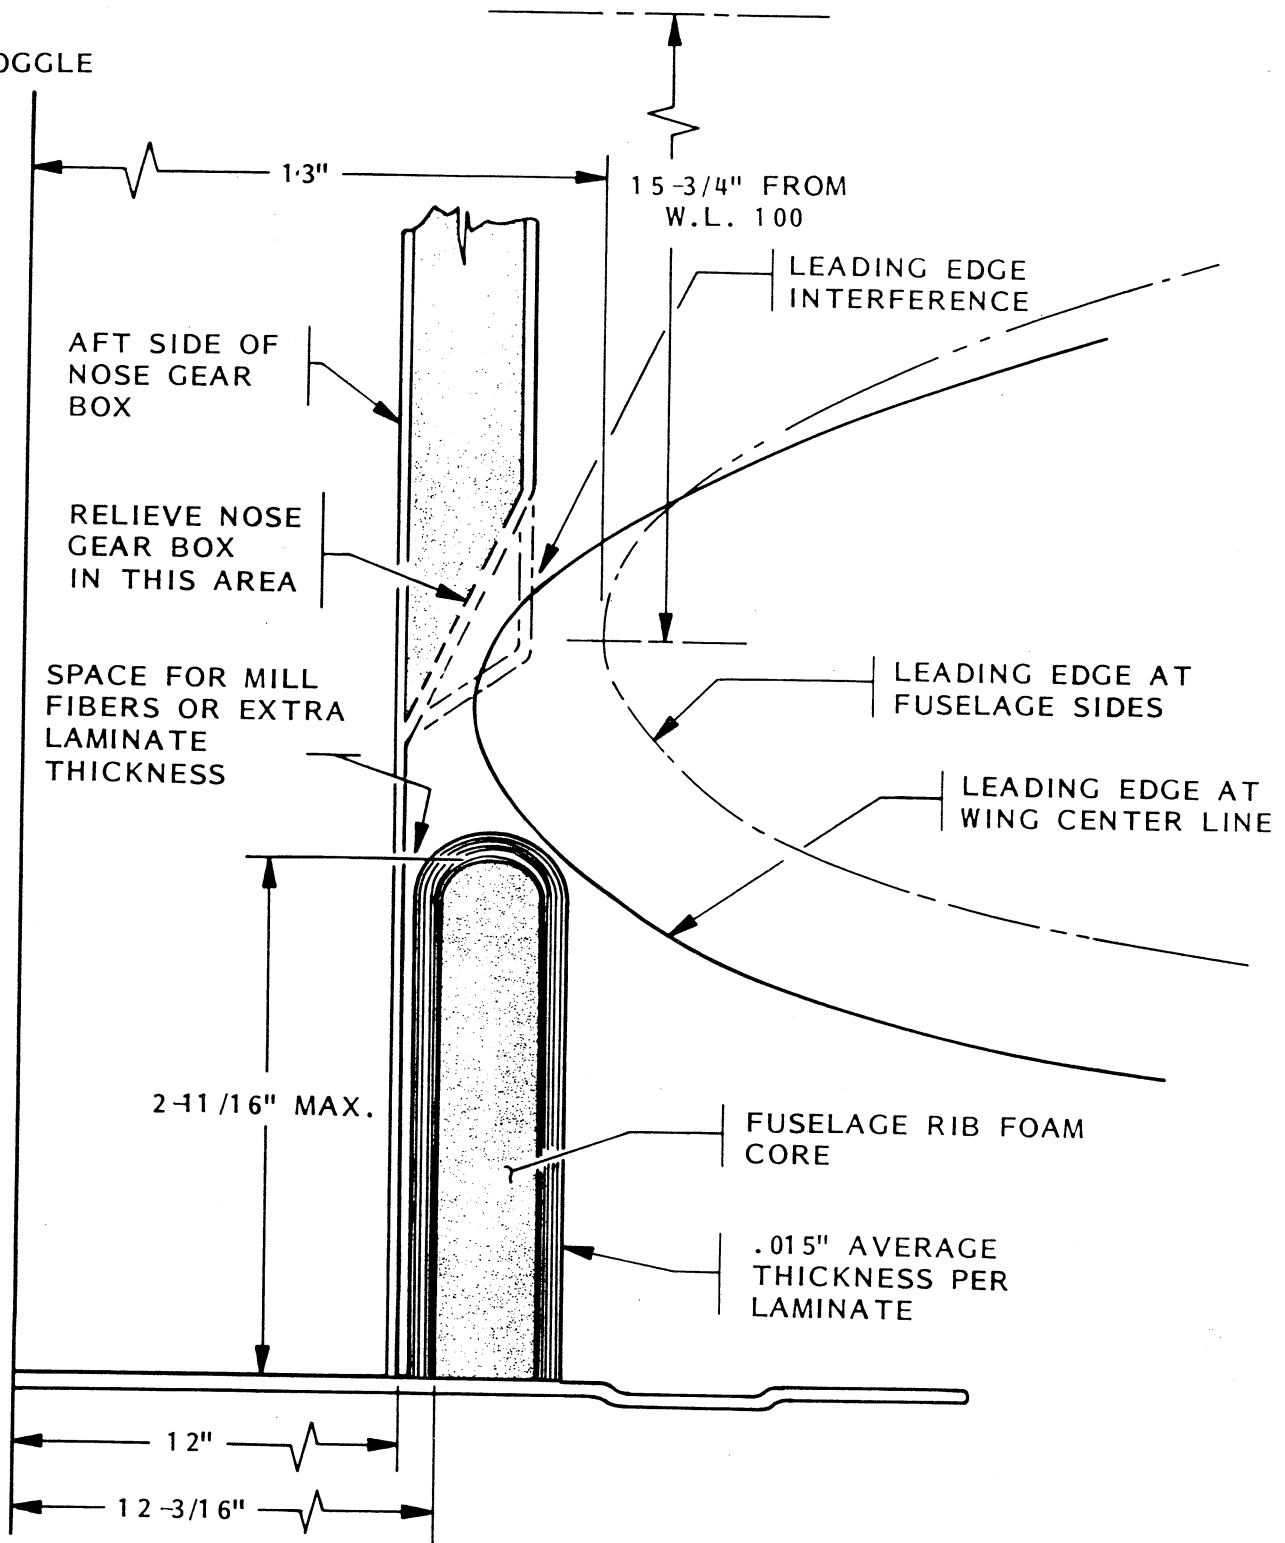
DESCRIPTION: The clearances between the wing leading edge and both the nose gear wheelwell box and the fuselage reinforcement rib are very tight. If the laminates on the fuselage rib or nose gear box are slightly too thick, or if the wing is mispositioned relative to the fuselage by as little as 1/16", the wing leading edge can contact part of the fuselage structure. FIGURE (1) shows the wing leading edge position relative to the fuselage reinforcement rib and the nose gear box if installed exactly according to the Instruction Manuals. Because we have had several reports of fuselage rib to wing interference from builders in the field, we recommend performing Step 2 (described below) to provide ample clearance.

GLASAIR III WING TO FUSELAGE RIB/NOSE GEAR BOX INTERFERENCE

Before installing the nose gear wheelwell box, bevel the outside laminates and foam core at the top of the cutout on the aft side, as shown in FIGURE (1). Then apply a two-layer laminate over the relieved area to replace the laminates that were removed. Install the wheelwell box as described in the Fuselage Assembly section of the Instruction Manuals.

If you encounter interference problems when fitting the wing to the fuselage, the nose gear wheelwell box and/or the fuselage reinforcement rib may be relieved to provide clearance for the wing leading edge, as shown in FIGURES (1) and (2).
