SERVICE BULLETIN 67

SUBJECT: TRIM SYSTEM INTERFERENCE BETWEEN CABLE DRUM AND TRIM CONTROL BOX HOUSING

APPLICATION: All Glasair II and Glasair III aircraft and Glasair Is that have been retrofitted with the Glasair II/III trim system

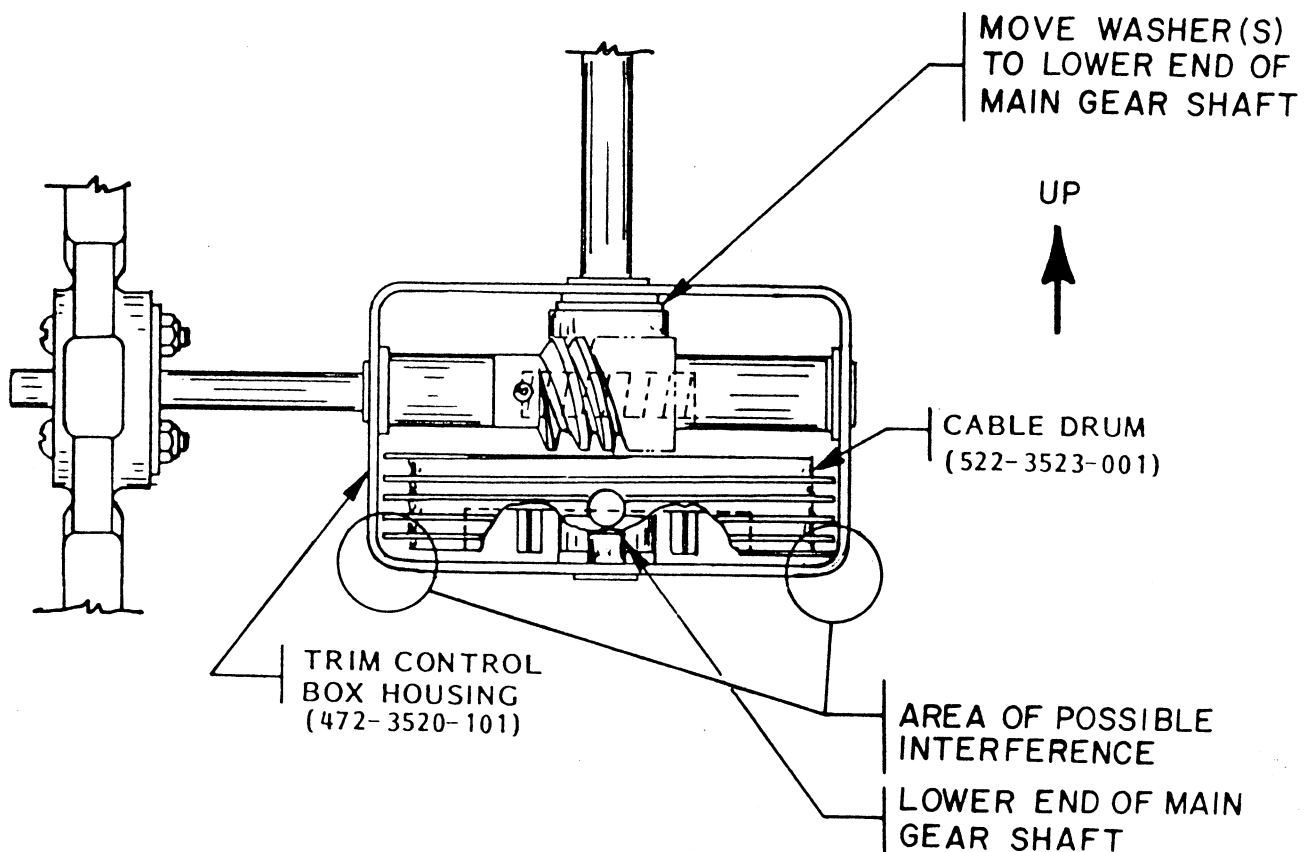
FIGURE (1)

DESCRIPTION: The position of the cable drum (522-3523-001) results in contact between the lowest cable guide flange on the drum and the rounded lower corners of the trim control box housing (472-3520-101) when the drum is rotated to certain positions, as shown in FIGURE (1). Under extreme conditions this interference may make it impossible for the cable drum to rotate sufficiently to contact the stop pin on the cable housing, thus limiting full elevator trim movement.

SOLUTION: If a washer has been installed between the upper end of the main gear and the upper NAS77-4-06 bushing in the trim housing, move the washer to the lower end of the main gear shaft, between the NAS42DD8-12 spacer and the lower NAS77-4-06 bushing. This shifts the cable drum upward in the housing to provide better clearance and also improves the alignment of the main gear with the worm drive.
