SERVICE BULLETIN 73

SUBJECT: POSSIBLY INCORRECT ENGINE MOUNT NUTS

APPLICATION: All Glasair aircraft.

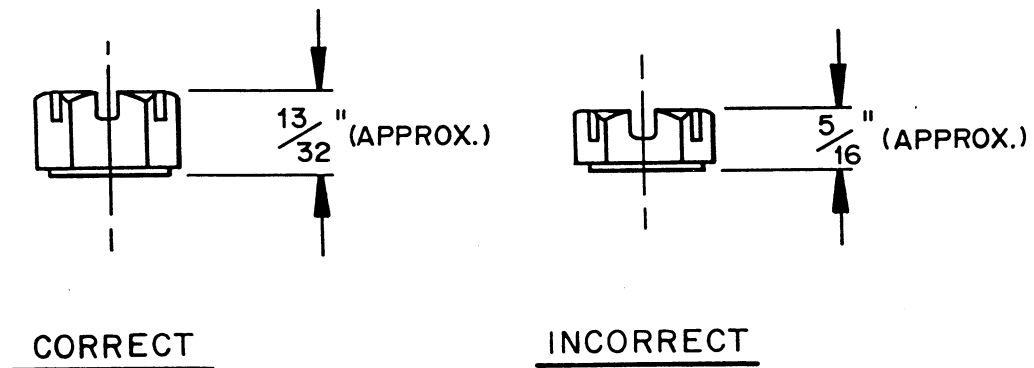
FIGURE (1)

DESCRIPTION: Some of the nuts that we have stocked since about 1986 for the engine mount bolts are incorrect. The nuts specified for the engine mount bolts are AN355-6 nuts, which are a tension type nut (about 13/32" long) to carry the tension loads on the engine mount bolts. Instead of the AN355-6 nut, our supplier shipped us a nut that is only about 5/16" long. These incorrect nuts are not as thin as a shear nut (AN320-6, 7/32" thick) which may only be used when the only loads applied to the bolt are perpendicular to the longitudinal axis of the bolt. Since we are unable to identify the nuts per AN, MS, or NAS standards, however, we are unable to determine their rated tension loads.

SOLUTION: Measure the length of the nuts (labelled AN355-6) supplied for your engine mount bolts. If the nuts are less than 13/32" long, as shown in FIGURE (1), the nuts are incorrect and must be replaced.

If you have the incorrect nuts, notify Stoddard-Hamilton's shipping department and we will ship replacements. We are asking that you return the incorrect nuts first, as usual, so that we can return them to our supplier for credit.
