SERVICE BULLETIN 74

APPLICATION: ALL GLASAIR II aircraft

SUBJECT: Clearance between exhaust system and oil cooler

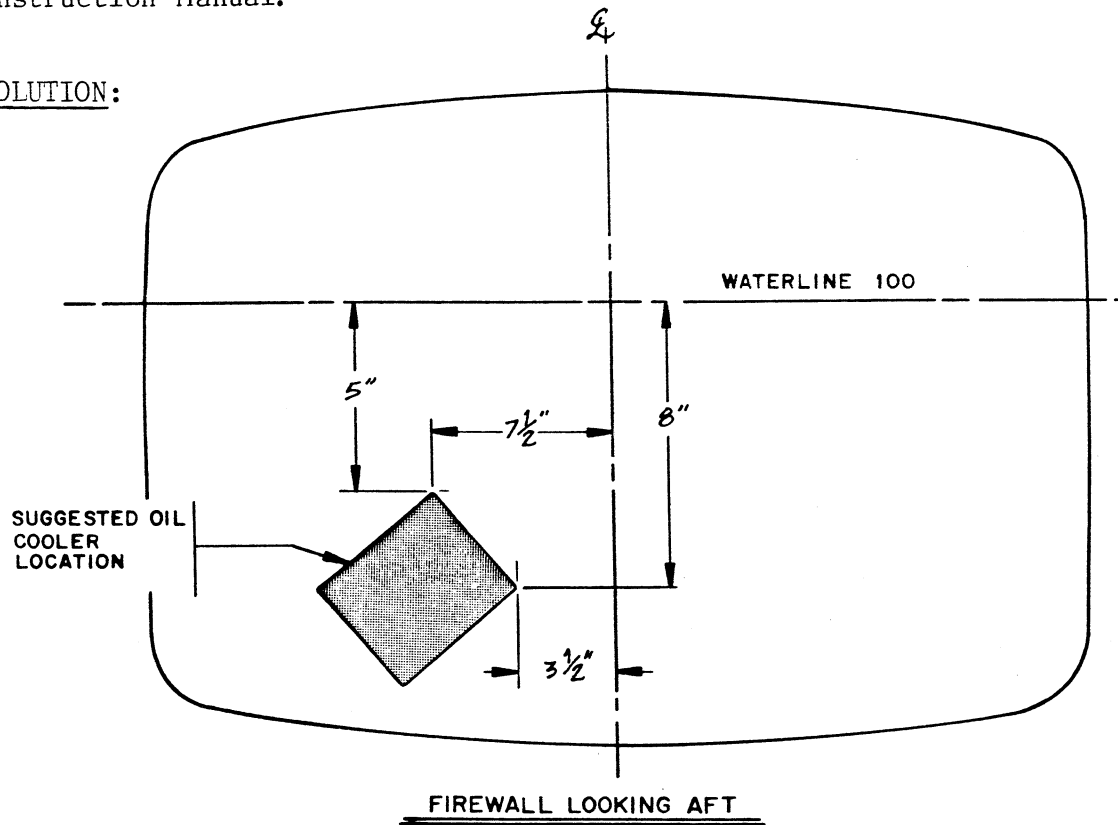
FIGURE (1)

DESCRIPTION: Several Glasair II builders have reported inadequate clearance between the exhaust system and the oil cooler if the oil cooler is mounted in the space reserved for it, as described in the FIREWALL BUILDUP subdivision of the FINAL ASSEMBLY section of the Instruction Manuals. The suggested oil cooler location is shown on page G-85 of the II RG Instruction Manual, on page G-75 of the II FT Instruction Manual, and on page G-77 of the II TD Instruction Manual.

The best alternative location for the oil cooler that we have found is mounted at an angle on the firewall, as shown in FIGURE (1). This is a suggested location only; builders should feel free to mount the oil cooler elsewhere to suit their individual requirements. The oil cooler could also be mounted to a set of brackets attached to the engine mount, to the inside of the engine cowling with the oil cooler air exiting through a set of louvers as on the Glasair III, or anywhere else that provides the necessary clearance from the exhaust system and other engine compartment components.
