SERVICE BULLETIN 82 MANDATORY

SUBJECT: POSSIBLE CRACKS IN GLASAIR III 90° INDUCTION ELBOWS AND SUPPORT ARMS

APPLICATION: All Glasair III 90° induction elbows and support arms shipped before 5/01/90.

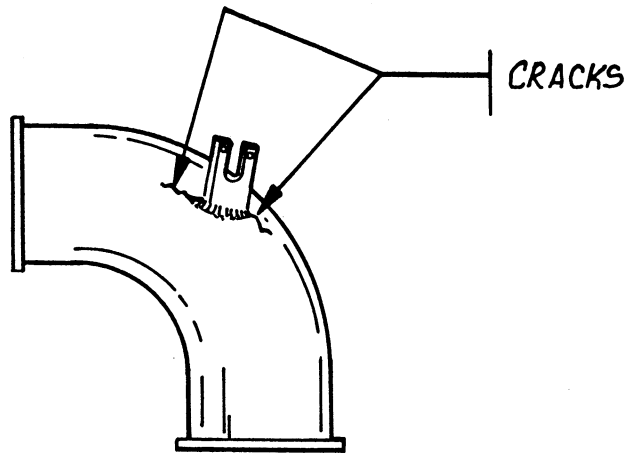
FIGURE (1)

We have had two reports of Glasair IIIs on which cracks were found on the outside radius of the 90° induction elbow. The cracks propagate from the weld at the base of the mixture control cable mounting tab, as shown in FIGURE (1), and in both instances occurred on aircraft with about 100 hours in service.

If your Glasair III has accumulated more than 100 hours of flight time, visually inspect the 90° induction elbow and its support arms for cracks in the areas indicated in FIGURES (1) and (2).

If cracks are found, please contact Stoddard-Hamilton Aircraft's product support division for a description of repair procedures.

If no cracks are found, continue to visually inspect this area every 25 hours of flight time or until reinforced per a supplement to this bulletin that will be mailed as soon as our analysis has been completed and reinforcement procedures have been developed.

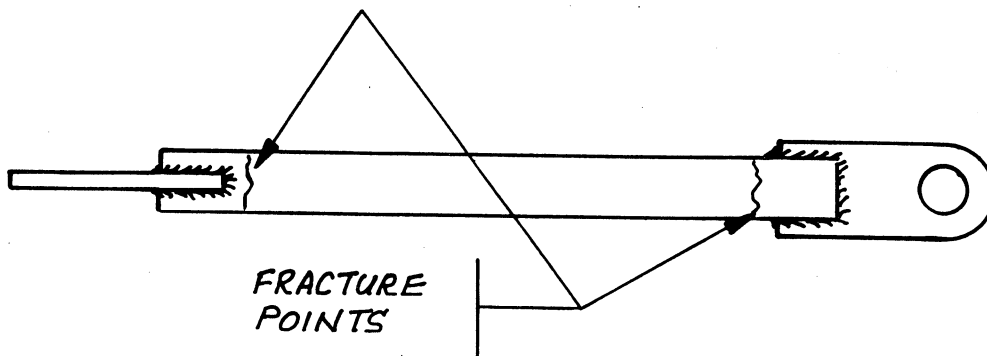
FIGURE (2)

One of the aircraft that reported the induction elbow cracks also had a broken induction elbow support arm. The arm failed just behind the support lug weld, as shown in FIGURE (2).
