SERVICE BULLETIN 83

SUBJECT: COSMETIC PAINT CRACKS AT BASE OF WINDSHIELD

APPLICATION: All Glasair II and III aircraft.

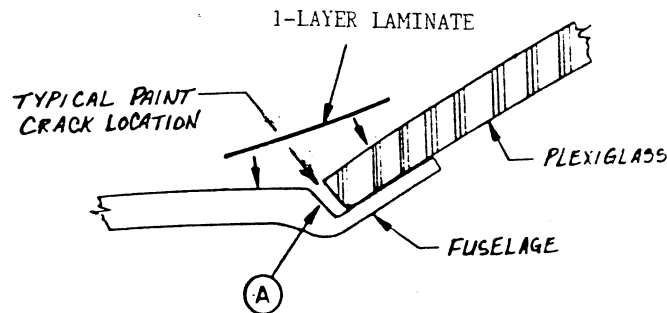
FIGURE (1)

DESCRIPTION: We have had a number of reports of cracks occurring in the paint around the windshield and rear windows on Glasair IIs and IIIs with at least 50 hours of flight time. The cracks occur along the gap between the plexiglass and the molded fiberglass windshield frame. This gap was filled during windshield installation with either a cabosil mixture, a Q-cell mixture, or possibly body putty. Although we suspect that these paint cracks are only cosmetic in nature, it is the responsibility of each Glasair owner to determine whether the crack is merely cosmetic or affects the integrity of the plexiglass bond.

1. To make sure you achieve a proper bond of the windshield into the fuselage, prepare the fuselage by sanding the paint/primer back to the fiberglass laminates underneath. Also be sure to remove any primer from the surface marked by A in FIGURE (1). Thoroughly roughen the bonding area of the plexiglass by sanding before bonding.
2. In the area along the forward lower edge of the windshield, reduce to a minimum the size of the Q-cell fillet used to fair the windshield into the upper surface of the fuselage nose. A thick layer of filler is more prone to cracking.

3. Apply a narrow, single layer laminate over the gap between the windshield and the windshield frame, as shown in FIGURE (1). Lap the laminate onto the windshield by about 1/4" and sand it smooth while tapering the edge. Fill small imperfections with a lightweight body filler, and paint the laminate to hide it as well as the inside flange to which the plexiglass is bonded.
