SERVICE BULLETIN 86

SUBJECT: LYCOMING AIRWORTHINESS DIRECTIVE CONCERNING PROPELLER GOVERNOR
EXTERNAL OIL LINE

APPLICATION: ALL STAINLESS STEEL PROPELLER GOVERNOR OIL LINE KITS FOR GLASAIR
I, GLASAIR II, AND GLASAIR II-S

90-04-06 TEXTRON LYCOMING: Amendment 39-6427.

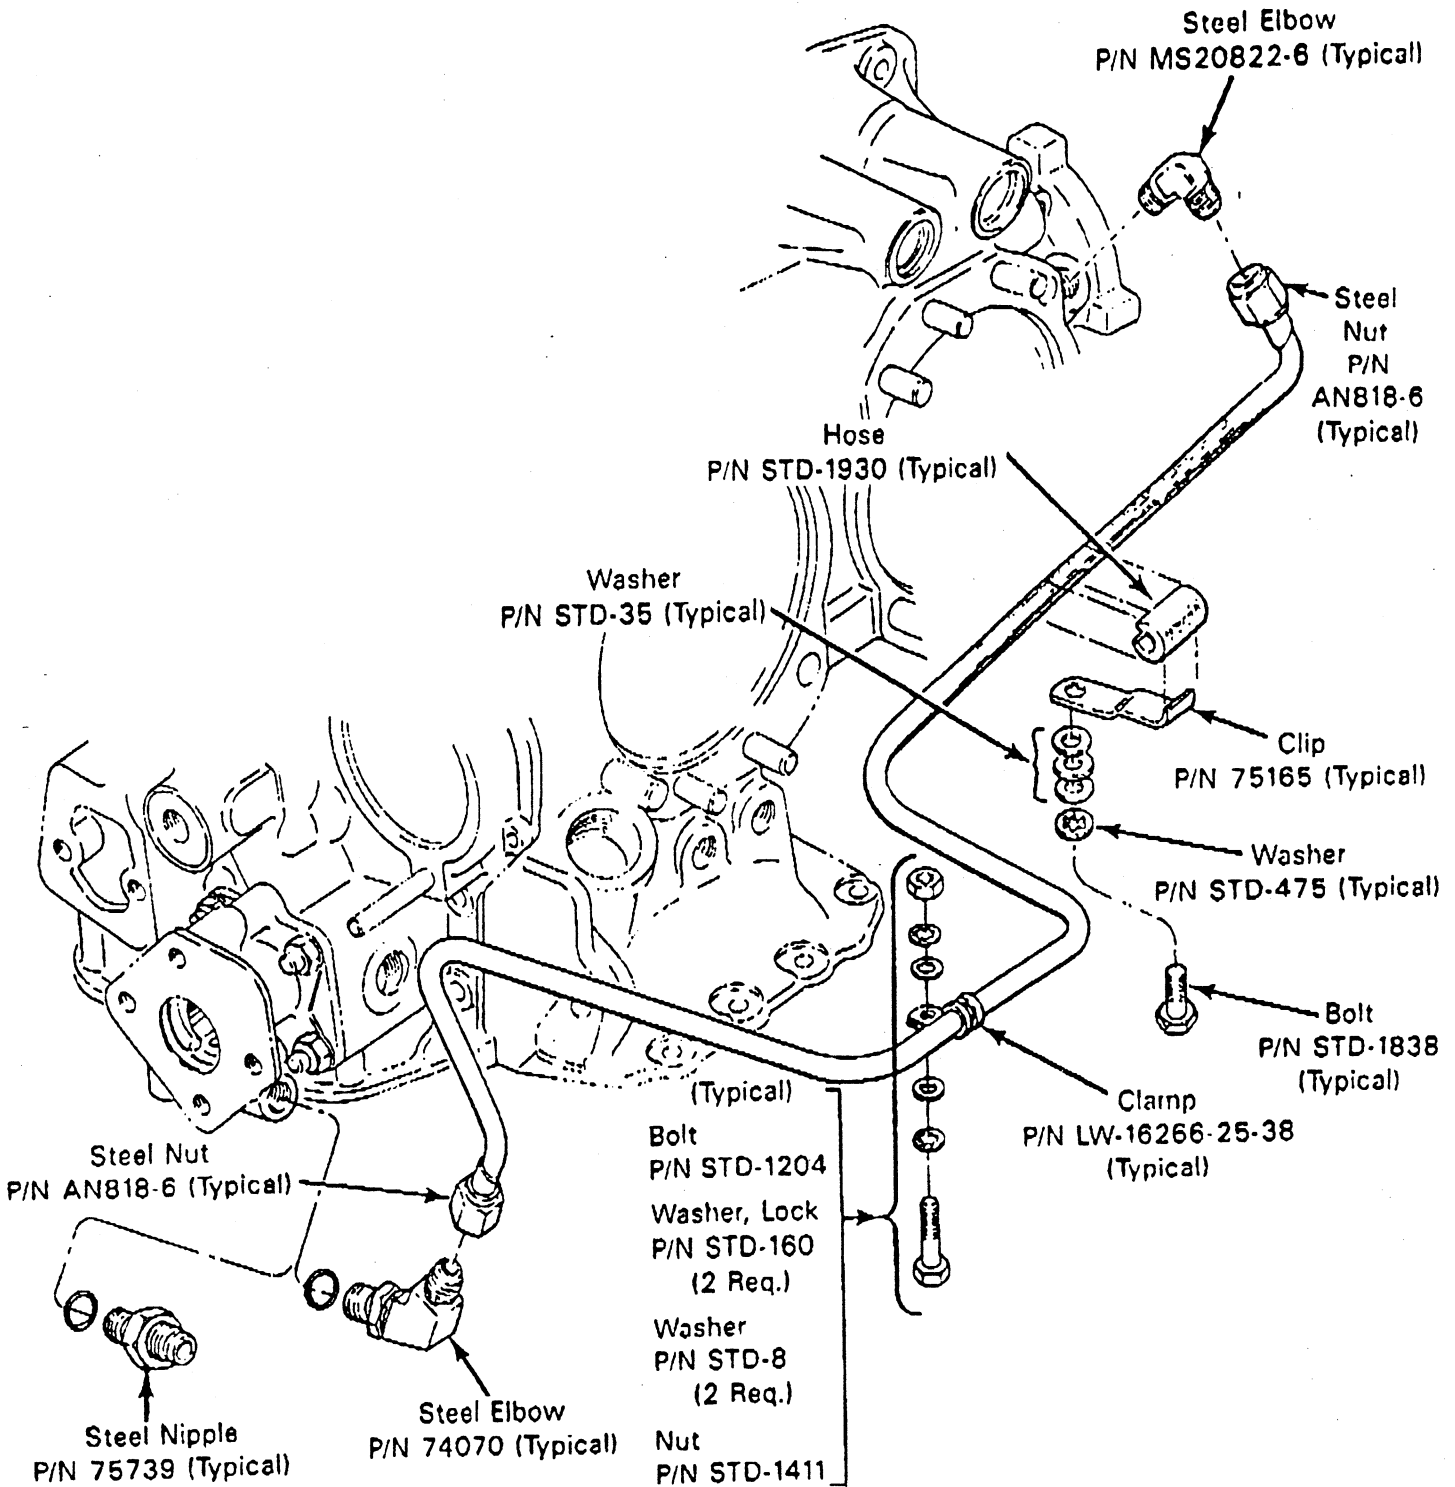
Figure 1. Propeller Governor Line Support

(1) Inspect the propeller governor external oil line for abrasions, cracks, and oil leaks along the length of the line and at the end attachment fittings. Inspect to determine that the two cushion type support clips (clamps) are properly installed as shown in Figure 1 of the Appendix to this AD, and assure that sufficient clearances exist between the oil line and adjacent components.

In all cases one or both of the Textron Lycoming supplied governor line clamps and/or supports installed at the plant and conforming to Textron Lycoming standards were missing. After careful inspection, it was determined that the clamps and/or supports had not been re-installed per Textron Lycoming specifications during field work on the engine. Proper governor line support is mandatory to avoid engine failure.

If the visual inspection reveals that clamps and/or supports are missing, the governor oil line should be thoroughly inspected to insure that no cracks exist. This includes that area under the ferrules at the flared ends of the lines.

(2) If any leaks, damage, or interference condition exists or if support clips are not properly installed, replace the governor oil line and its attachment end fittings with new parts even though the parts show no visible damage. Refer to Figure 1 in the Appendix to this AD, for parts identification, line routing, and location of support clips.

A visual inspection should be made to ascertain that both the Textron Lycoming specified clamps and/or supports are installed properly and are intact.

In reference to Figure 1, the views and identification of parts are only typical. They may not necessarily portray your particular installation. Refer to Parts Catalog for proper clamps. Nevertheless, special attention should be given during dismantling of the governor oil line on your engine to insure both clamps and/or supports are reassembled to the original specified configuration.
