SERVICE BULLETIN 89 MANDATORY

SUBJECT: FT NOSE GEAR STRUT REINFORCEMENT

APPLICATION: All Glasair I FT and Glasair II FT nose gear struts shipped before 7/13/90 or before kit number 2083.

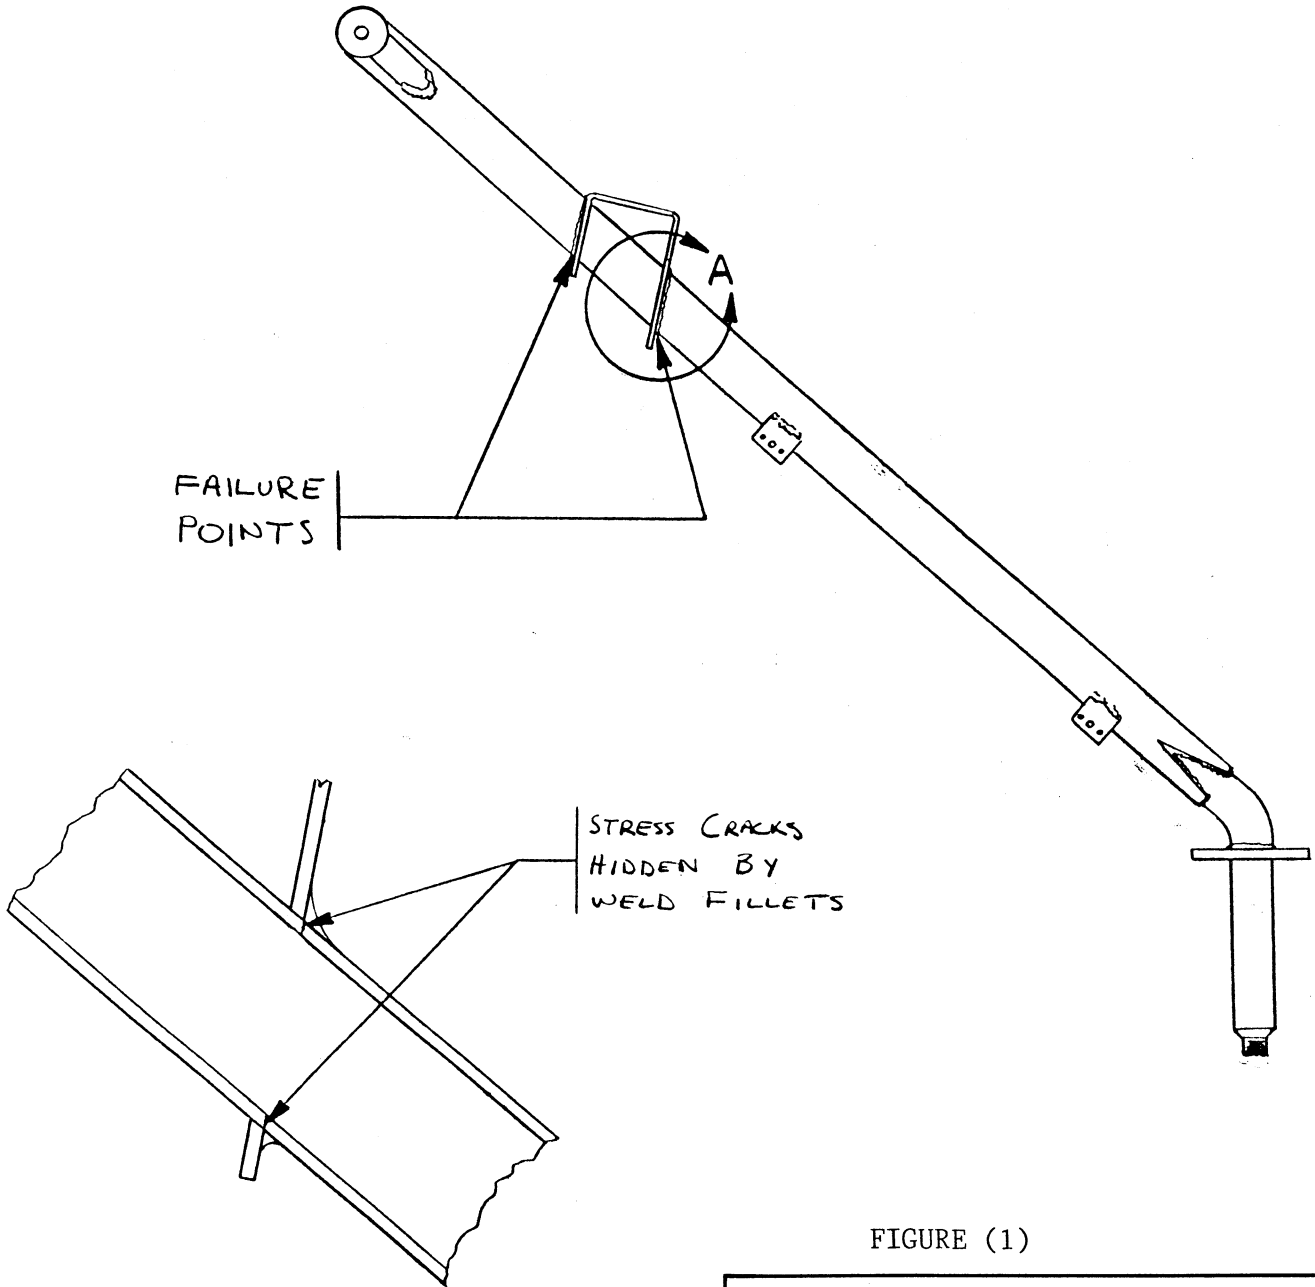
FIGURE (1)

DESCRIPTION: After two failures of FT nose gear struts in the field, we are requiring that the struts be reinforced to prevent further failures that may cause serious damage or injury. Nose gear struts may fail at either the upper or the lower weld around the 1-3/8" diameter tube at the shock truss assembly, as shown in FIGURE (1).

The exact cause of the failures is unknown, but they have occurred at highly stressed parts of the strut. In both instances, a stress crack began under the weld between the shock strut channel and the strut tube in a location that cannot be inspected until after a failure has occurred. Refer to the Detail in FIGURE (1).
