SERVICE BULLETIN 91 MANDATORY

SUBJECT: FAILURE OF THE ALTERNATE AIR DOOR SPRING (injected induction system)

APPLICATION: Glasair III, and any Glasair I, II, or II-S aircraft fitted with the fuel-injected induction system air filter assembly.

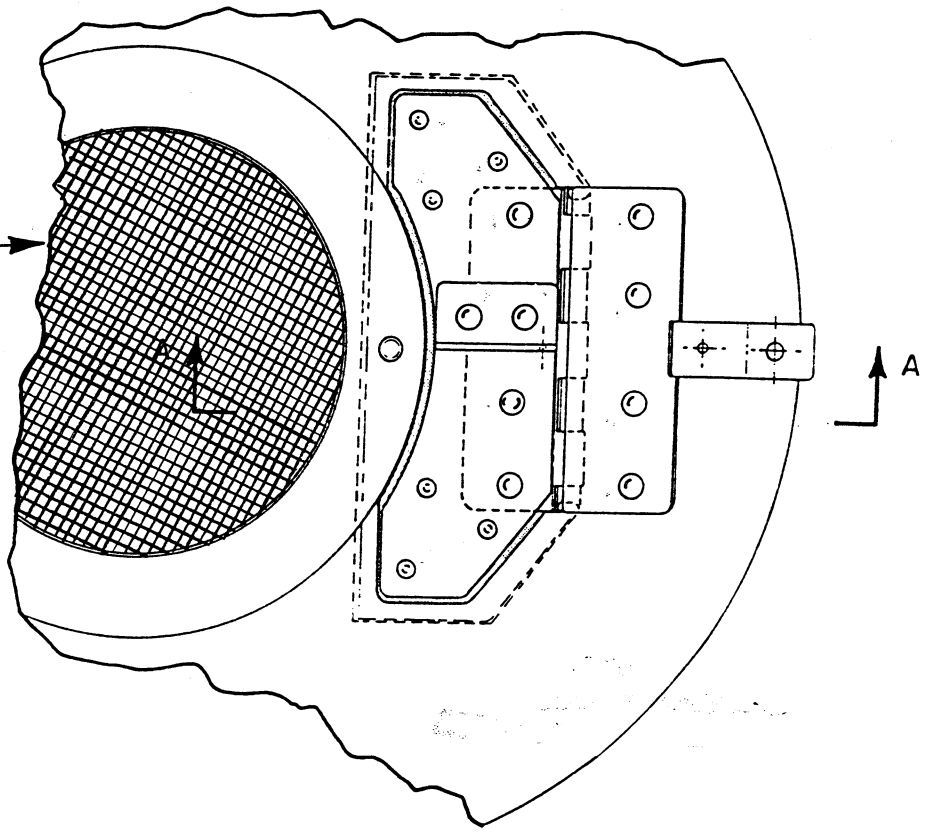
FIGURE (1)

Screen location

SAFETY WIRE EXCESS LOOP

SAFETY WIRE LOOP

VIEW A-A

To eliminate wear and damp vibration between the alternate air door spring and its mounting tabs, apply a generous bead of silicone at each end of the spring where it attaches to the tabs. This has worked well on our factory Glasair III, N54ORG. As a backup, run a piece of safety wire through the middle of the spring and anchor the safety wire to the induction filter cover plate to retain the spring in case of breakage. The safety wire loop must be long enough to allow the door to open properly. As another possible remedy to prevent engine ingestion of these components, Stoddard-Hamilton Aircraft, Inc. is testing a 14 mesh per square inch stainless steel screen installed at the base of the spun flange.
