SERVICE BULLETIN 91 MANDATORY

SUBJECT: FAILURE OF THE ALTERNATE AIR DOOR SPRING (injected induction system)

APPLICATION: Glasair III, and any Glasair I, II, or II-S aircraft fitted with the fuel-injected induction system air filter assembly.

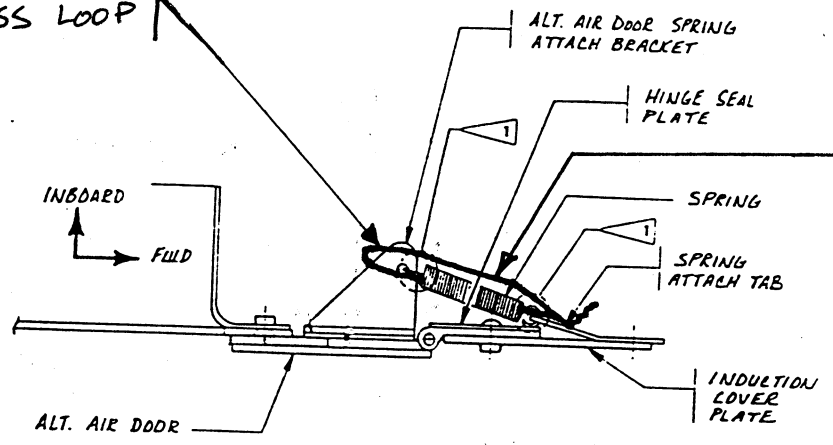
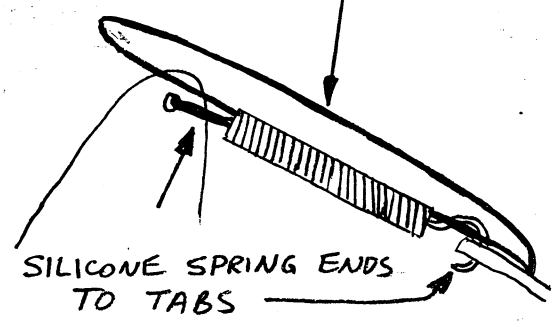
FIGURE (1)

SAFETY WIRE EXCESS LOOP

SAFETY WIRE LOOP

1 APPLY SILICONE IN THESE AREAS TO PREVENT CHAFING AND DAMP VIBRATION

To eliminate wear and damp vibration between the alternate air door spring and its mounting tabs, apply a generous bead of silicone at each end of the spring where it attaches to the tabs. This has worked well on our factory Glasair III, N54ORG. As a backup, run a piece of safety wire through the middle of the spring and anchor the safety wire to the induction filter cover plate to retain the spring in case of breakage. The safety wire loop must be long enough to allow the door to open properly. As another possible remedy to prevent engine ingestion of these components, Stoddard-Hamilton Aircraft, Inc. is testing a 14 mesh per square inch stainless steel screen installed at the base of the spun flange.
