SERVICE BULLETIN 95

SUBJECT: GLASAIR III LANDING GEAR OLEO STRUT WELDED JOINTS

APPLICATION: All Glasair III landing gear oleo struts  
(Serial numbers 051 to 101 in particular)

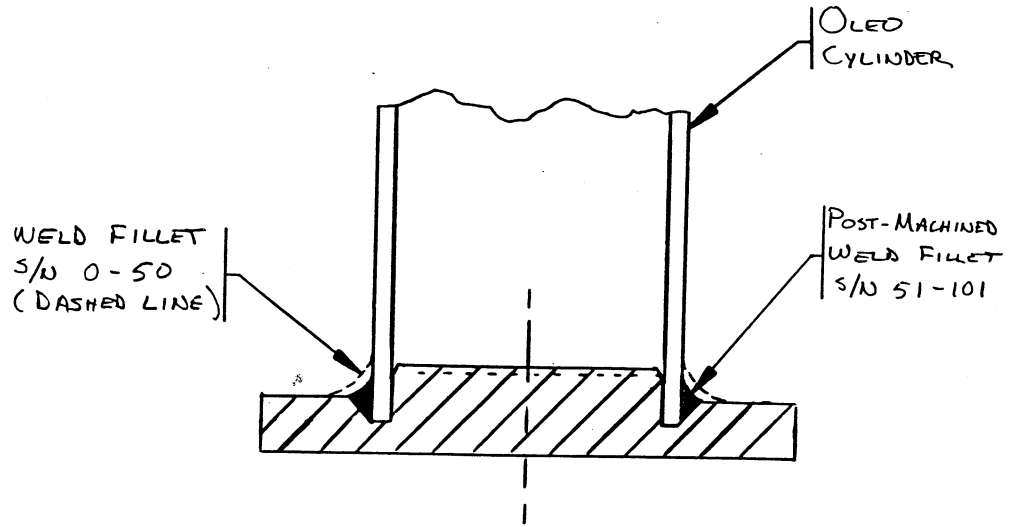
FORK ATTACH FLANGE  
SERIAL NUMBERS 0 - 101

DESCRIPTION: We recently received notification of a failure of the weld at the junction between the chrome oleo cylinder and the fork mounting flange (see illustration). The failure, which occurred on a customer's Glasair III nose gear, resulted in damage to the propeller and required an engine tear-down.

An inspection of the welded joint revealed that the weld had slowly cracked over time as indicated by rust along most of the severed joint and moisture and rust which had invaded the inside of the cylinder. We think that the cracked weld could probably have been spotted with more thorough pre-flight inspection procedures, although engine oil and dirt likely concealed the problem.

The cylinder that failed came from the second production run of Glasair III landing gear. In this lot, the weld was post-machined to provide clearance for the fork attachment bolts. Possible causes of this failure could be uneven weld penetration compounded by post machining, weld cavities, etc. or an extra hard landing. A hard landing may cause a break or a crack in a weak weld. Subsequent takeoffs and landings could then cause the crack to propagate.

It is difficult to predict the extent of the problem or the potential for failure for second production run landing gear. Therefore, we will advise but not require replacement of the chrome oleo cylinders for gear struts with serial numbers 51 to 101. The replacement cost of these components can be considered inexpensive insurance compared to the replacement cost of a propeller, an engine tear-down, or the cost of other components that could be damaged as a result of a gear strut failure.

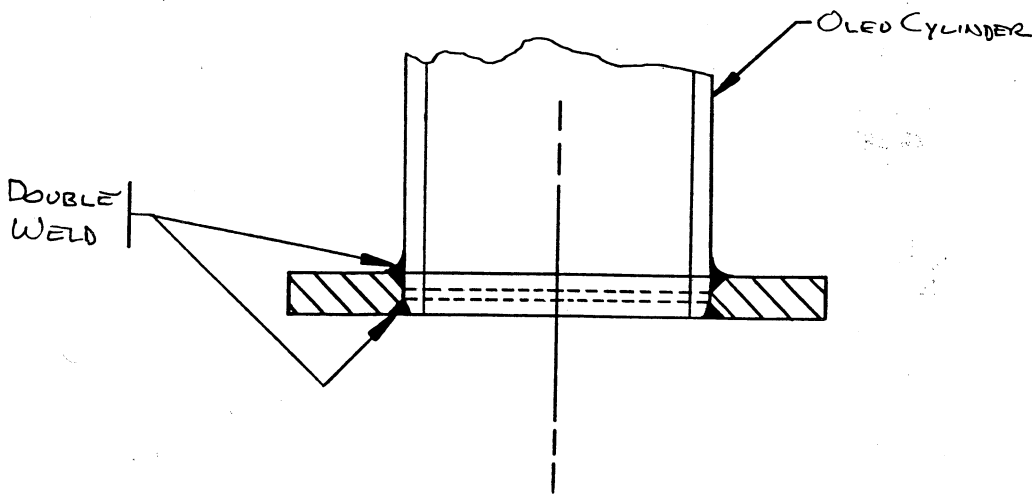
FORK ATTACH FLANGE  
SERIAL NUMBERS ABOVE 101

These third production run cylinders have the smaller radius welds to eliminate interference with assembly bolts, but use a different mounting flange design than the first and second production runs. Redesign of the mounting flange allowed a secondary weld to the cylinder on the lower side of the flange and eliminated the deep countersink that invited uneven weld penetration and weld cavities. (Refer to FIGURE [1].)

Since we stock only a few replacement cylinders, we will initiate a special production run of these parts for Glasair III builders who wish to upgrade their oleo struts to the most recent design.
