SUBJECT: ELEVATOR TRIM BOX MAIN GEAR ASSEMBLY

APPLICATION: All Glasair II, II-S, and III elevator trim gear box assemblies, and Glasair I retrofit trim systems shipped before 9/12/90.

MODEL GLASAIR	ASSEMBLY NAME SERVICE BULLETIN 96	REVISION	DATE 12/21/90	VOLUME	PAGE 1 of 4
------------------	--------------------------------------	----------	------------------	--------	----------------

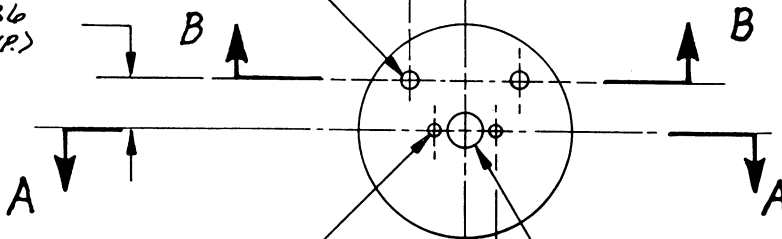
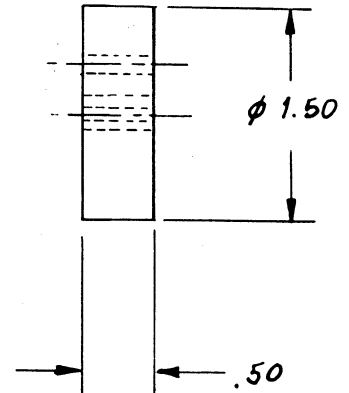
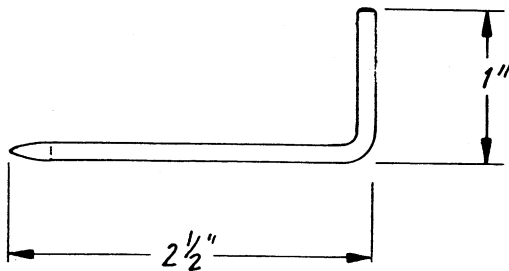
CABLE DRUM, MAIN GEAR DRILLING
JIG TOOL FABRICATION

The two .094" diameter steel dowel pins, as well as replacement roll pins for use when reassembling the trim gear box, are included with this Service Bulletin. In addition, a trim gear drilling jig tool (Part No. 810-0155-001) is needed to accomplish the trim system modification. The jig tool may be either purchased (\$15.00) or borrowed. If borrowed, we require a \$15.00 deposit to guarantee the tool's return in good condition. Contact Stoddard-Hamilton's order desk to place your order. The jig tool is illustrated in FIGURE (1) if you prefer to fabricate it yourself.
