SUBJECT: ELEVATOR TRIM BOX MAIN GEAR ASSEMBLY

APPLICATION: All Glasair II, II-S, and III elevator trim gear box assemblies, and Glasair I retrofit trim systems shipped before 9/12/90.

MODEL GLASAIR	ASSEMBLY NAME SERVICE BULLETIN 96	REVISION	DATE 12/21/90	VOLUME	PAGE 1 of 4
------------------	--------------------------------------	----------	------------------	--------	----------------

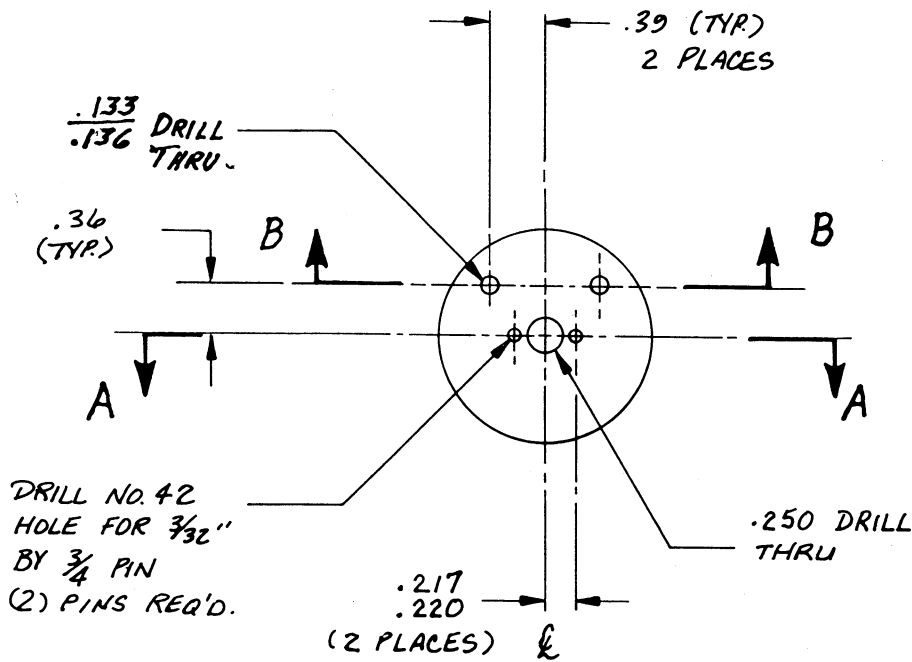
DESCRIPTION: We have had reports of failure of the main gear shaft in the elevator trim box. Loads in the system are transmitted from the cable drum to the main gear by the roll pins that secure the components to the shaft. The shaft fails where it has been weakened by the roll pin holes.

The two .094" diameter steel dowel pins, as well as replacement roll pins for use when reassembling the trim gear box, are included with this Service Bulletin. In addition, a trim gear drilling jig tool (Part No. 810-0155-001) is needed to accomplish the trim system modification. The jig tool may be either purchased (\$15.00) or borrowed. If borrowed, we require a \$15.00 deposit to guarantee the tool's return in good condition. Contact Stoddard-Hamilton's order desk to place your order. The jig tool is illustrated in FIGURE (1) if you prefer to fabricate it yourself.

CABLE DRUM, MAIN GEAR DRILLING
JIG TOOL FABRICATION

FABRICATE FROM MILD STEEL

OPTIONAL ALIGNMENT PIN

FABRICATE (2) FROM $.125$ " STEEL
OR ALUMINUM ROD
