SERVICE BULLETIN 98

SUBJECT: SLOTTED FLAP HINGE POINT CORRECTIONS

APPLICATION: All Slotted Flap Kits shipped before 1/24/91

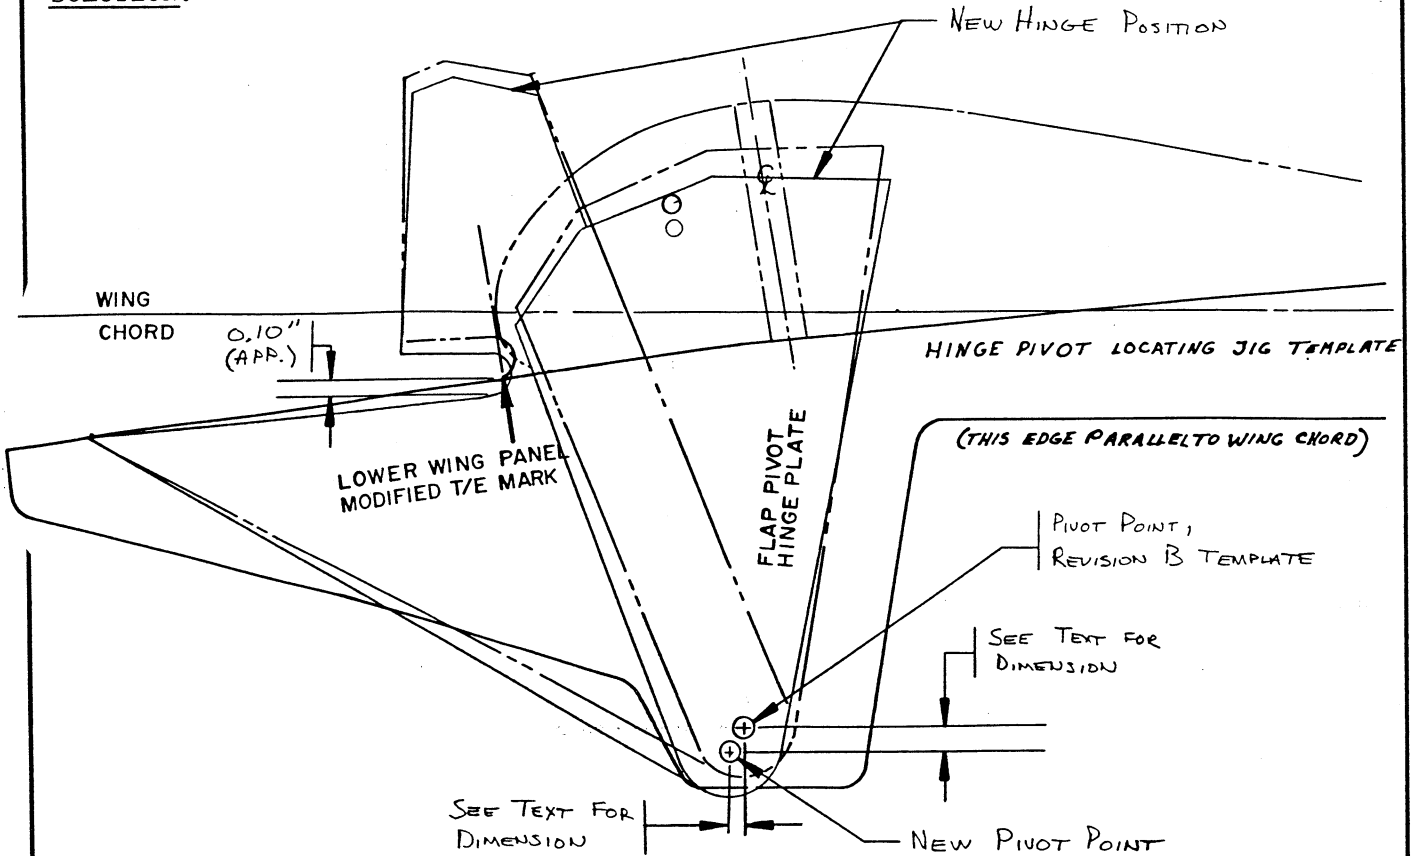
Some builders have experienced problems when using the Revision B Hinge Locating Jig Templates. In some cases, the templates position the flap hinge pivot plates too high so they extend too close to the upper surface of the flaps. This, in turn, causes the rod-end bearing on the actuator rod to protrude above the upper surface of the flap. One cannot simply drill a new hole and trim off the top of the pivot plate, because this changes the lever arm for the actuator.

If you experience a problem with the flap actuator rod-ends protruding above the upper surface of the flap, the only thing you can do is to lower the flap hinge pivot point to get everything back inside the flap without changing the lever arm for the actuator. Try locating new hinge pivot points on the Revision B Hinge Locating Jig Templates, as shown in FIGURE (1) and as described in the following table:

- Inboard Hinge: locate the new hinge pivot point .16" below and .13" forward of the existing pivot point shown on the Revision B Hinge Locating Jig Template.
- Outboard Hinge: locate the new hinge pivot point .16" below and .11" forward of the existing pivot point shown on the Revision B Hinge Locating Jig Template.

- Both Hinges: locate new hinge pivot points .22" below and .08" forward of the existing Revision B Hinge Locating Jig Templates.

To achieve the new hinge point position, rest the leading edge of the wing attach plate against the lower surface of the wing and rotate the aft end down. This will require trimming some material off the notch cut in the attach plate to clear the lower spar cap, and will leave approximately a 0.1" gap between the lower wing skin and the wing attach plate at the modified wing trailing edge. If you trim the wing attach plates, be sure to remove all sharp edges and scratches in the relieved areas. Accomplish this at both the inboard and outboard hinge plates. This modification should be enough to get the flap hinge pivot plate back inside the flap.
