SERVICE BULLETIN 108 MANDATORY

SUBJECT: Glasair III Cowl Flap Rod End Bearings (Stoddard-Hamilton Stock No. 170-0110-003)

APPLICATION: All 170-0110-003 rod end bearings shipped either with or without kits between 7/3/91 and 12/31/91. These bearings are used in the Glasair III cowl flap linkage.

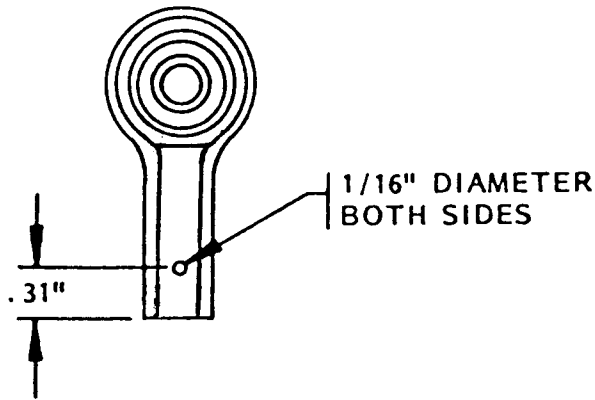
FIGURE (1)

DESCRIPTION: Some of the 170-0110-003 rod end bearings recently shipped lack the two small inspection holes that are necessary to determine if the rod ends are threaded sufficiently onto their actuator rods. The affected rod ends are part number MW3MT-2, manufactured by Aurora Bearing.

If the rod end bearings shipped to you lack the inspection holes, they must be modified to permit inspection for adequate threading onto the actuator rods. Using a 1/16" drill bit, drill holes through both sides of the rod end bearing. Locate the holes .31" from the threaded end of the bearing, as shown in FIGURE (1).

To inspect for sufficient threading of the rod end bearing onto the actuator rod, insert a piece of .040" or smaller safety wire into the inspection hole. If the safety wire can be passed through either inspection hole past the end of the threaded actuator rod, an unsafe condition exists. The actuator rod must be threaded into the rod end bearing past the inspection hole.
