SUBJECT: Drag Brace Weld Clearance Inspection

APPLICATION: All Glasair III aircraft prior to kit number 3295.

MODEL	ASSEMBLY NAME	REVISION	DATE	VOLUME	PAGE
GLASAIR III	SERVICE BULLETIN 129		1/10/95		1 of 2

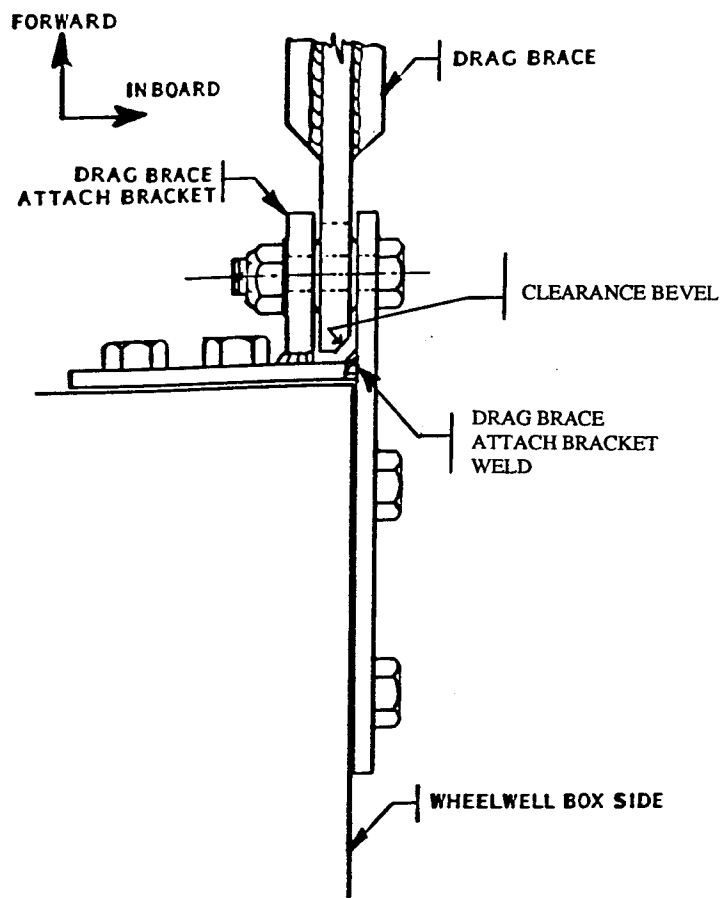
FIGURE (1)

DESCRIPTION: Some Glasair III nose gear drag braces (363-5410-101) may have been fabricated without proper clearance bevels. The bevels provide clearance between the aft edges of the drag brace arms and the welds on the drag brace attach brackets, as shown in FIGURE (1). Improper clearance can cause additional friction during gear operation and may effect proper retraction or extension of the nose gear.

REQUIRED ACTION: A one-time inspection is required to verify that the drag brace incorporates the bevels. The inspection is easily done even if the drag brace has been installed on the airplane. Visually confirm that the aft edge of the drag brace has a minimum of 1/16" clearance from the weld, as shown in FIGURE (1), throughout the entire range of travel of the drag brace.
