SUBJECT: Elevator Torque Tube Assembly welds

© STODDARD-HAMILTON AIRCRAFT, INCORPORATED				
MODEL	ASSEMBLY NAME	REVISION	DATE	PAGE
GLASAIR	SERVICE BULLETIN 140		11/30/95	1 of 1

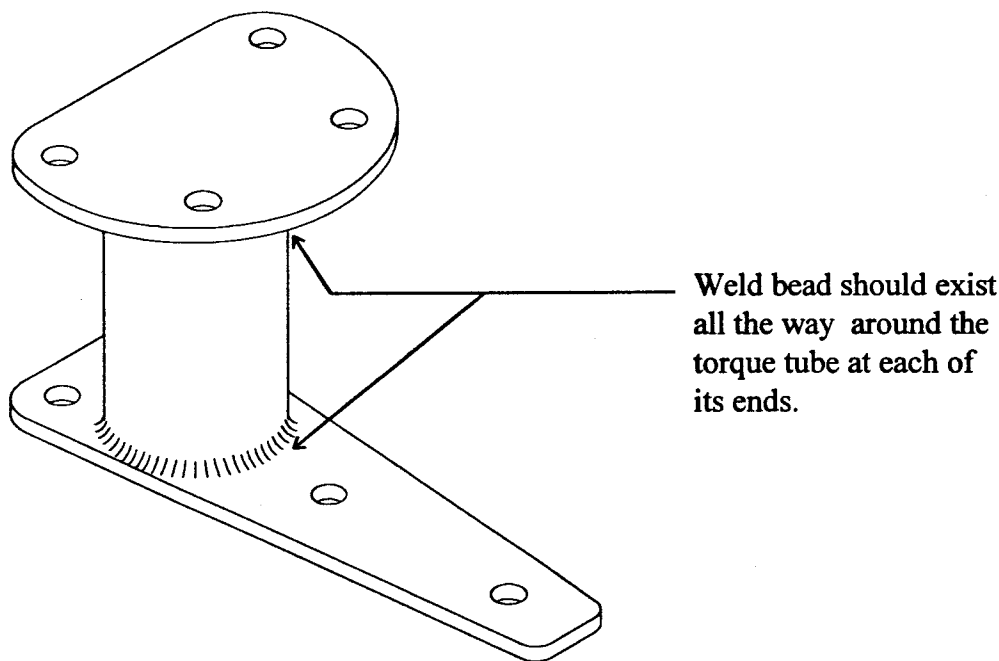
FIGURE 1

DESCRIPTION: It has come to our attention that some elevator torque tubes may have been shipped without being completely welded. A weld bead should exist all the way around the torque tube at each of its ends as shown.

REQUIRED ACTION: Visually inspect the Elevator Torque Tube Assemblies (472-3410-101) for complete welds per Figure 1. If an improperly welded torque tube is found, contact Stoddard-Hamilton for a return authorization and replacements of the subject part.
