SUBJECT: AN470A4-7 soft rivets

MODEL	ASSEMBLY NAME	REVISION	DATE	VOLUME	PAGE
GLASAIR	SERVICE BULLETIN 142		11/30/95		1 of 1

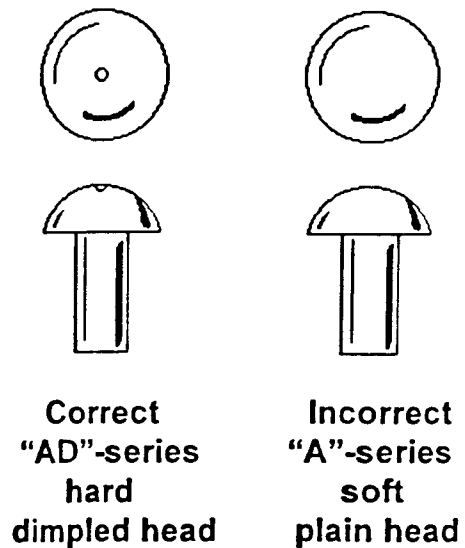
Figure 1

DESCRIPTION: It has come to our attention that the supply of AN470AD4-7 universal-head rivets shipped with several Glasair kits was contaminated with some AN470A4-7 rivets. These "A" -series rivets, which were inadvertently mixed in with the "AD" -series rivets by our vendor, are made of a much softer aluminum alloy than the "AD" -series rivets specified for the Glasair and therefore have insufficient strength. **They should not be used anywhere in the Glasair construction.**

REQUIRED ACTION: First, inspect your supply of AN470AD4-7 rivets and remove all the soft "A" -series rivets. They can be distinguished from the "AD" -series rivets by inspecting the rivet heads. As shown in Figure 1, the standard "AD" -series rivets have a small dimple in the center of the head, while the soft, "A" -series rivets have plain heads.

Second, inspect the Glasair assemblies specified in Table 1 (if you have completed them) to see if any soft, "A"-series rivets were used. If you discover any soft rivets, you must **drill them out and replace them** with proper AN470AD4-7 rivets. If necessary, refer to "FABRICATION TECHNIQUES" in the *Glasair Instruction Manual* to refresh your memory on the proper procedure for replacing defective rivets.
