**SERVICE BULLETIN 145**

**SUBJECT:** Glasair III Rod-End Bearings (Part Number 170-0110-003)

**APPLICABILITY:** 170-0110-003 rod-end bearings shipped to Glasair III builders before 6/30/96 (through kit serial number 3308)

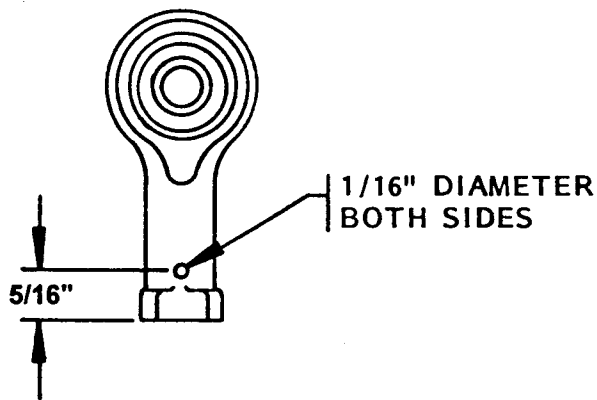
**ROD-END BEARING MODIFICATION**

**DISCUSSION:** The affected rod-end bearing, which is used in the Glasair III cowl flap installation, may lack the two small inspection holes that are necessary to determine if the rod-end is threaded a sufficient distance onto its actuator rod.

Any rod-end bearing without inspection holes must be modified to permit verification of adequate threading onto the control actuator rod. Using a 1/16" bit, drill holes through both sides of the rod end bearing 5/16" from the threaded end of the bearing, as shown.
