SERVICE BULLETIN 149 — MANDATORY

SUBJECT: Main landing gear trunnion tubes, possible cracking

APPLICABILITY: Glasair III main landing gear S/N 0-51

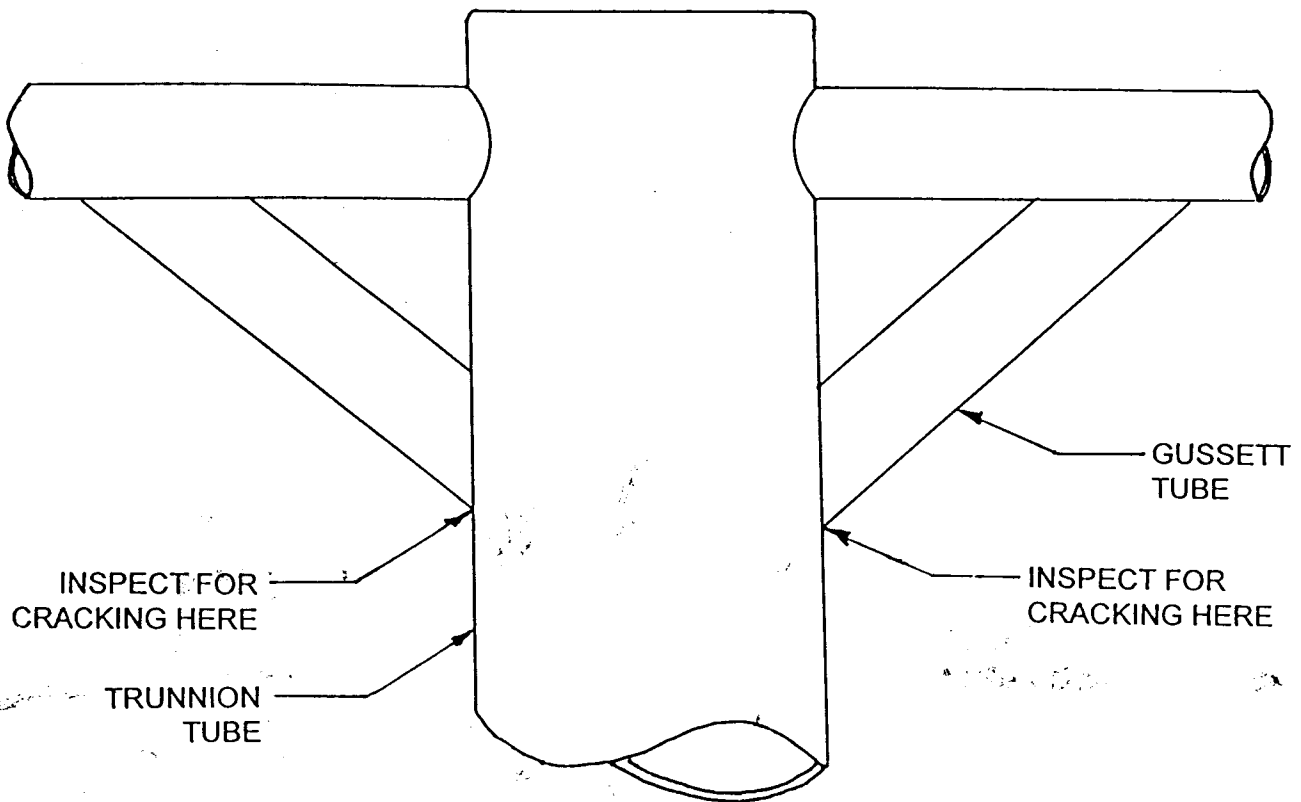
Figure 1: Main Gear Trunnion Assembly

DISCUSSION: We have received reports of cracking in the main landing gear trunnion tube near or along the bottom edge of the welds where the gusset tubes join the main tube, as indicated by the flags in Figure 1. If allowed to advance, such cracking can eventually rupture the wall of the trunnion tube, causing a loss of strut pressure. If a pilot failed to note the loss of strut pressure during the preflight inspection, the strut could fail to extend on takeoff, and subsequently fail to retract into the wing properly.

REQUIRED ACTION: Before further flight, perform a visual inspection of the welds in the areas indicated in Figure 1. Check for any sign of cracking in the paint or of hydraulic fluid leakage. Repeat this inspection at intervals of not more than 25 hours of service for the life of the landing gear.

If cracking is detected, the most practical solution is to replace the trunnion assembly. The difference between the cost of a new trunnion assembly and the cost of reworking an original one is small. Our vendor advises us that the rework would take several months to accomplish, as it would require disassembly of the gear leg, stripping the paint off the trunnion assembly, re-welding the cracks, normalizing and re-heat treating the assembly, re-applying paint and reassembling the gear. Additionally, the finished product would still be an original-design trunnion, subject to cracking in time just as it did initially. The current trunnion design, on the other hand, has been upgraded in many important respects, including the use of thicker-walled tubing and the addition of gusset plates, both of which make cracking in this area extremely unlikely. For all these reasons, Stoddard-Hamilton will not support the reworking of first-run trunnion assemblies in the event cracking is discovered.
