SERVICE BULLETIN 150 — MANDATORY

SUBJECT: Fram fuel filter assembly (P/N 332-0341-101)

APPLICABILITY: All Glasair II, II-S, Super II and III aircraft, as well as any Glasair I aircraft retrofitted with the Fram fuel filter assembly.

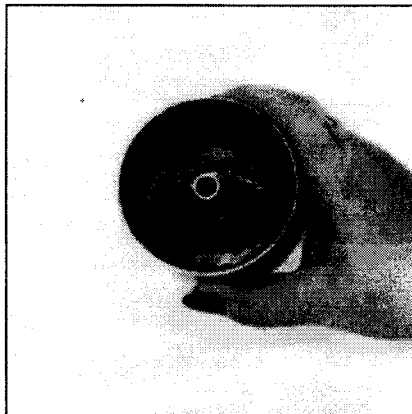
Figure 1

DISCUSSION: While replacing the fuel filter element on Stoddard-Hamilton's Glasair Super II RG demonstrator, the mechanic noticed a small amount of rust in the very bottom of the bowl. This rust was presumably caused by a very small amount of water that remained trapped in the bowl below the level of the drain outlet for an extended period of time. If allowed to progress unchecked, such rust could eventually compromise the integrity of the bowl, causing a potentially dangerous fuel leak.

Option 3: **Seal the bottom of the bowl, eliminating the low spot.** As noted above, the appearance of rust in the bottom of the bowl is traceable to the fact that there is a very small area of the bowl that is below the drain outlet. Preventing water from collecting in this area will also prevent further rusting. A fairly straightforward way to accomplish this is to fill the bottom of the bowl up to the level of the drain outlet with a fuel-proof sealer such as Pro-Seal or Jeffco 9700.

Then set the bowl upright on a table and fill it up to the level of the drain outlet with sealer. Do **not** level the bowl, but rather allow it to sit a slight angle due to protrusion of the drain fitting. As shown in Figure 1, allowing the sealer to harden with the bowl tilted a few degrees **away** from the outlet guarantees that the outlet is at the bowl's new low point. (Although it is difficult to see, the outlet is at the 12 o'clock position in Figure 1).
