SERVICE BULLETIN 154 — MANDATORY

SUBJECT: Gear warning buzzer (P/N 210-0677-001)

APPLICABILITY: Version 2 Glasair IIIs (i.e., Kit #3296 and higher); earlier Glasair IIIs with the Emergency Gear Extension Retrofit Kit (P/N 353-5800-502) installed; and any Glasair I RG, II RG, II-S RG or Super II RG that has been modified by replacement of the standard PC board with the current Glasair III diode board

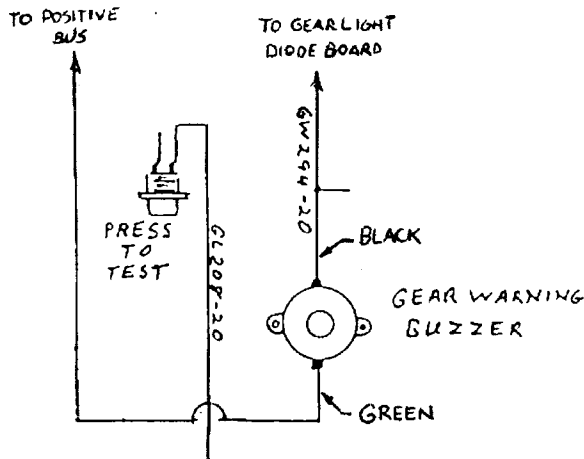
DISCUSSION: A potential hazard associated with the landing gear warning buzzer has come to our attention. If wired according to our instructions, the outer case of the buzzer will, at least sometimes, be electrically “hot,” thus posing a potential fire hazard if it should be inadvertently grounded through contact with baggage or some other metal component of the aircraft. Whether the buzzer case is always hot or only sometimes hot depends on how it is wired, but in either instance, precautions must be taken to ensure that the case cannot be inadvertently grounded.

Figure 1: Worst-Case Buzzer Polarity (Case Always Hot)

Also, inspect the buzzer to determine whether it is wired according to Figure 1 or Figure 2 above. If it is wired according to Figure 1 so that the green wire goes to the positive bus and the case is continuously hot, rewire it according to Figure 2.

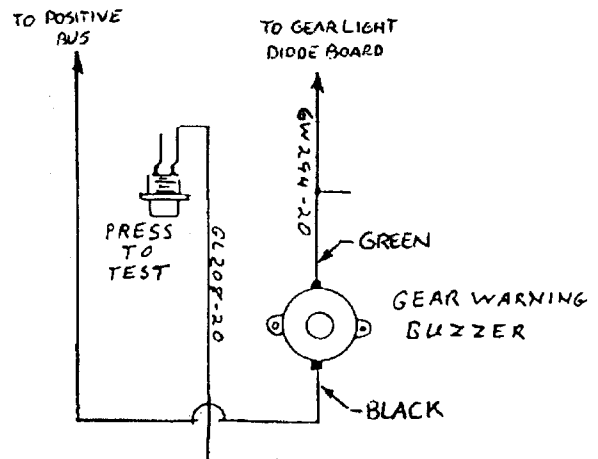
Figure 2: Best-Case Buzzer Polarity (Case Hot Only When Buzzer Is Activated)
