SERVICE LETTER 7

SUBJECT: Factory Molded Landing Gear Boxes

APPLICATION: All Glasair II RG, II-S RG, Super II-S RG, and G-III Aircraft shipped prior to 11/16/94 and still under construction.

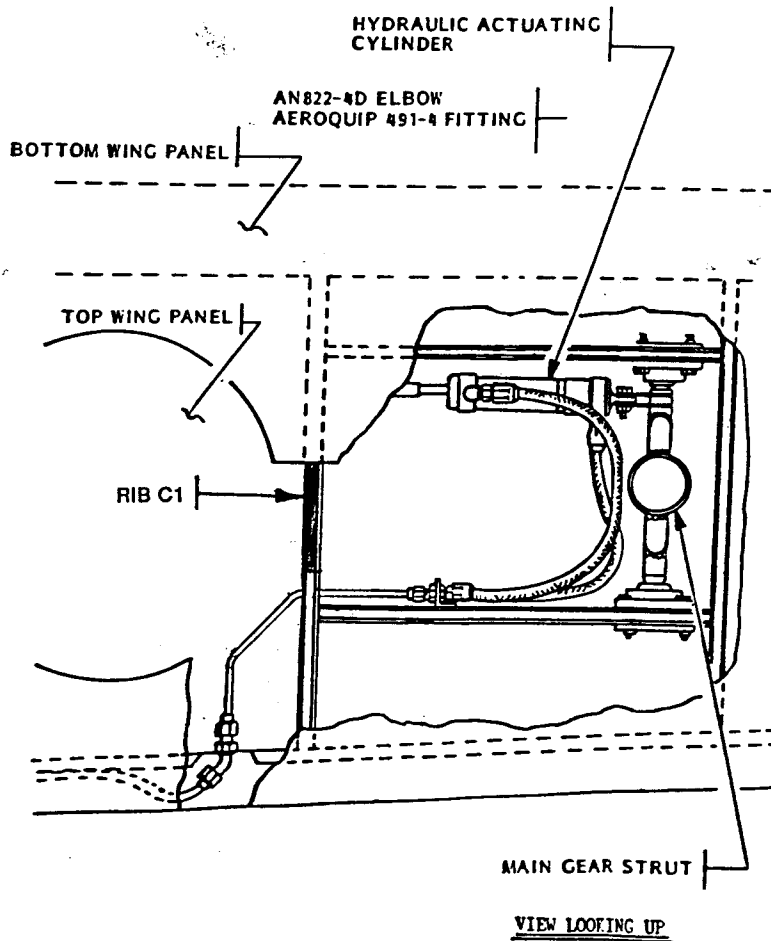
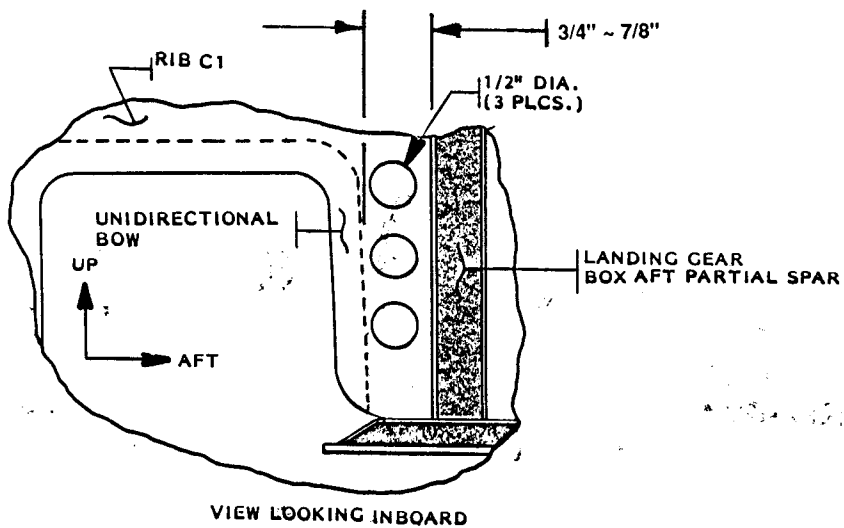
FIGURE (1)

DESCRIPTION: Some builders are having difficulty routing the hydraulic actuator lines through the C-1 rib between the unidirectional bow and the landing gear box aft partial spar, as called out in the instruction manual and shown in FIGURE (1). This problem may occur if, during fabrication of the landing gear box, the unidirectional bow was molded in too far aft (see FIGURE 2, upper illustration), leaving too little space for the three 1/2" holes called for in the instruction manual.

RECOMMENDED ACTION: The easiest cure for this lack of space is to simply avoid the area and take a slightly different route than shown in the assembly manual and FIGURE (1).

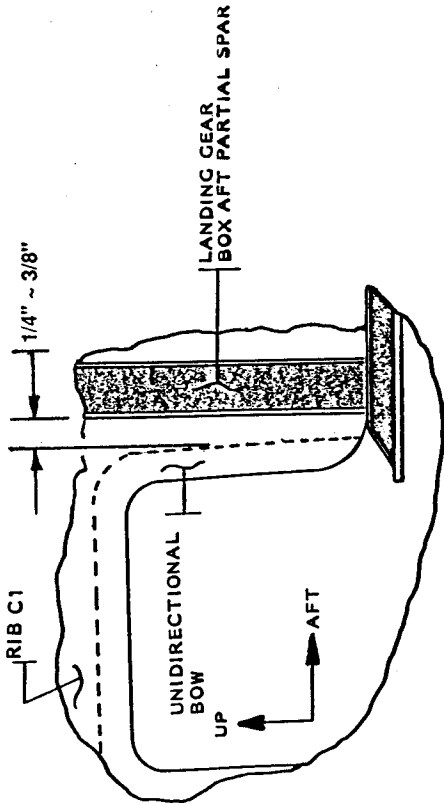
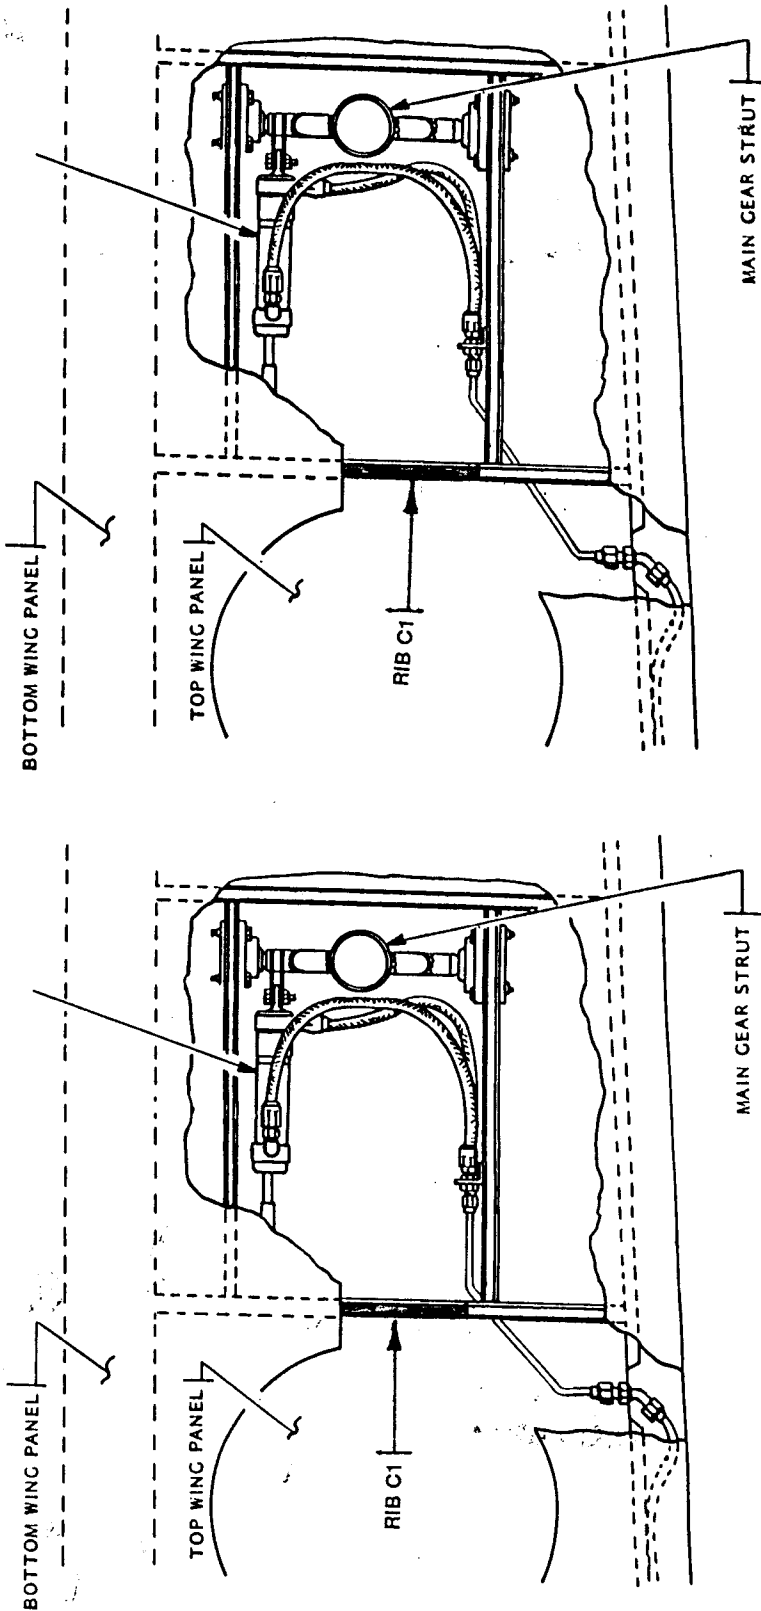
If the hydraulic line exit area of your landing gear boxes looks more like the one in FIGURE (2) than the desired configuration shown in FIGURE (1), use the following suggestions for alternative hydraulic line routing.

FIGURE (2) shows two slightly different paths for the hydraulic lines to follow. Both involve drilling the 1/2" pass through holes at a 45° angle to the landing gear box partial spar surface. The view on the left has the holes right in the corner of the gear box, the second is pulled back (outboard) toward the union fitting angle. The results are the same, but the one on the left is probably easier to accomplish and requires the least amount of work.

We also recommend adding a plastic tube or a protective sleeve, such as spiral wrap, over the tubes where they go through the holes and then "potting" them in place with silicone sealant. This acts as both an anti-chafe device and as a sealant to protect the laminate and its foam core.
