**SERVICE LETTER 7**

**SUBJECT:** Factory Molded Landing Gear Boxes

**APPLICATION:** All Glasair II RG, II-S RG, Super II-S RG, and G-III Aircraft shipped prior to 11/16/94 and still under construction.

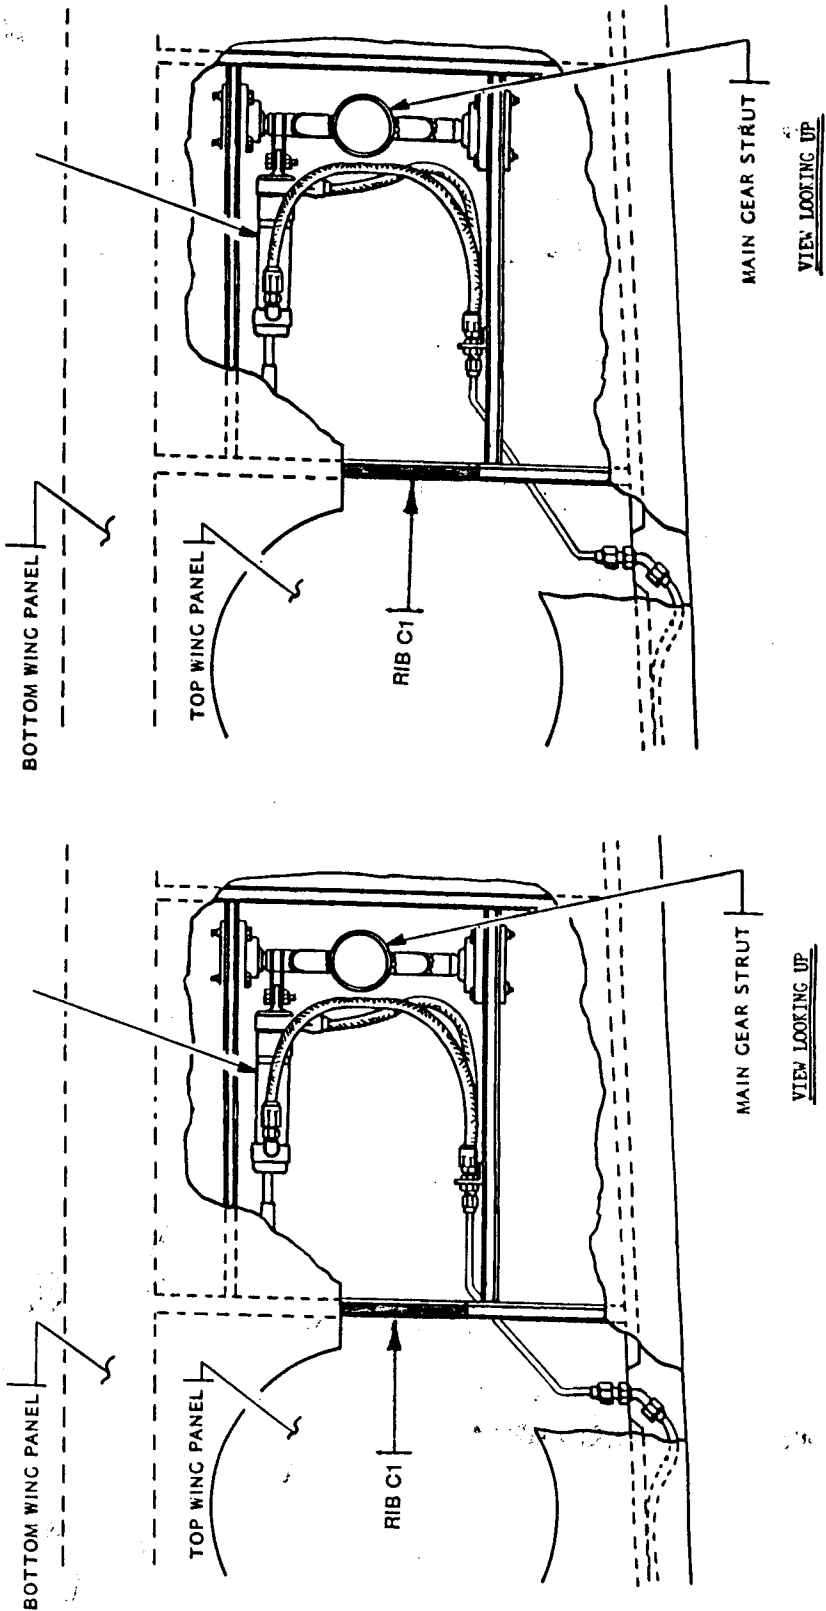
If the hydraulic line exit area of your landing gear boxes looks more like the one in FIGURE (2) than the desired configuration shown in FIGURE (1), use the following suggestions for alternative hydraulic line routing.

FIGURE (2) shows two slightly different paths for the hydraulic lines to follow. Both involve drilling the 1/2" pass through holes at a 45° angle to the landing gear box partial spar surface. The view on the left has the holes right in the corner of the gear box, the second is pulled back (outboard) toward the union fitting angle. The results are the same, but the one on the left is probably easier to accomplish and requires the least amount of work.

We also recommend adding a plastic tube or a protective sleeve, such as spiral wrap, over the tubes where they go through the holes and then "potting" them in place with silicone sealant. This acts as both an anti-chafe device and as a sealant to protect the laminate and its foam core.
