Service Bulletin 157

Subject: Glasair IIS 200hp RG Engine Mounts; Part No.: 222-0269-103

Applicability: Engine mounts delivered between June, 2001 and March 2005

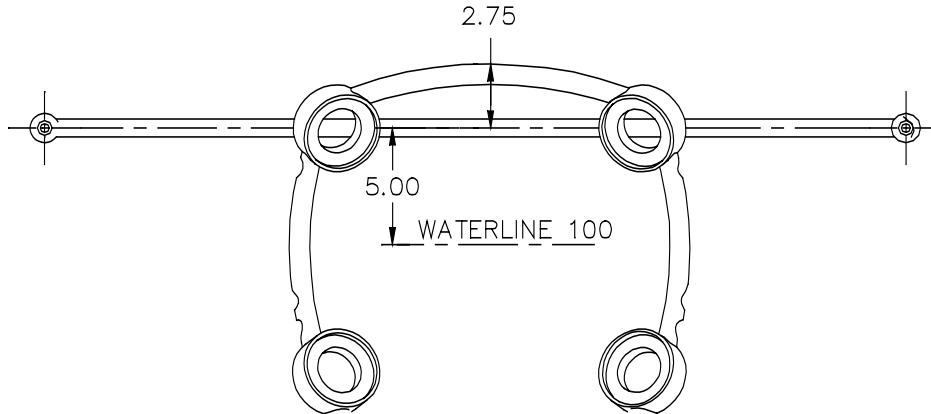
Required Action: If you have already installed the engine mount and you have determined there exists satisfactory clearance between the described center tube and the upper cowl as shown in Figure 1, no further action is required.

The mount can be measured on the ground or hung on the firewall if that is an option. The maximum distance between the top surface of the center tube to a horizontal centerline defined by the two upper engine mount attach points on the firewall **should be approximately 2.75** inches as shown in Figure 1. This would place the top of the tube at approximately **waterline 107.75**.

The mounts that were modified would have a noticeable error of approximately **1-1.5" higher than this dimension**. This would place the measured dimension at approximately 3.75 – 4", which would equate to waterline 108.75 or higher.

Figure 1: Measurements on acceptable mounts.

If your measurement exceeds this acceptable dimension as discussed above, you are required to return the engine mount directly to the engine mount vendor. If you respond to this service bulletin by **May 31, 2005**, your mount will be repaired (or replaced) and returned at no charge to you.
