GLASTAR SERVICE BULLETIN 49

MANDATORY

Subject: Inspection of welded cage and seat assemblies for cracking.

Applicability: All Flying GlaStar Aircraft

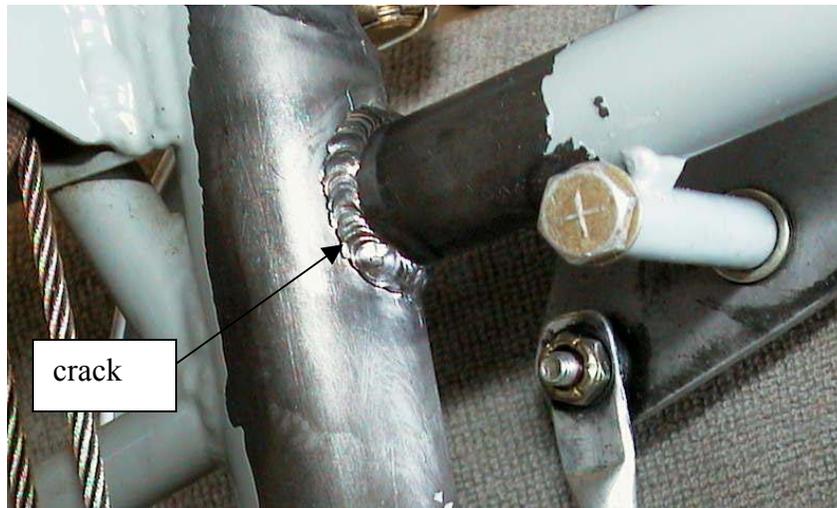
Item 1: We have recently been informed that, while performing an inspection of a GlaStar taildragger, cracking was noted on two welded tubes in the steel cage. Specifically, the affected tubes are the ones where the lower 3/4" diameter tube on the truss above the doors intersects with the 1" diameter tube on the vertical truss just aft of the main door. The vertical tube has a 1-1/8" sleeve welded over it at this intersection. The cracking was evident on both sides of the aircraft, limited to the forward side of the 1-1/8" sleeve. The crack was visible through the powder-coat finish. Reference Figure 1.

Figure 1. Cracking of weld at tube intersection.

Based upon inspection of this weld from the photo and our conversations with the repair facility, it appears to us that the welds are separating from the tubes right at the weld line. Often, fatigue cracking of tubular structure, will occur in the heat affected zone and the cracking will occur slightly away from the weld bead itself. The failure of the weld right at the weld bead (as in this case) is usually evidence of a cold weld.

Based upon our review of the photo and information gathered, we believe that the weld in question is that of a MIG process. In general, the MIG weld will be rougher and will tend to have a convex weld bead, whereas the TIG weld will be smoother and generally have concave weld beads. When done properly, MIG and TIG are equally sufficient welds. However, operators performing MIG welds must be extra careful not to cold weld or cold lap a joint.

Stoddard-Hamilton Inc. only MIG welded for a short period of time and eventually went back to TIG welding all the welded structures at their premises. (All cages welded by New Glastar LLC are TIG welded.) Based upon the in service date of the aircraft in question, we believe that this cage (# 147) was one of Stoddard Hamilton's early MIG welded cage assemblies.

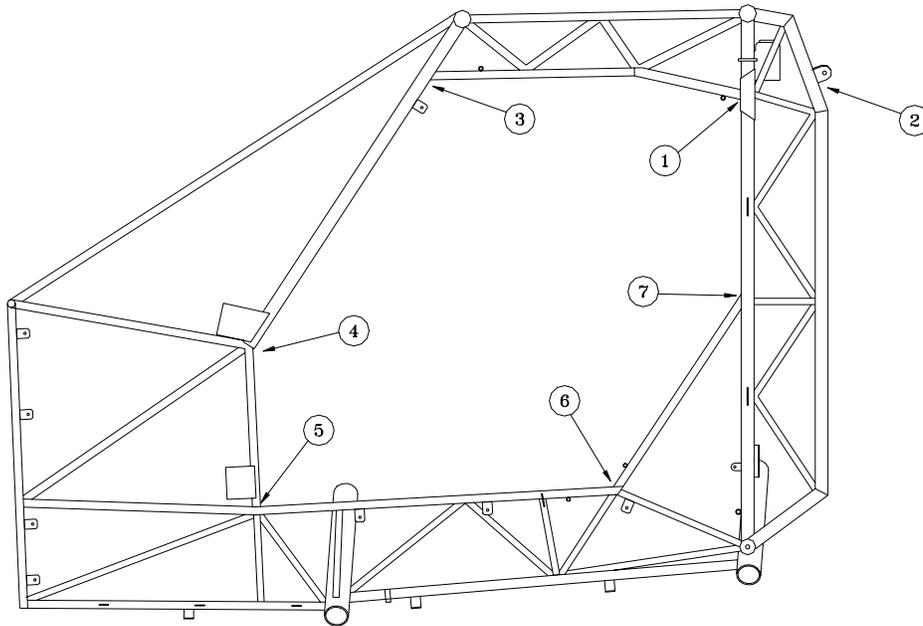
Although cracking was only discovered at point 1 in Figure 2, it is recommended that you inspect the other points as well. These points make up the structural ring of the door, which must transfer the shear loads and bending moment through the fuselage.

Item 1: Before next flight, the owner shall perform a visual inspection of the tubes and welds indicated in Figure 2 below. Although the GlaStar cage is a highly redundant tubular structure, these specific joints are identified as critical to inspect for the purposes of this service bulletin.

Visual inspection should be done with a mirror and flashlight. You will need to remove any interior covers that might be installed which impede complete access to the desired joints. Carefully look for any signs of cracking in the vicinity of the weld bead or right under the weld bead. The powder coating used on the cages and other structure is brittle enough, that should any cracking occur or be severe enough under the coating, the crack will transfer through to the surface and be visible to the eye. You may want to pick at or press the powder coat with the edge of a wooden tongue depressor to see if the coating has bridged any initial crack.

If you feel you have identified an area in item 1 or 2 above that is showing signs of cracking, it is recommended that you inspect the area further with a penetrant inspection. These kits are available through most aircraft supply companies. Penetrant inspection works by having a dye penetrate into a flaw such as a crack and then after the application of a developer, the highly visible dye shows up on the contrasting surface of the developer. It is a very cost effective way to inspect for weld integrity or on older aircraft for fatigue cracks.

After you have complied with the visual inspection described herein, it is recommend that you fully inspect the points identified in Figures 2 and 3 above at your next and all subsequent annual inspections. Additionally it is recommended that you inspect the following areas on a routine (annual) basis:

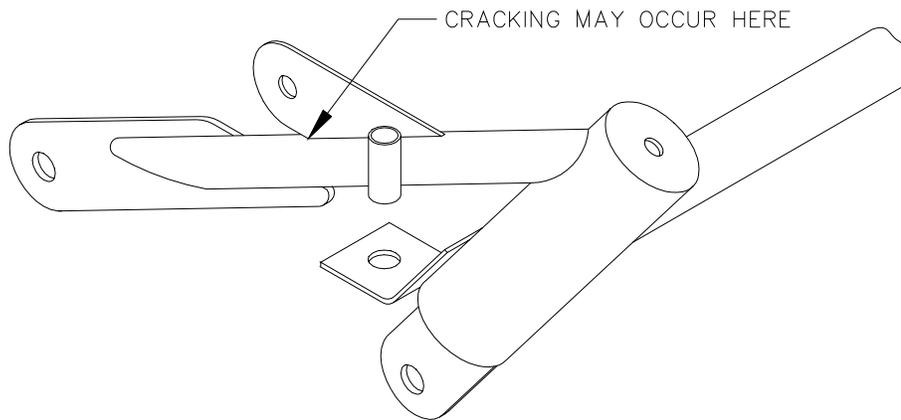
SECOND-RUN SEAT BASE (P/N 802-03000-03)

Item 2: We have also been informed, that cracking of a seat base tube has been discovered on more than one occasion where the owner (or 3rd party build centers) have modified the seat back to a "high back" configuration. To date, we are unaware of any cracking of the "stock" seat base tubes; thus, it is possible that extending the height of the seat back has overstressed the seat base from that originally designed. Note: The specific part number of the "stock" base is the 802-03000-03. This part (currently in production) is known as the "second run" seat base in the assembly manuals and can be seen in Figure 28, page 68 of the Section X Final Assembly. Cracks were discovered where the seat back pivot tab is welded to the tube as can be seen in Figure 3.

Figure 3. Seat base where cracks have occurred.

Item 2: The seat base should also be inspected for signs of cracking. Builders who have modified their seat backs to the "high back" configuration should pay particular attention to the area noted in the figure above.

If you note any cracking in the above structures, contact New GlaStar LLC for additional information and a repair procedure for your particular case. We will request that you provide us with your cage number, which is stamped in one of two areas: either on the taildragger gear truss on the right side, or above the right rear spar hinge on the rear spar carry-through end cap.
