GlaStar / Sportsman Service Bulletin 64- MANDATORY

Subject: Inspection of welded cage and seat assemblies for cracking.

Applicability: All Flying GlaStar/Sportsman Aircraft (Rev A. updated to include all Sportsman aircraft and 100 hour inspection for float plane operators.)

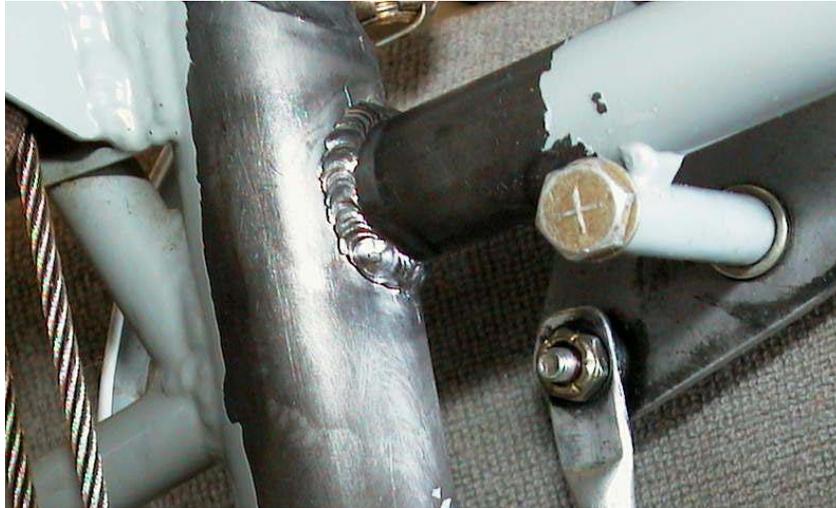
Item 1: We have recently been informed that, while performing an inspection of a GlaStar / Sportsman taildragger, cracking was noted on two welded tubes in the steel cage. Specifically, the affected tubes are the ones where the lower 3/4" diameter tube on the truss above the doors intersects with the 1" diameter tube on the vertical truss just aft of the main door. The vertical tube has a 1-1/8" sleeve welded over it at this intersection. The cracking was evident on both sides of the aircraft, limited to the forward side of the 1-1/8" sleeve. The crack was visible through the powder-coat finish. Reference Figure 1.

Figure 1. Cracking of weld at tube intersection.

Based upon inspection of this weld from the photo and our conversations with the repair facility, it appears to us that the welds are separating from the tubes right at the weld line. Often, fatigue cracking of tubular structure, will occur in the heat affected zone and the cracking will occur slightly away from the weld bead itself. The failure of the weld right at the weld bead (as in this case) is usually evidence of a cold weld.

Based upon our review of the photo and information gathered, we believe that the weld in question is that of a MIG process. In general, the MIG weld will be rougher and will tend to have a convex weld bead, whereas the TIG weld will be smoother and generally have concave weld beads. When done properly, MIG and TIG are equally sufficient welds. However, operators performing MIG welds must be extra careful not to cold weld or cold lap a joint.

Stoddard-Hamilton Inc. only MIG welded for a short period of time and eventually went back to TIG welding all the welded structures at their premises. (All cages welded by Glasair Aviation LLC are TIG welded.) Based upon the in service date of the aircraft in question, we believe that this cage (# 147) was one of Stoddard Hamilton's early MIG welded cage assemblies.

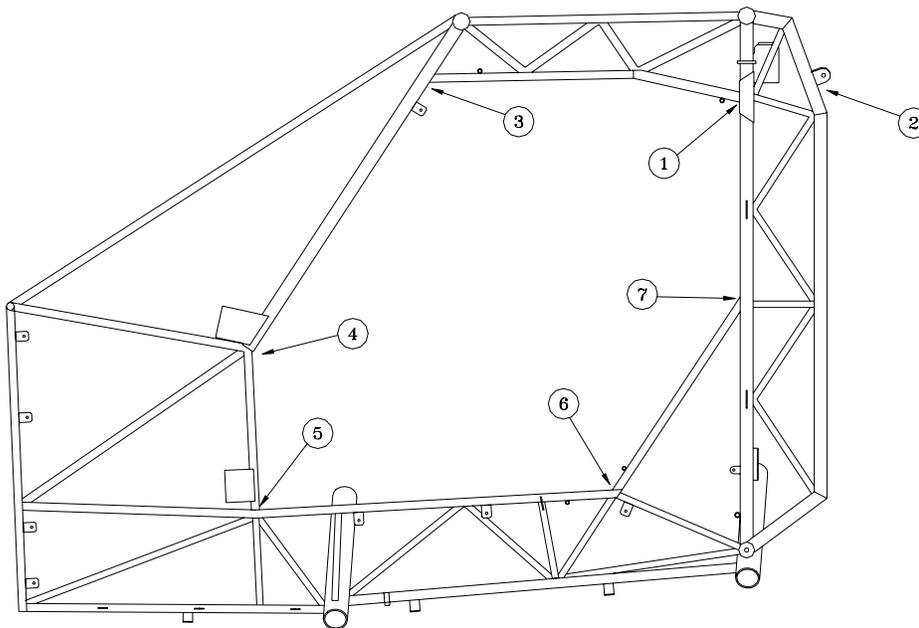
Figure 2. Points of inspection on fuselage cage structure.

Although cracking was only discovered at point 1 in Figure 2, it is recommended that you inspect the other points as well. These points make up the structural ring of the door, which must transfer the shear loads and bending moment through the fuselage.

Item 1: Before next flight, the owner shall perform a visual inspection of the tubes and welds indicated in Figure 2 below. Although the GlaStar / Sportsman cage is a highly redundant tubular structure, these specific joints are identified as critical to inspect for the purposes of this service bulletin.

Visual inspection should be done with a mirror and flashlight. You will need to remove any interior covers that might be installed which impede complete access to the desired joints. Carefully look for any signs of cracking in the vicinity of the weld bead or right under the weld bead. The powder coating used on the cages and other structure is brittle enough, that should any cracking occur or be severe enough under the coating, the crack will transfer through to the surface and be visible to the eye. You may want to pick at or press the powder coat with the edge of a wooden tongue depressor to see if the coating has bridged any initial crack.

If you feel you have identified an area in item 1 or 2 above that is showing signs of cracking, it is recommended that you inspect the area further with a penetrant inspection. These kits are available through most aircraft supply companies. Penetrant inspection works by having a dye penetrate into a flaw such as a crack and then after the application of a developer, the highly visible dye shows up on the contrasting surface of the developer. It is a very cost effective way to inspect for weld integrity or on older aircraft for fatigue cracks.

If you note any cracking in the above structures, contact Glasair Aviation LLC for additional information and a repair procedure for your particular case. We will request that you provide us with your cage number, which is stamped in one of two areas: either on the taildragger gear truss on the right side, or above the right rear spar hinge on the rear spar carry-through end cap.

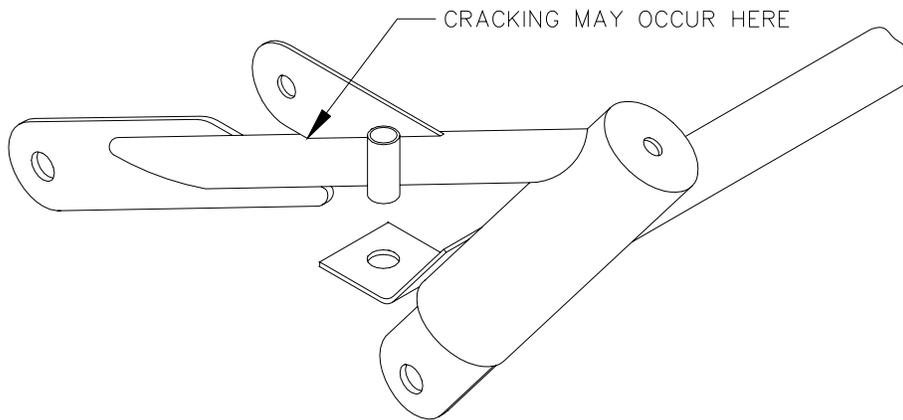
SECOND-RUN SEAT BASE (P/N 802-03000-03)

Item 2: We have also been informed, that cracking of a seat base tube has been discovered on more than one occasion where the owner (or 3rd party build centers) have modified the seat back to a "high back" configuration. To date, we are unaware of any cracking of the "stock" seat base tubes; thus, it is possible that extending the height of the seat back has overstressed the seat base from that originally designed. Note: The specific part number of the "stock" base is the 802-03000-03. This part (currently in production) is known as the "second run" seat base in the assembly manuals and can be seen in Figure 28, page 68 of the Section X Final Assembly. Cracks were discovered where the seat back pivot tab is welded to the tube as can be seen in Figure 3.

Figure 3. Seat base where cracks have occurred.

Item 2: The seat base should also be inspected for signs of cracking. Builders who have modified their seat backs to the “high back” configuration should pay particular attention to the area noted in the figure above.
