**SERVICE BULLETIN 72**

**Subject:** Autopilots Cable Clamps

**Applicability:** All Sportsman and GlaStar Aircraft

**Date:** 7-11-14

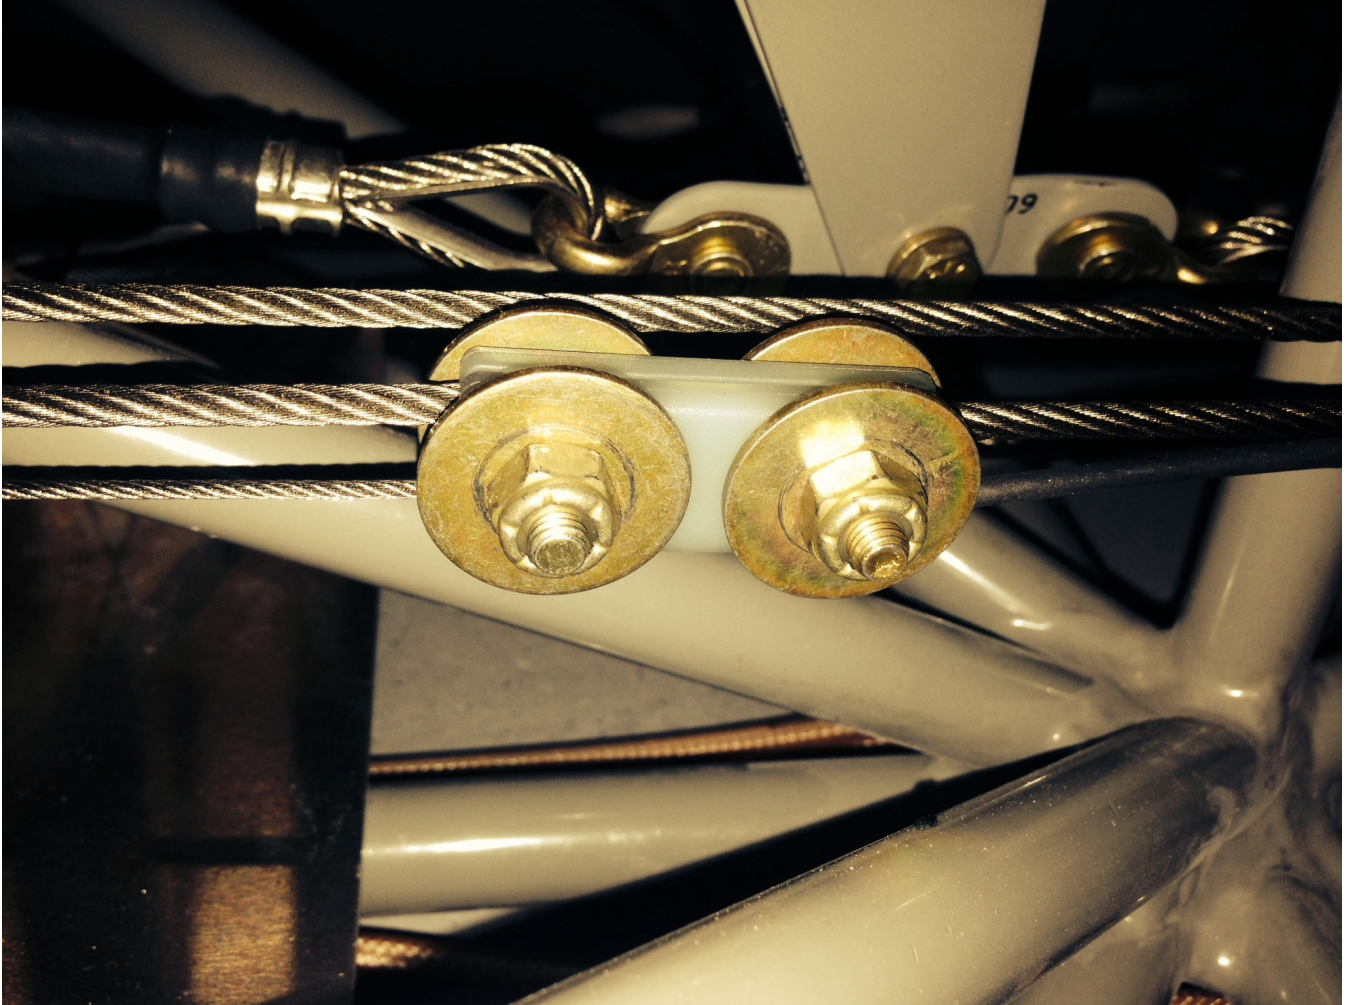
There have been several reports of slipping autopilot cables using the clamp system that is common for Trutrak, Advanced Flight System, Garmin and Dynon Systems installed in the GlaStar and Sportsman. The original material that we have seen that sometimes slips is a black plastic clamp. At some point the material changed to a Green color and Trutrak has just released a metal version.

Before your next flight inspect your autopilot clamps. If you have the inspection ports in the seat pans you will be able to see the color and type of the clamps without removing the seat pans. If you do not have the inspection ports you will need to remove the seat pans to determine what clamps are installed. If you have the black clamps they should be replaced with the new metal ones, if you have the Green ones they are serviceable.

If the clamps are held on with just a nut and bolt then you should add large area washers on each side of the clamp.
