Service Bulletin 70

Vertical fin cracks

All Sportsman aircraft

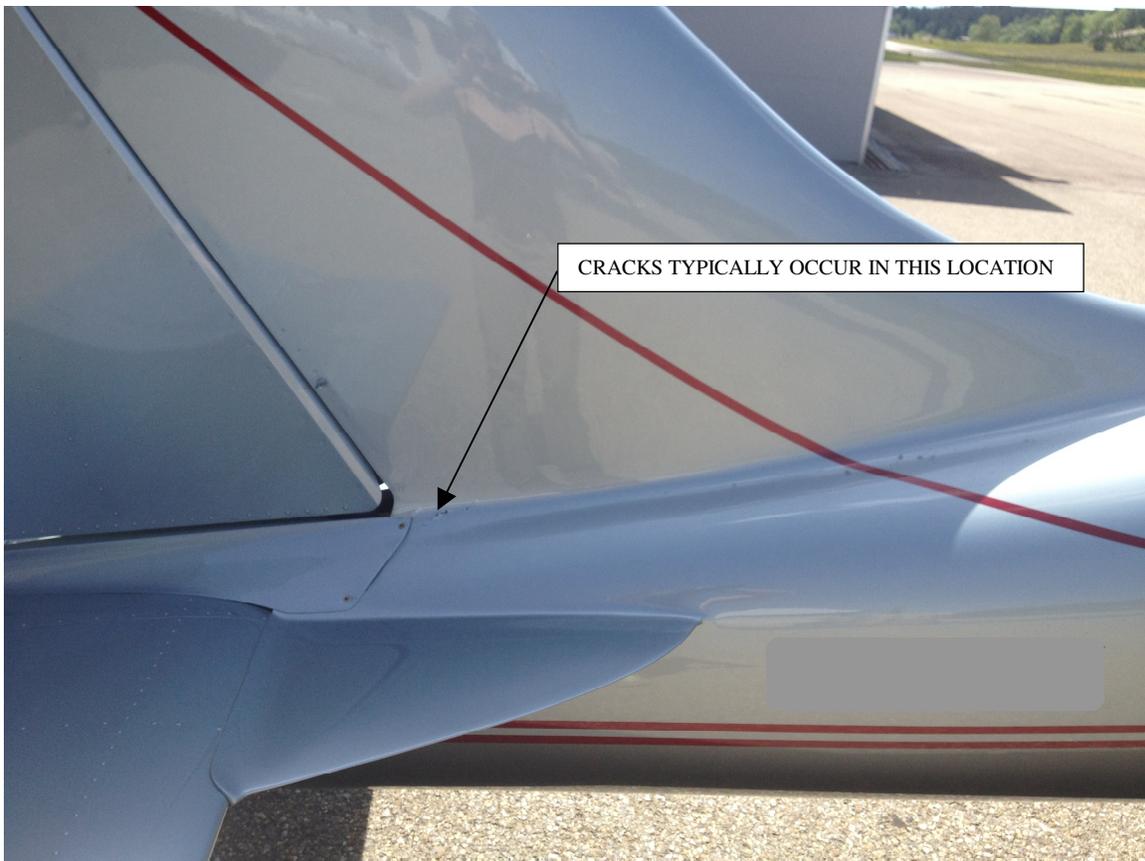
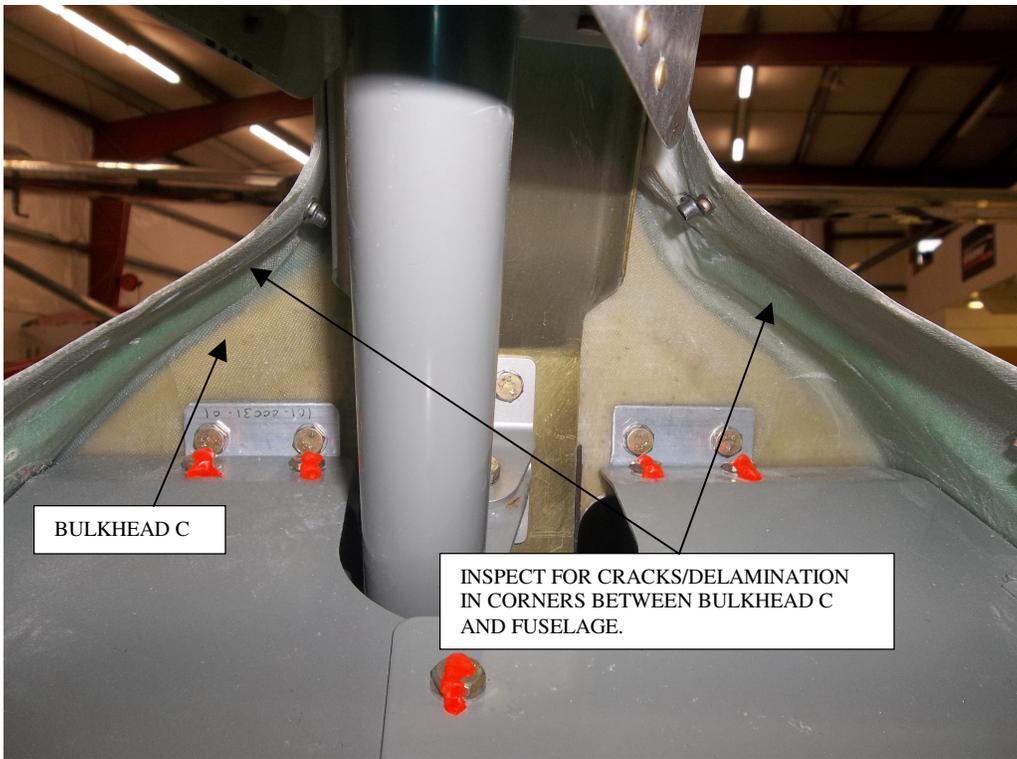
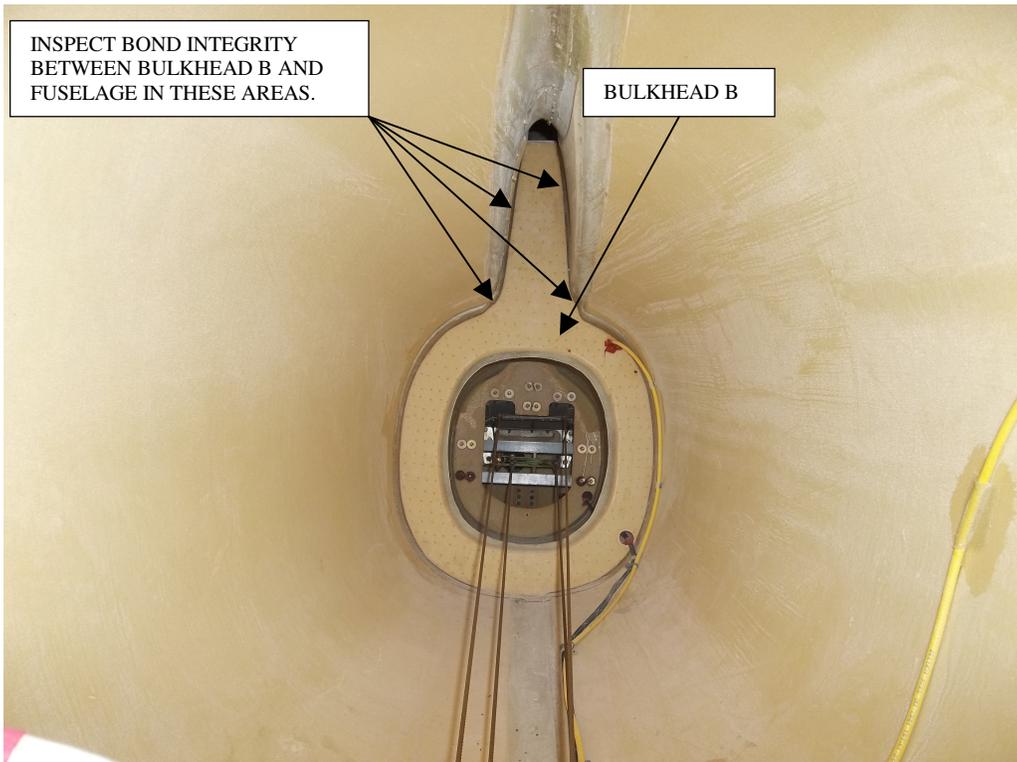
A few owners of Sportsman aircraft have reported cracks showing up at the aft base of the vertical fin and in some instances have reported cracking of the laminates and adhesion bond between bulkheads B and C and the vertical fin. Exterior cracking is most commonly found on the right-hand side where the vertical fin meets the aft fuselage at its base. The left-hand vertical fin is molded as a part of the fuselage, whereas the right-hand vertical fin half is bonded to the fuselage and vertical fin as a separate piece during fuselage assembly. The exterior cracks are commonly showing up along the bonding joint. Minor cracking may simply indicate separation of the cosmetic filler used in paint preparation.

Bulkhead B can be inspected by crawling into the aft fuselage. Bulkhead C can also be inspected from the inside, but is best inspected by removal of the rudder base fairing. If cracking or separation is evident in the bonding laminates between the upper portion of bulkhead C and the vertical fin, then deeper inspection will be necessary through the lower inspection hole or removal of the stabilizer.
