Glasair Service Bulletin 1

Subject: Nose Gear Scissors

Models Affected: RG Landing Gear #01-70

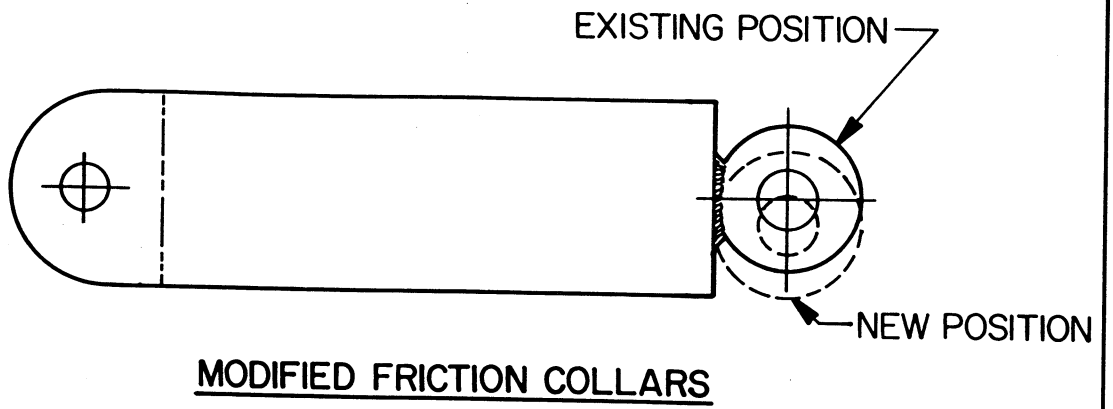
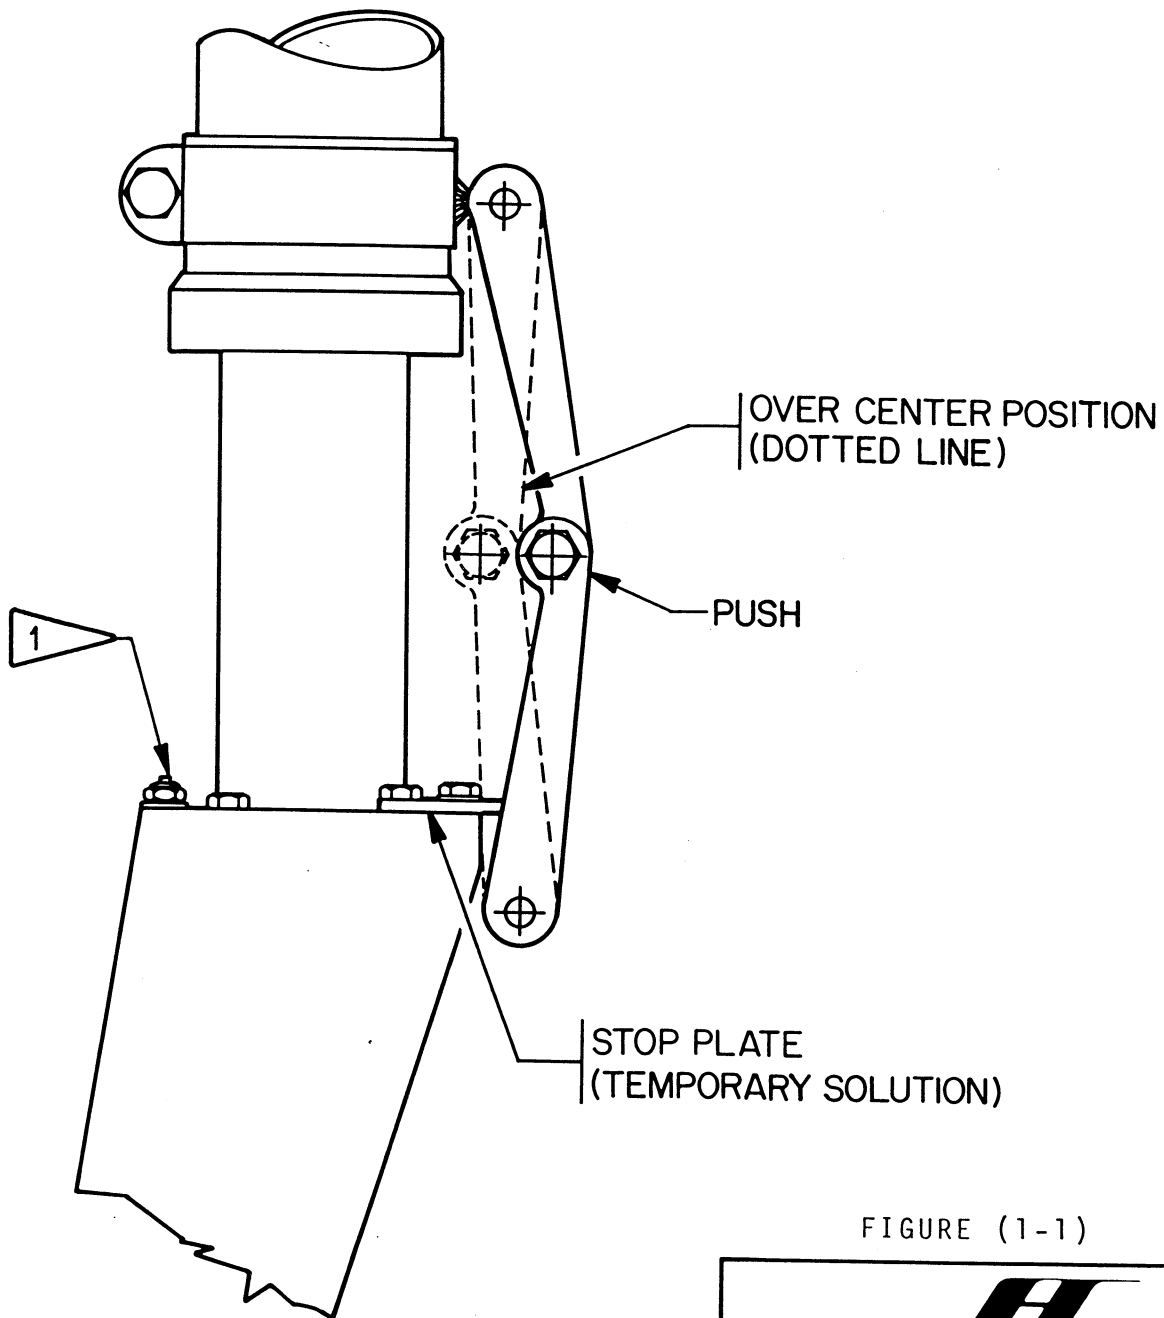
FIGURE (1-1)

On some of the nose gear struts in the first production run, the upper and lower pivot points for the scissors are too far apart, allowing the possibility of the scissors rotating over center and locking the oleo strut in its fully extended position.

To check your nose gear strut, first bolt the aft ends of the shimmy damper friction collars together using the AN hardware provided, as shown in FIGURE (3-23) on page 3-37 of the RG Appendix. Now, with the strut fully extended, push inward on the center pivot point of the scissors, as shown in FIGURE (1-1), using firm thumb pressure. If the scissors rotate to the over center position, shown by the dotted line in FIGURE (1-1), then a problem exists which must be remedied. Be aware that, with the gear struts fully extended, the nose gear scissors are normally in a flatter position than the main gear scissors, and also that rubber O-rings are used in the oleo struts to cushion the extension stop. So, do not use excessive force to accomplish this test; just use firm thumb pressure.

The aft bolt that holds the nose gear fork to the oleo strut, referenced by Flag #1 in FIGURE (1-1), may rub on the tire. This bolt should already have been installed with the head toward the tire but, in some instances, there is still too little clearance. If this is the case, remove the bolt and countersink the bolt hole (on the side toward the tire) for an AN509-10R14 screw. We will supply the screw, if needed.

If your testing shows a problem to exist with the main gear scissors, we will exchange your shimmy damper friction collars with a modified set on which the scissors boss has been lowered 1/8". The collars can easily be replaced with the nose gear struts mounted on the airplane. These modified parts should be ready for shipment in the near future.

If you planned to have your airplane flying before parts are available, fabricate a stop plate and bolt it to the nose gear fork, as shown in FIGURE (1-1), to keep the scissors from rotating to the over center position. This stop plate can be removed after you receive and install the modified friction collars.

NOTE: In extreme cases all three of the aft bolts will need to be inverted and countersunk.
