SERVICE BULLETIN 7

MODEL  
GLASAIR FT

DATE  
10/17/85

SUBJECT: WELDS OMITTED ON GLASAIR FT INBOARD RIB ATTACH BRACKET

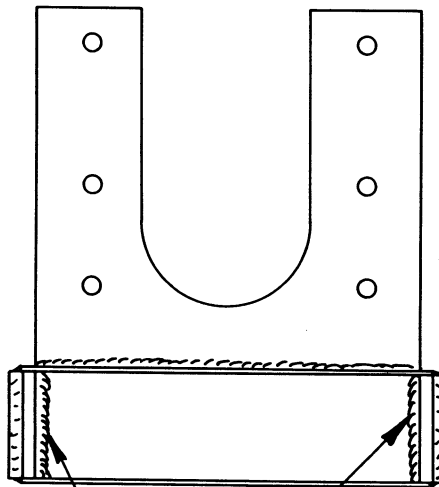
SIDE VIEW

WELDS REQUIRED HERE  
(BOTH SIDES OF BRACKET)

DESCRIPTION: The inboard rib attach bracket delivered with your Glasair FT landing gear hardware omitted four necessary welds. Without these welds, shown in FIGURE (1), the component lacks the necessary strength to withstand possible loads imposed by the landing gear.

SOLUTION: The omitted welds must be completed, using either the oxy-acetylene or gas tungsten arc welding (TIG) process, before the airplane is flown. The builder has the choice of completing these welds himself or shipping the bracket to us for welding in our shop.

Since the cadmium plating will be burned off by welding, the part must either be replated or painted for corrosion protection.
