MODEL  
GLASAIR FT

ASSEMBLY NAME  
SERVICE BULLETIN 7

SUBJECT: WELDS OMITTED ON GLASAIR FT INBOARD RIB ATTACH BRACKET

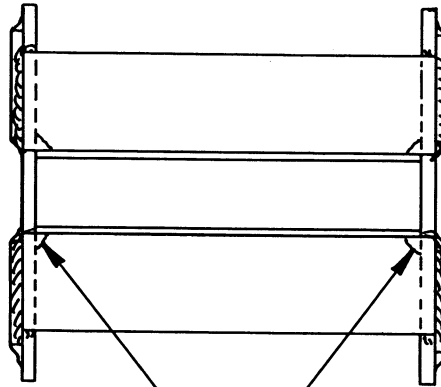
PLAN VIEW

WELDS REQUIRED HERE  
(BOTH SIDES OF BRACKET)

DESCRIPTION: The inboard rib attach bracket delivered with your Glasair FT landing gear hardware omitted four necessary welds. Without these welds, shown in FIGURE (1), the component lacks the necessary strength to withstand possible loads imposed by the landing gear.

SOLUTION: The omitted welds must be completed, using either the oxy-acetylene or gas tungsten arc welding (TIG) process, before the airplane is flown. The builder has the choice of completing these welds himself or shipping the bracket to us for welding in our shop.

Since the cadmium plating will be burned off by welding, the part must either be replated or painted for corrosion protection.

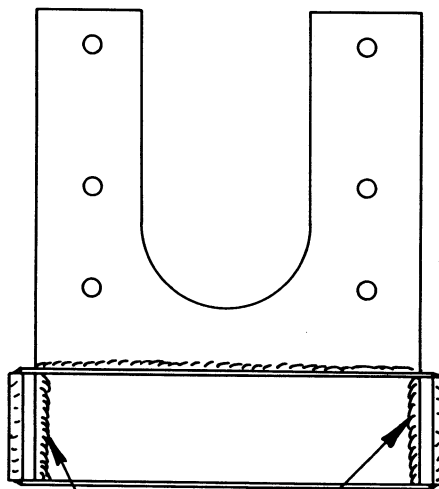
SIDE VIEW

WELDS REQUIRED HERE  
(BOTH SIDES OF BRACKET)
