SERVICE BULLETIN 9B

SUBJECT: Nose Gear Shimmy

APPLICATION: All Glasair RG aircraft.

STODDARD-HAMILTON
AIRCRAFT, INCORPORATED

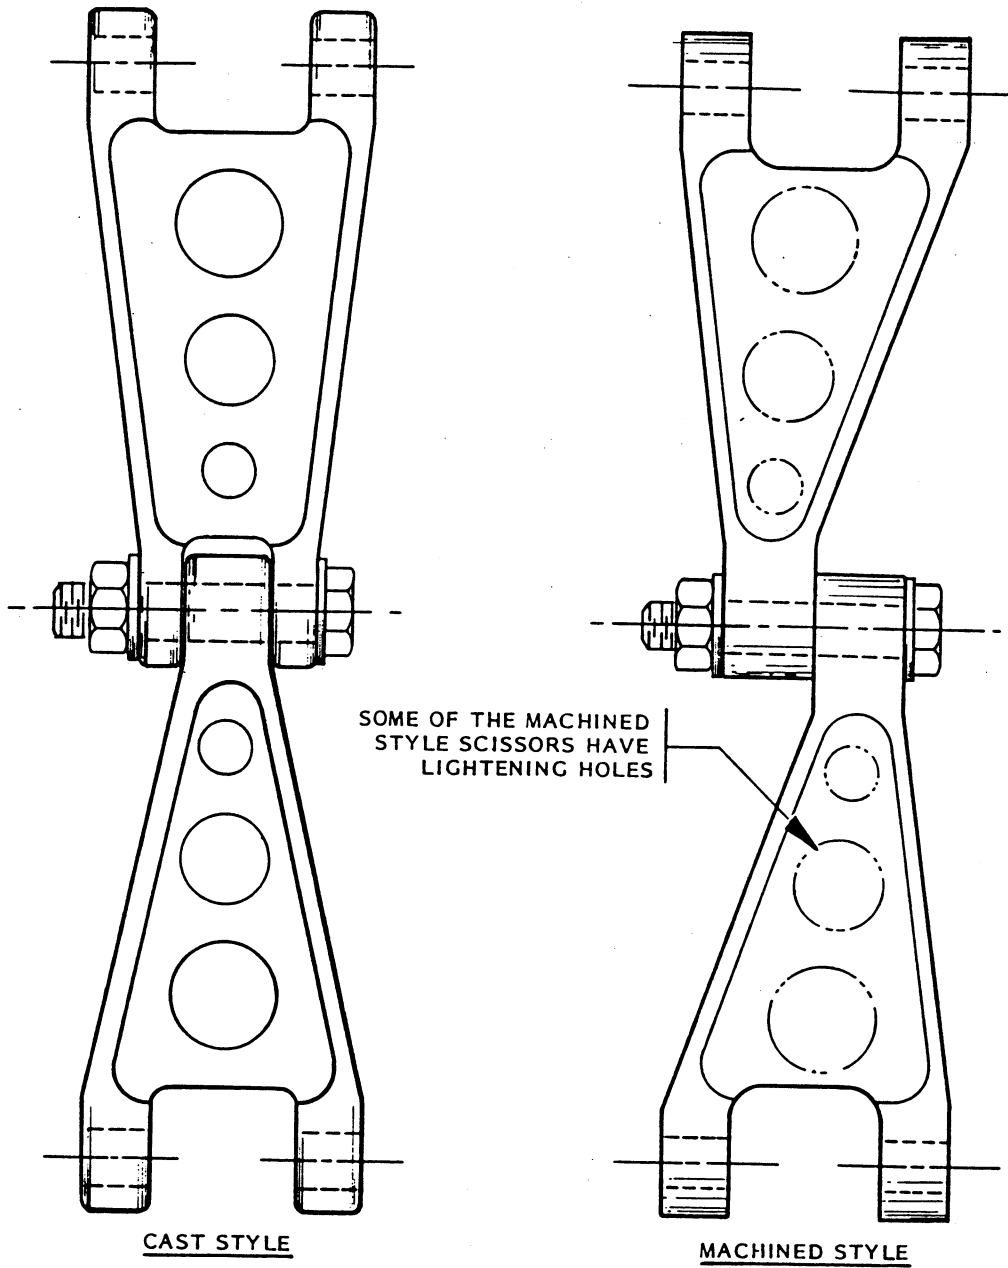
FIGURE (1)

Another possible source of play in the nose gear assembly is the Nyliner bushings used in the scissors pivot joints. If you are continuing to experience nose gear shimmy, and you have eliminated all the other potential causes discussed in Service Bulletin 9, you may want to consider replacing the Nyliner bushings in your nose gear scissors with aluminum bronze bushings.

NOSE GEAR SCISSORS

Two types of scissors have been used on Glasair RGs, as illustrated in FIGURE (1). An aluminum insert was used with some of the machined style scissors, allowing the aluminum bronze bushings to be pressed into place without any drilling or reaming.

To press the aluminum bronze bushings into place, the scissors must first be drilled and reamed to accommodate the larger outside diameter of the bushings.

CAUTION: It is very critical when drilling and reaming the scissors for the larger bronze bushings that proper alignment is maintained and the scissor lugs are not flexed. A drill fixture should be made to hold the scissors and a specially ground pilot ream should be used. It is very likely that the scissors could be ruined if these holes are not properly drilled.

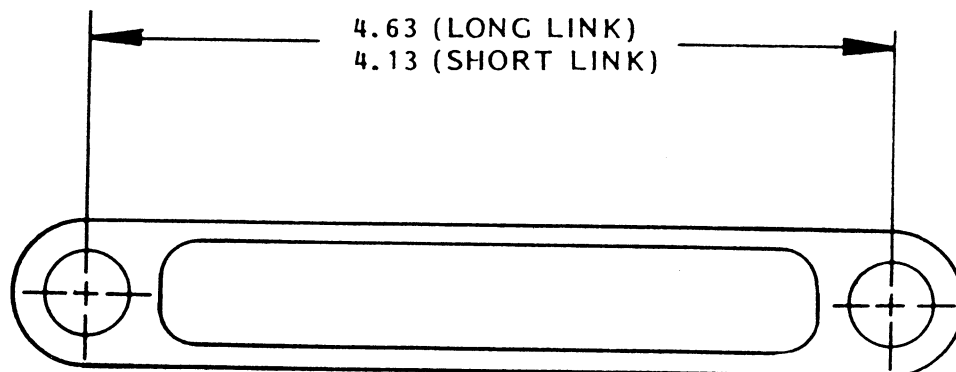
FIGURE (2)

The installation of a longer drag link may have had the effect of reducing nose gear shimmy on one Glasair RG with which we experimented. The longer drag link was standard equipment in the first 70 sets of RG landing gear but we went to a shorter link on later gear to make the airplane easier to steer. The effect of the longer link when the gear is extended is to angle the strut out farther toward the front slightly, increasing the amount of caster which may tend to stabilize the nose wheel.

NOSE GEAR DRAG LINK

To determine if you have the longer or shorter drag link, measure between the centers of the two drag link pivot bolts, as shown in FIGURE (2). The short link is 4.13 in. between pivot centers; the longer link is 4.63 in. between centers, as shown.

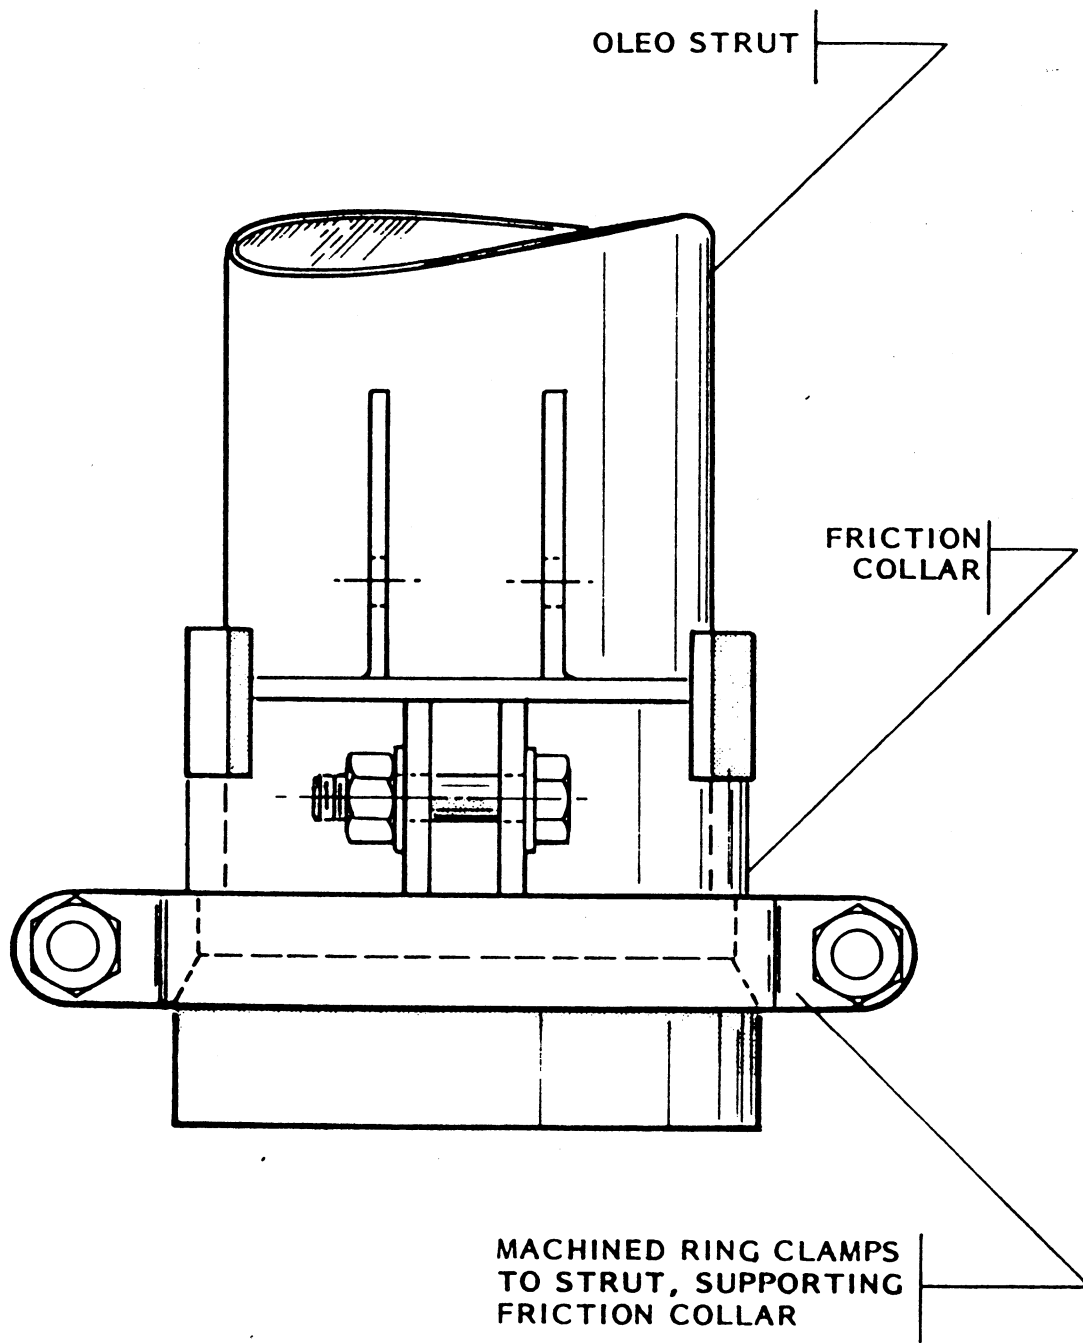
Another area of possible contribution to shimmy is "racking" of the friction collar clamps. The lower edge of the friction collar is chamfered to clear the cylinder/gland weld which allows the collar to rack slightly when load is applied. Ideally, the collar needs to be captured snugly in a recess.

A possible method of stabilizing the friction collars is a lower clamping ring for the nose gear oleo strut. This ring would clamp around the strut just below the friction collar recess and would provide a surface for the collars to bear against, preventing the collars from racking under load. See FIGURE (3) for a clarification of this concept.
