SERVICE BULLETIN 9B

SUBJECT: Nose Gear Shimmy

APPLICATION: All Glasair RG aircraft.

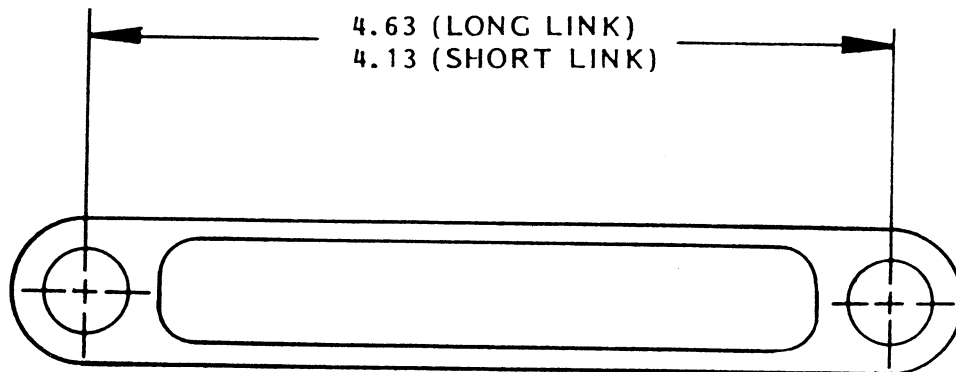
FIGURE (2)

The installation of a longer drag link may have had the effect of reducing nose gear shimmy on one Glasair RG with which we experimented. The longer drag link was standard equipment in the first 70 sets of RG landing gear but we went to a shorter link on later gear to make the airplane easier to steer. The effect of the longer link when the gear is extended is to angle the strut out farther toward the front slightly, increasing the amount of caster which may tend to stabilize the nose wheel.

To determine if you have the longer or shorter drag link, measure between the centers of the two drag link pivot bolts, as shown in FIGURE (2). The short link is 4.13 in. between pivot centers; the longer link is 4.63 in. between centers, as shown.
