SERVICE BULLETIN 12

SUBJECT: F3416M ROD END BEARINGS

APPLICATION: Service Bulletin 12 applies to Glasair airframe kits through serial number 795. This includes kits shipped on or before 4/30/86.

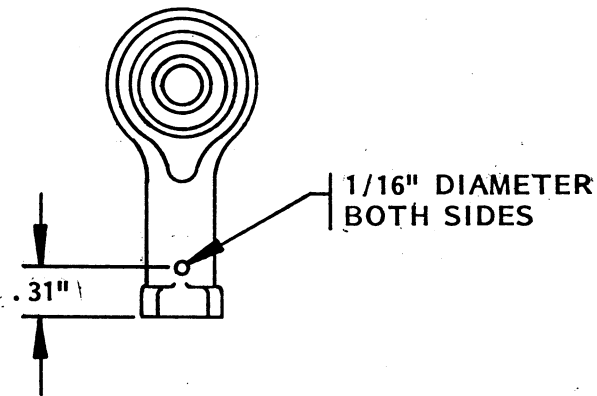
FIGURE (1)

DESCRIPTION: Some of the F3416M rod end bearings shipped with recent kits lack the two small inspection holes that are necessary to determine if the rod ends are threaded onto their actuator rods sufficiently.

The rod end bearings must be modified to allow inspection for adequate threading onto the rod ends. Using a 1/16" drill bit, drill holes through both sides of the rod end bearing. Locate the holes .31" from the threaded end of the bearing, as shown in FIGURE (1).
