SERVICE BULLETIN 44, Revision A

SUBJECT: GLASAIR FT NOSE LANDING GEAR MODIFICATION

APPLICATION: All Glasair I FT aircraft

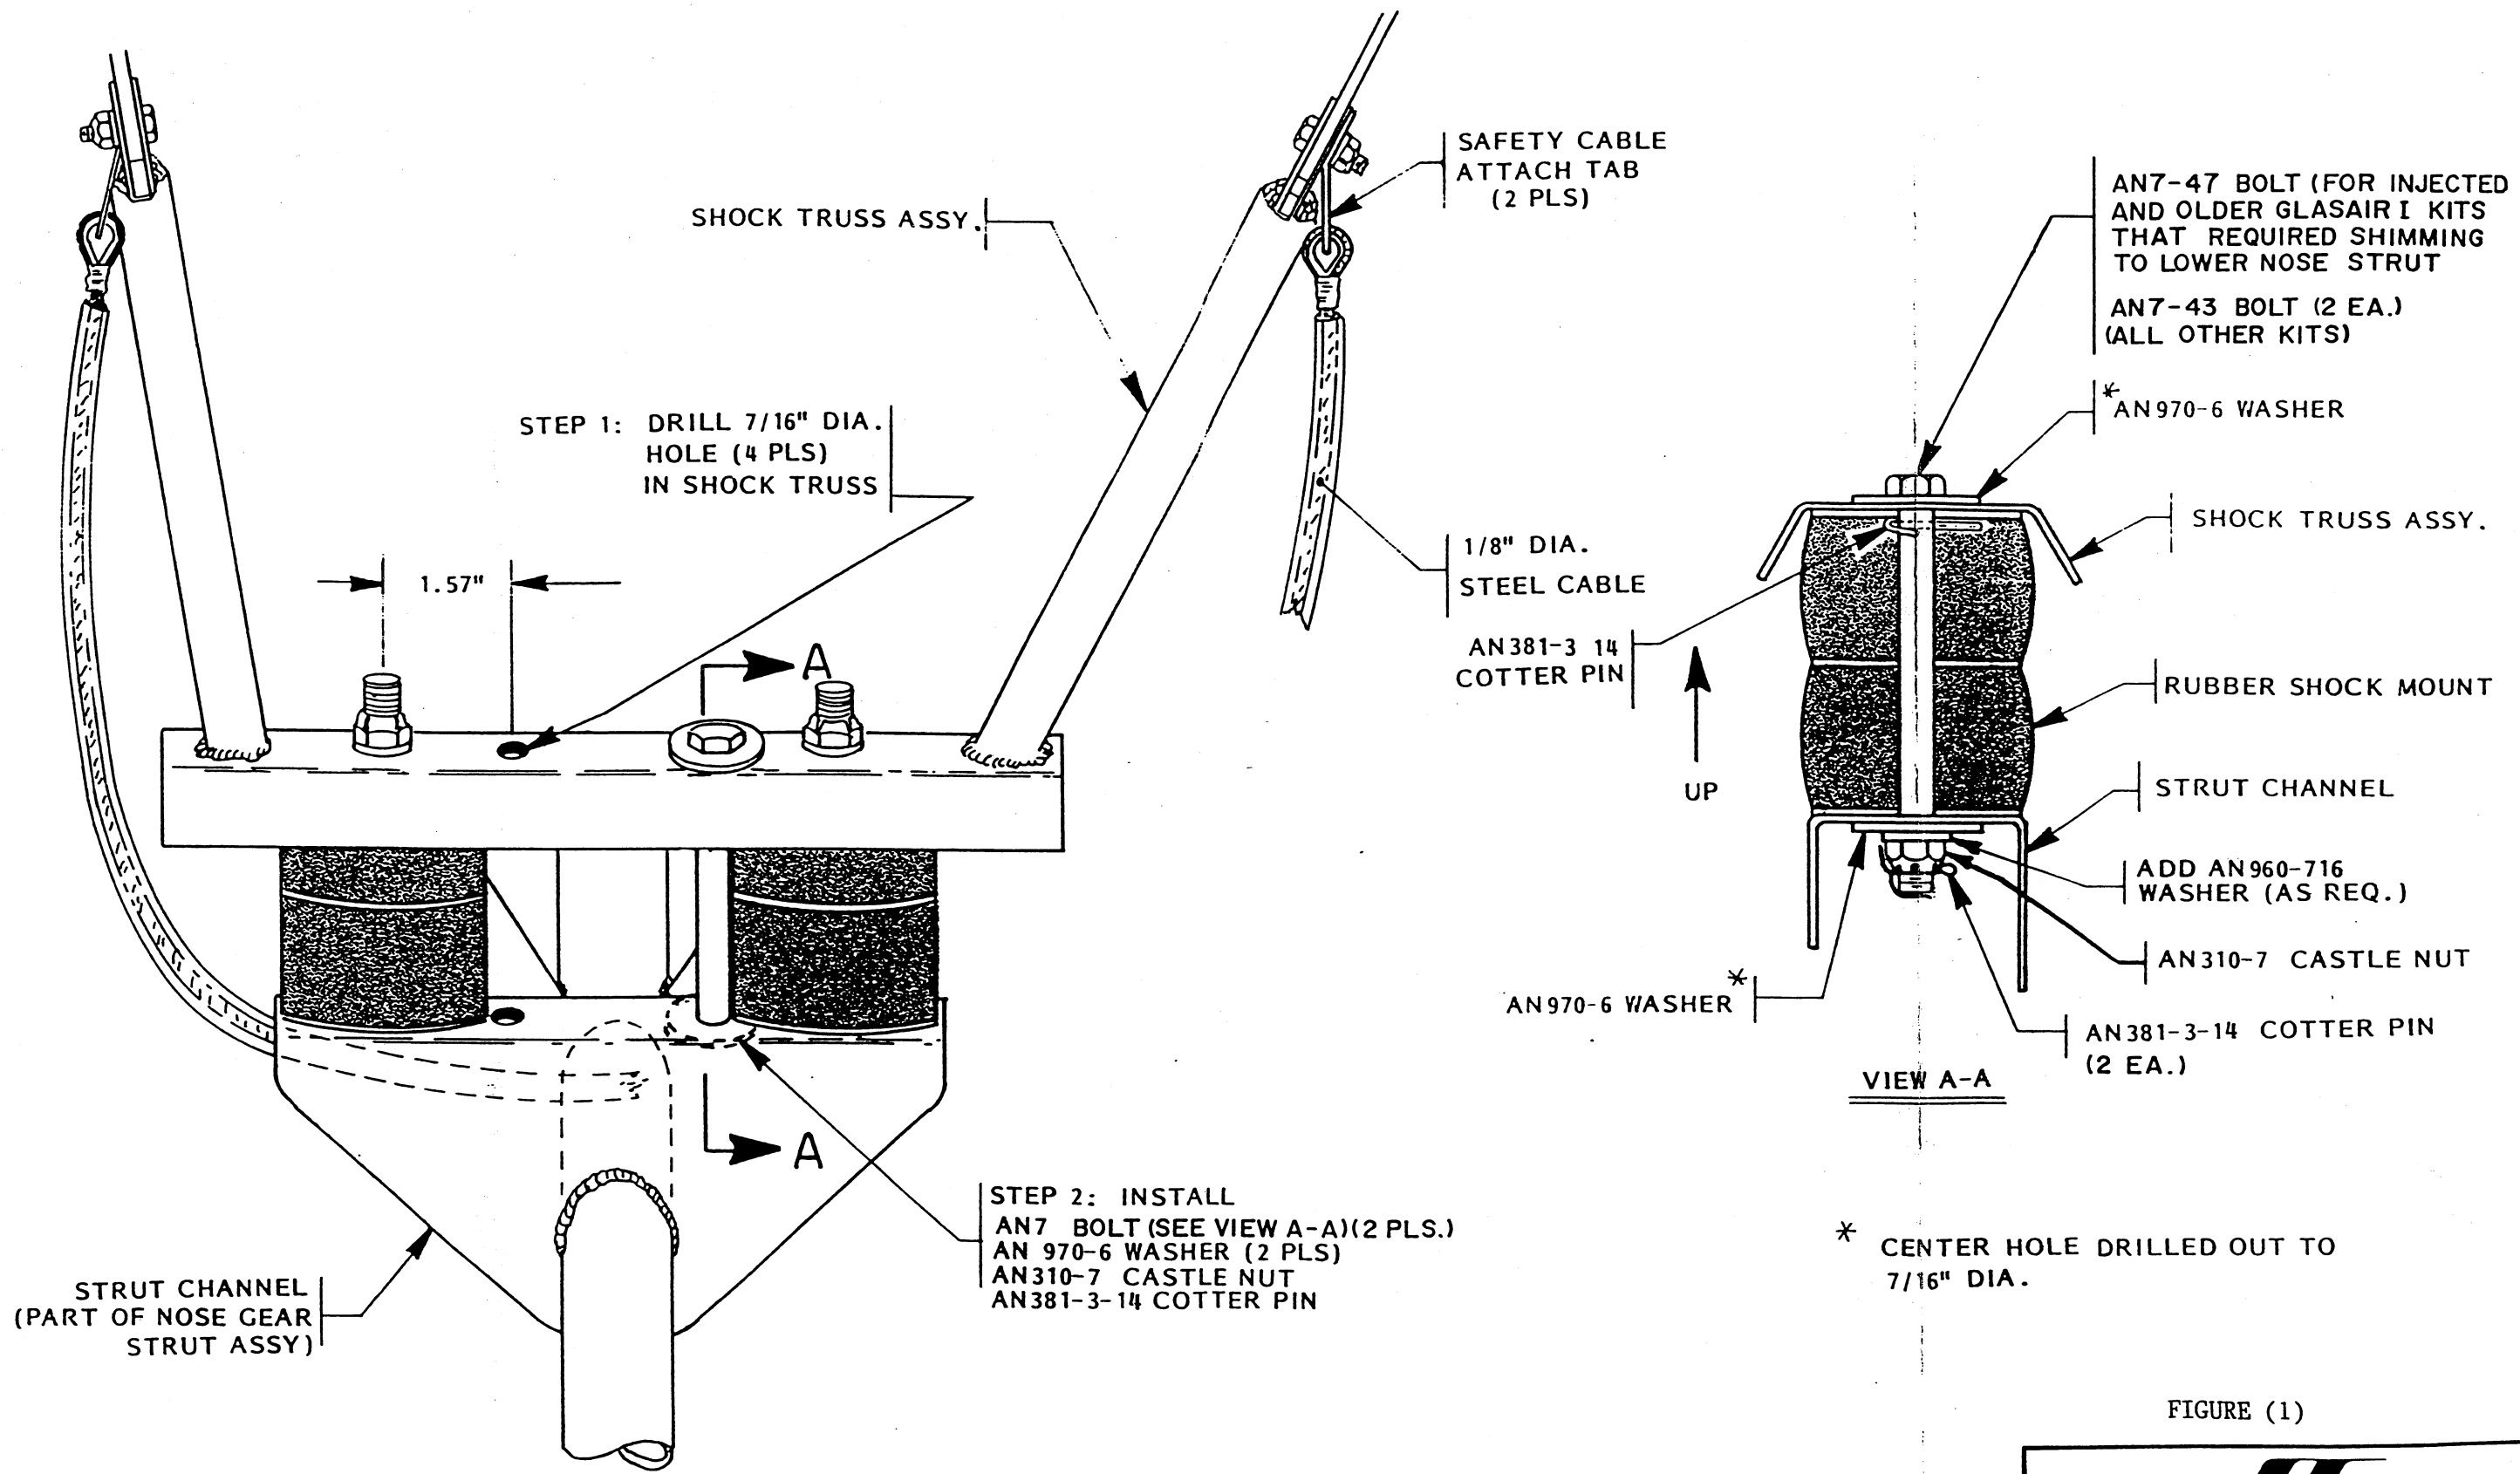
FIGURE (1)

DESCRIPTION: The single length of 1/8" diameter safety cable has been found to be inadequate to withstand the drag loads imposed on it during some unusual landing conditions. Builders have experienced failure of the safety cable and subsequent shearing of the rubber shock mounts. The result has been for the nose gear assembly to fold under the airplane and to either shear off or cause the airplane to slide on its lower cowling.

After receiving reports of two separate Glasair FT accidents involving failure of the nose gear strut assembly, Stoddard Hamilton Aircraft has investigated and tested both the strength of the gear strut and the drag load capability of the truss assembly. Although the nose gear strut itself proved to be very strong, the drag load capability of the truss assembly installation was marginal. Strengthening of the truss attachment per this Service Bulletin has proved to be a suitable fix both in destructive and non-destructive testing performed at our facilities.

SOLUTION: To prevent the drag landing gear loads from being absorbed by the rubber shock mounts and the safety cable, we require the installation of (2) AN7 bolts between the shock truss assembly and the nose landing gear strut channel. All drag loads will be transferred to these bolts and will not be transferred to the rubber shock mounts which are designed only to handle compression loads. Older Glasair I's and Glasair I's with injected engine mounts require AN7-47 bolts. All other Glasair FT's which did not need shims in the shock absorber assembly to lower the nose gear strut require AN7-43 bolts.

5. Assemble the shock truss assembly to the strut channel assembly using the rubber shock mounts. Insert the AN7 bolts and washers into the landing gear assembly, as shown in View A-A FIGURE (1).

NOTE: If interference problems exist between the bolt heads and cables or wires immediately around them, drill a 3/32" Dia. hole in each bolt shank immediately below the shock truss assembly, as shown in View A-A FIGURE (1). Install a AN381-3-14 cotter pin to restrict the upward movement of the bolt, in the shock truss assembly.

STEP 1: DRILL 7/16" DIA. HOLE (4 PLS) IN SHOCK TRUSS

STEP 2: INSTALL AN7 BOLT (SEE VIEW A-A)(2 PLS.) AN 970-6 WASHER (2 PLS) AN310-7 CASTLE NUT AN381-3-14 COTTER PIN
