SERVICE BULLETIN 71 REVISION A MANDATORY

SUBJECT: INSPECTION REQUIREMENTS FOR GLASAIR III ENGINE MOUNTS

APPLICATION: All Glasair III aircraft with more than 100 hours logged on the airframe and with an engine mount that was shipped before 12/11/89.

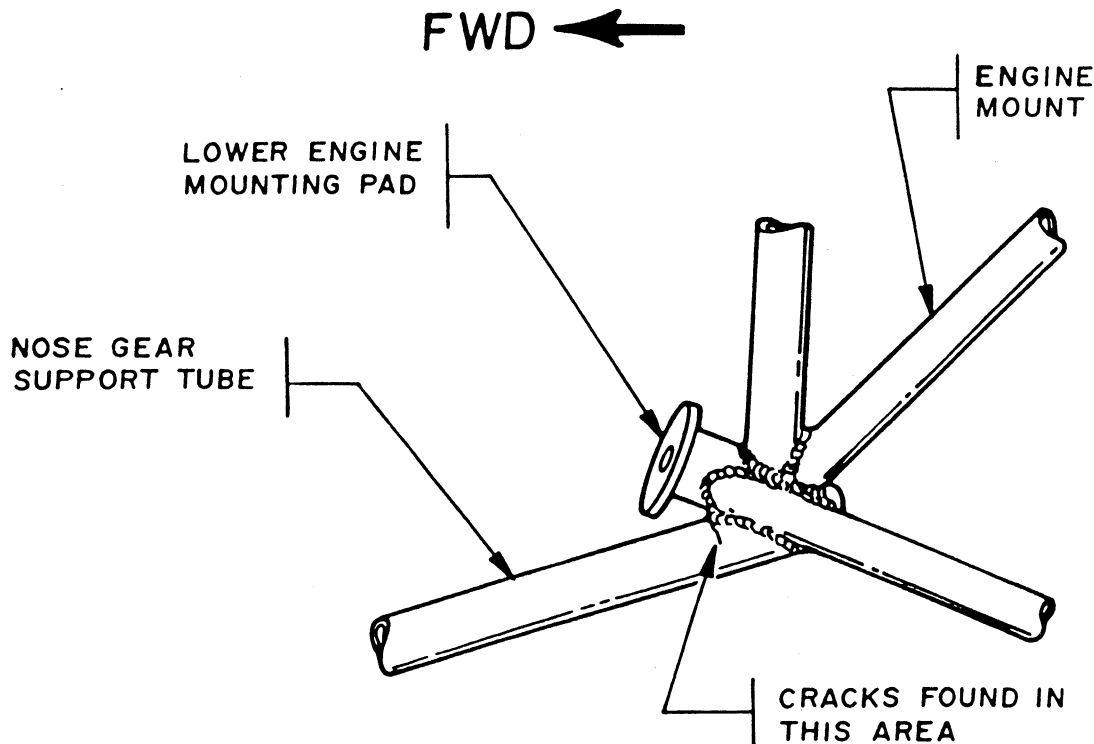
FIGURE (1)

DESCRIPTION: During an inspection of our Glasair III prototype, we found cracks in the engine mount nose gear support tubes. The aircraft has over 950 hours logged with extensive aerobatics over the past three years. The cracks begin at the forward sides of the welds that attach the large nose gear support tubes to the lower engine mount points, as shown in FIGURE (1).

If your Glasair III has accumulated more than 100 hours of flight time, visually inspect the engine mount for cracks in the areas indicated in FIGURE (1).

If cracks are found, please contact Stoddard-Hamilton Aircraft's product support division for a description of repair procedures.

WARNING: If no cracks are found, continue to visually inspect this area every 25 hours or until reinforced per supplement A Revision B to this bulletin, not to exceed 200 hours total time in service.
