SERVICE BULLETIN 71 SUPPLEMENT A REVISION C MANDATORY

SUBJECT: REINFORCEMENT PROCEDURES FOR GLASAIR III ENGINE MOUNTS

APPLICATION: All black powder-coated engine mounts for Glasair III aircraft.

STODDARD-HAMILTON AIRCRAFT, INCORPORATED					
MODEL GLASAIR III	ASSEMBLY NAME SERVICE BULLETIN 71-A	REVISION C	DATE 1/2/96	VOLUME	PAGE 1 of 2

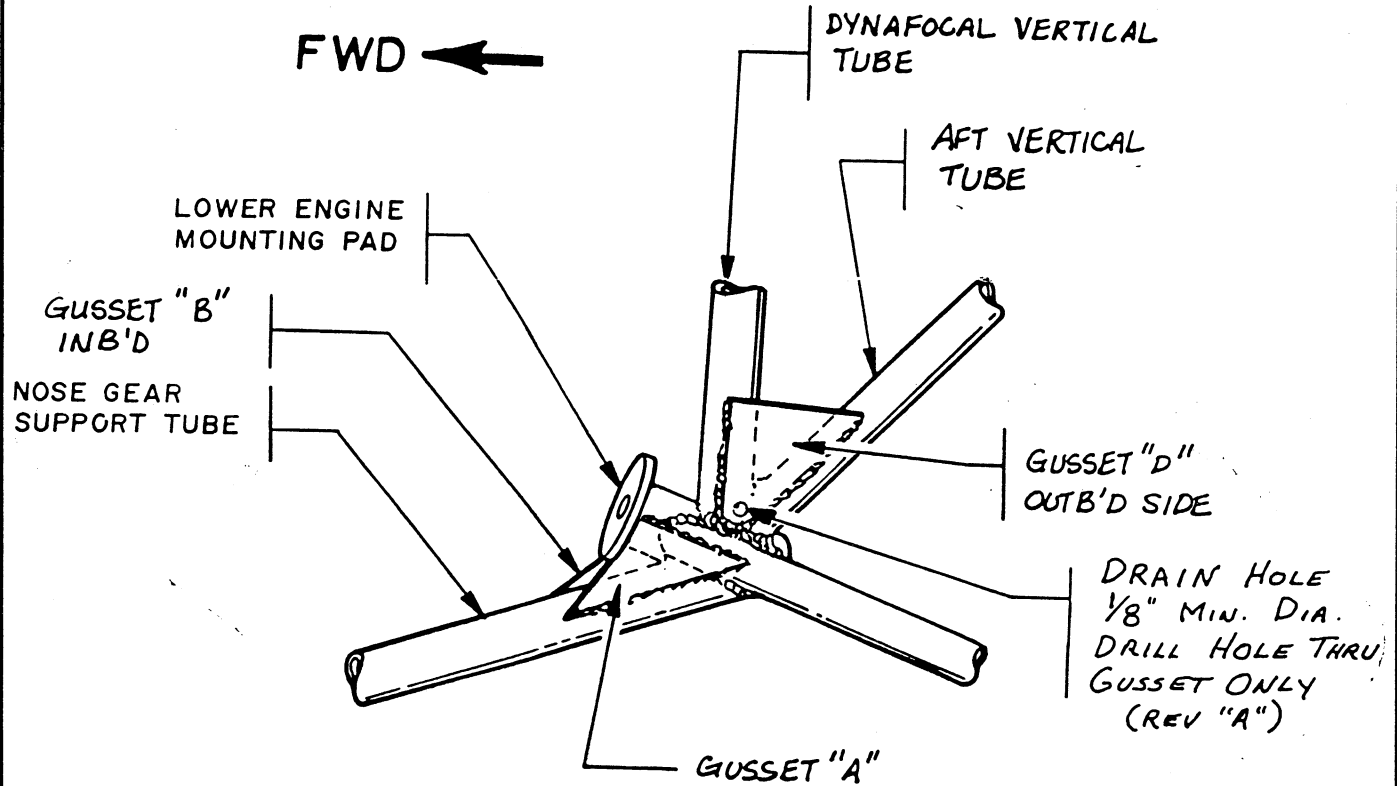
FIGURE (1)

DESCRIPTION: We require that all Glasair III engine mounts shipped prior to 12/11/89 be reinforced per the following instructions, as shown in FIGURE (1), before 200 hours total time in service have accumulated. Gussets A and B are to be welded to the sides of the cluster welds and the engine mount bushing tubes, as shown. Gussets D fit between the outboard sides of the vertical dynafocal tubes and the aft vertical tubes that angle up to the upper firewall attach points.

NOTE: Eight engine mounts shipped before 12/11/89 were reinforced with gussets A and B on each side, as shown in FIGURE (1). These engine mounts need only the additional D gusset on each side.

Fabricate two each of gussets A and B, using .090" thick 4130 steel sheet. Also fabricate two each of gusset D from .060" thick 4130 steel sheet. (Gusset D is thinner because the aft vertical engine mount tube has a thinner wall thickness than the others.)

Remove the engine mount paint locally in the areas to be welded. We recommend using paint remover and a wire brush or particle blasting.

WARNING: Since proper welding techniques must be used to achieve the necessary weld quality and to maintain the integrity of the engine mount, only an experienced welder should attempt this work. We recommend the TIG (tungsten-inert gas) welding process. The entire cluster weld must be stress relieved after welding.

After reinforcement, possible corrosion pockets exist between the D gussets and the engine mount tubes. To drain any liquid that might collect in these pockets, drill 1/8" diameter holes (minimum) through the D gussets at the lowest points of the pockets, as shown in FIGURE (1).

Thoroughly clean the reworked area and prime with an epoxy primer (available from a local auto body supply house). Finish the job with a high temperature flat black enamel.
