SERVICE BULLETIN 82 SUPPLEMENT A

SUBJECT: REWORKING THE GLASAIR III 90° INDUCTION ELBOW

APPLICATION: All Glasair III 90° induction elbows and support arms shipped before 10/8/90

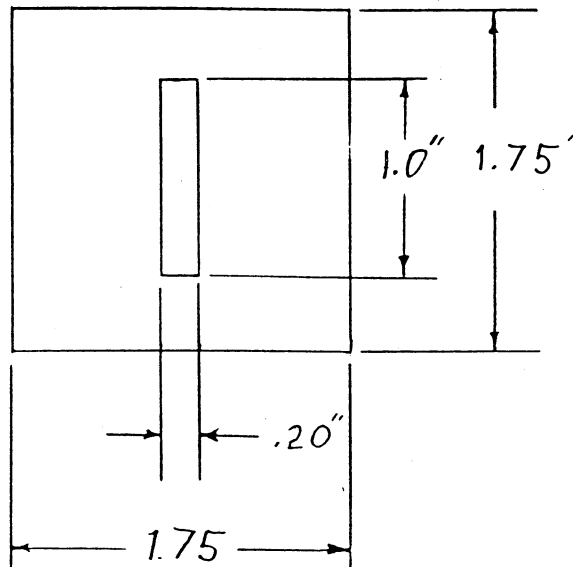
FIGURE (1)

Cracking found at the base of the welded control cable mounting tab in the two instances originally reported may have been the result of the metal being stretched too thin during the tube bending process to properly support the tab. To reinforce these areas, weld a 4130 steel sheet reinforcement patch around each of the control cable mounting tabs. The reinforcement patches must be slotted to slip over the tabs and formed to match the curvature of the tube by heating with a torch and hammering into shape.

Remove the cadmium plate in the areas where the welding will be done, and weld the patches to the elbow and all around the tabs. After welding, paint the elbow with an epoxy primer to protect against corrosion.

**NOTE:** If one of the control cable attach tabs is too short to accommodate the patch, cut off the tab and fabricate a new, slightly longer one from .125" thick 4130 steel sheet. Reweld the new tab in the same location and at the same angle as the original tab before welding the patch in place. This sequence ensures that the tab is attached to both layers of material for maximum strength.
