SERVICE BULLETIN 82 SUPPLEMENT A

SUBJECT: REWORKING THE GLASAIR III 90° INDUCTION ELBOW

APPLICATION: All Glasair III 90° induction elbows and support arms shipped before 10/8/90

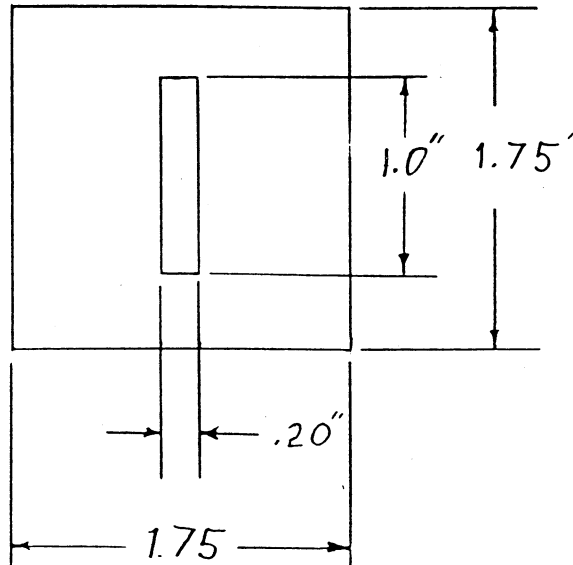
FIGURE (1)

REINFORCEMENT PATCH

.063" 4130 STEEL

Cracking found at the base of the welded control cable mounting tab in the two instances originally reported may have been the result of the metal being stretched too thin during the tube bending process to properly support the tab. To reinforce these areas, weld a 4130 steel sheet reinforcement patch around each of the control cable mounting tabs. The reinforcement patches must be slotted to slip over the tabs and formed to match the curvature of the tube by heating with a torch and hammering into shape.

Remove the cadmium plate in the areas where the welding will be done, and weld the patches to the elbow and all around the tabs. After welding, paint the elbow with an epoxy primer to protect against corrosion.

**WARNING:** Cadmium plating must be removed before welding; otherwise dangerous cyanide gas may be released by the heat of welding.

**NOTE:** If one of the control cable attach tabs is too short to accommodate the patch, cut off the tab and fabricate a new, slightly longer one from .125" thick 4130 steel sheet. Reweld the new tab in the same location and at the same angle as the original tab before welding the patch in place. This sequence ensures that the tab is attached to both layers of material for maximum strength.
